# Big Cypress Basin Field Station Activity Report

Juan Bethencourt  
Superintendent  
August 27, 2020

# Merritt/S-488 Pump Station ME#1 Repair

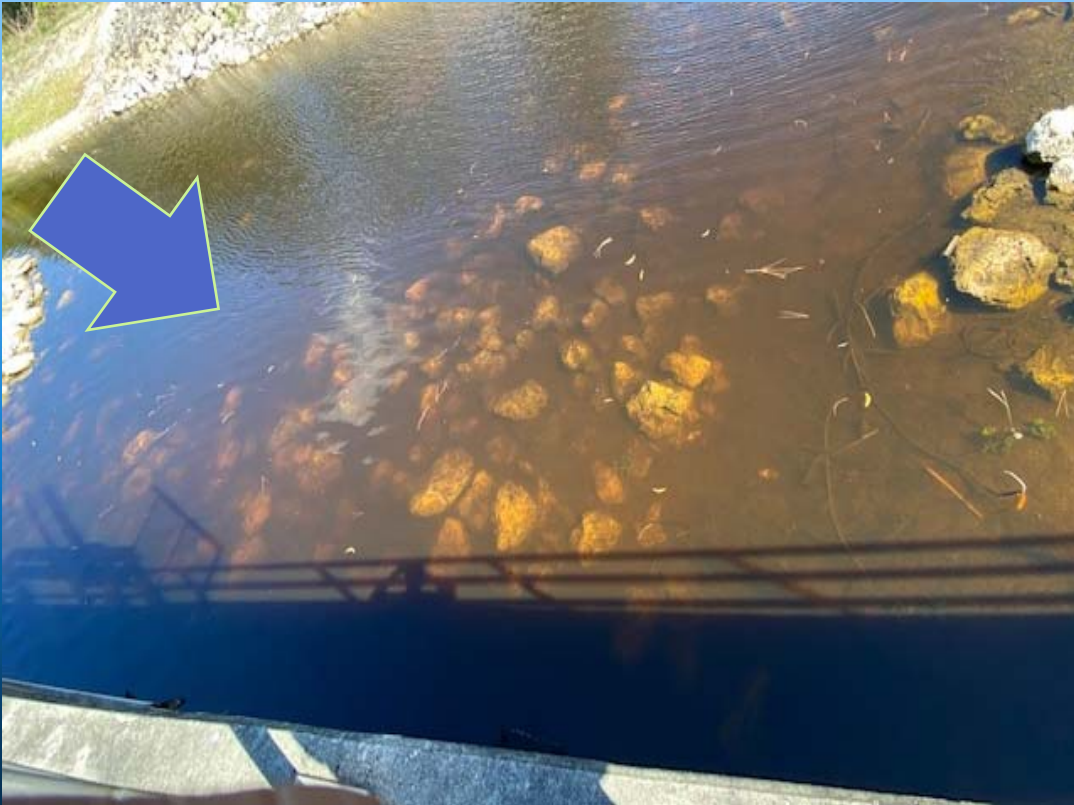
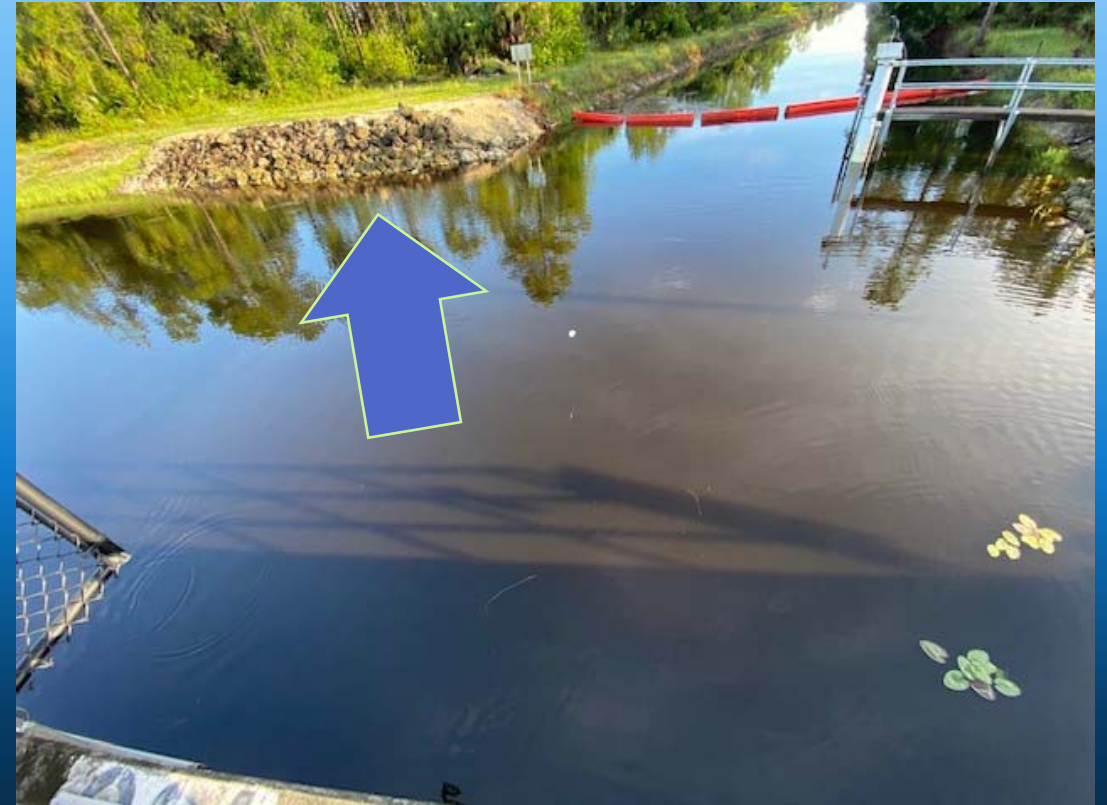
Corkscrew Canal Bank Repairs

Before

After

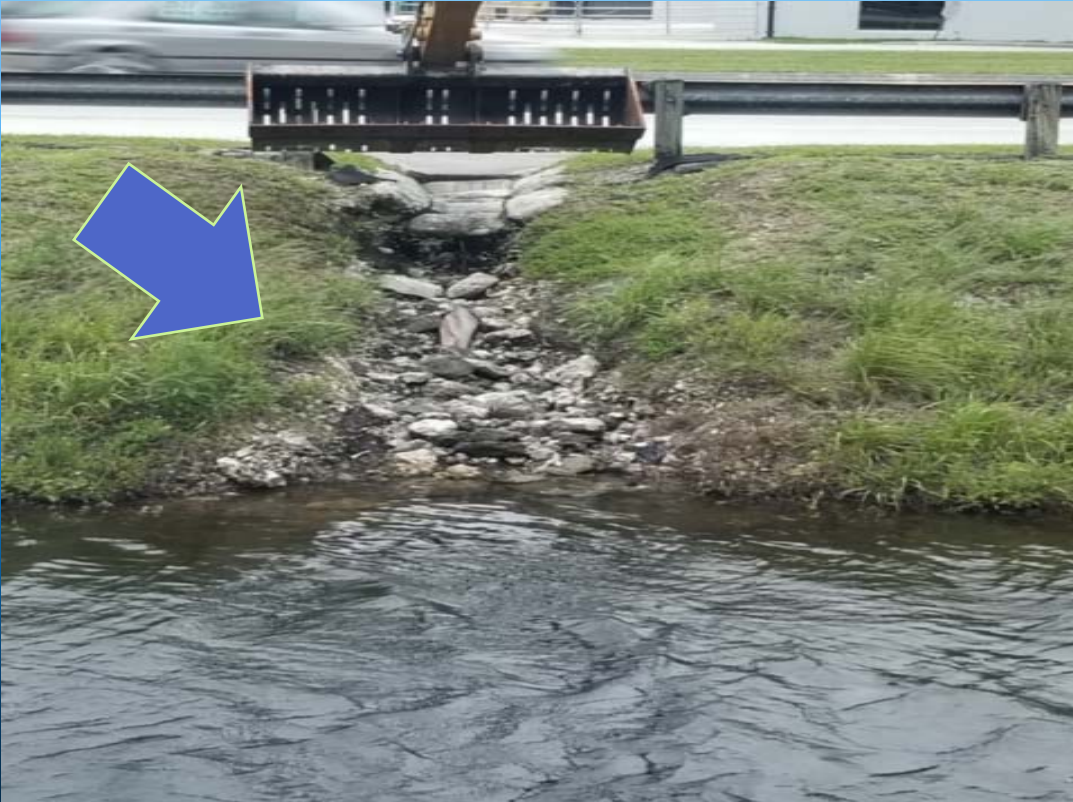
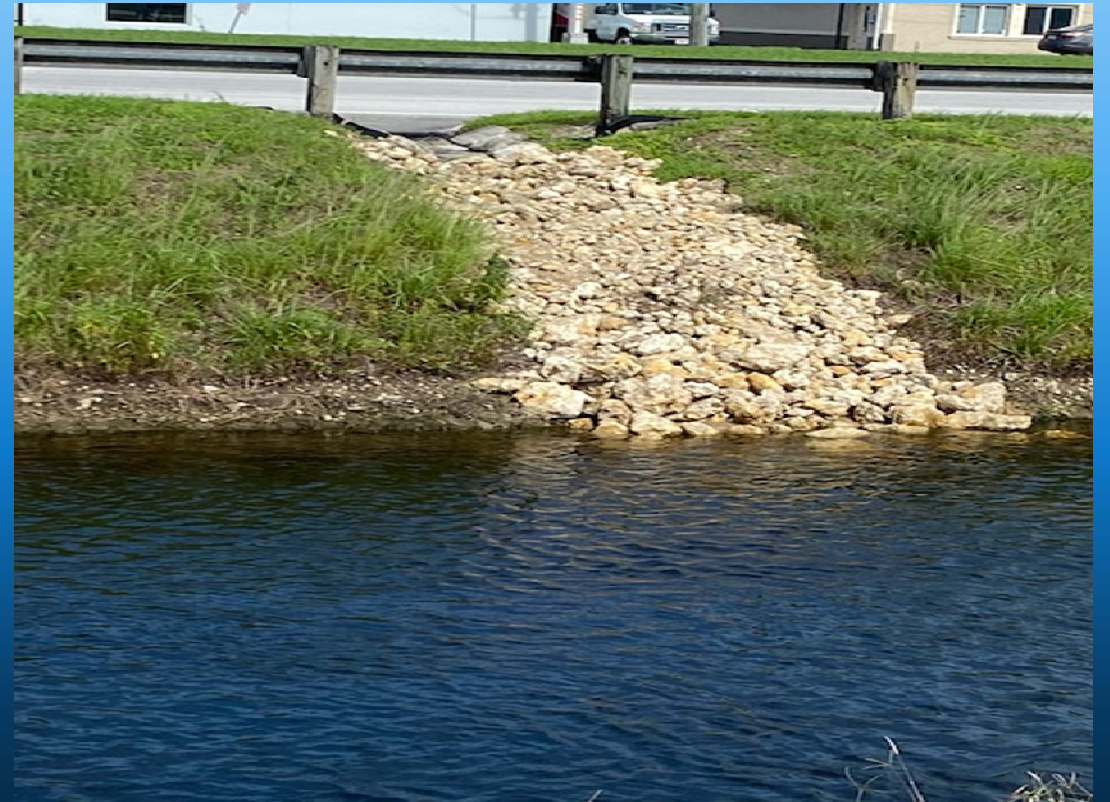
951 Canal Bank Repairs

Before

After

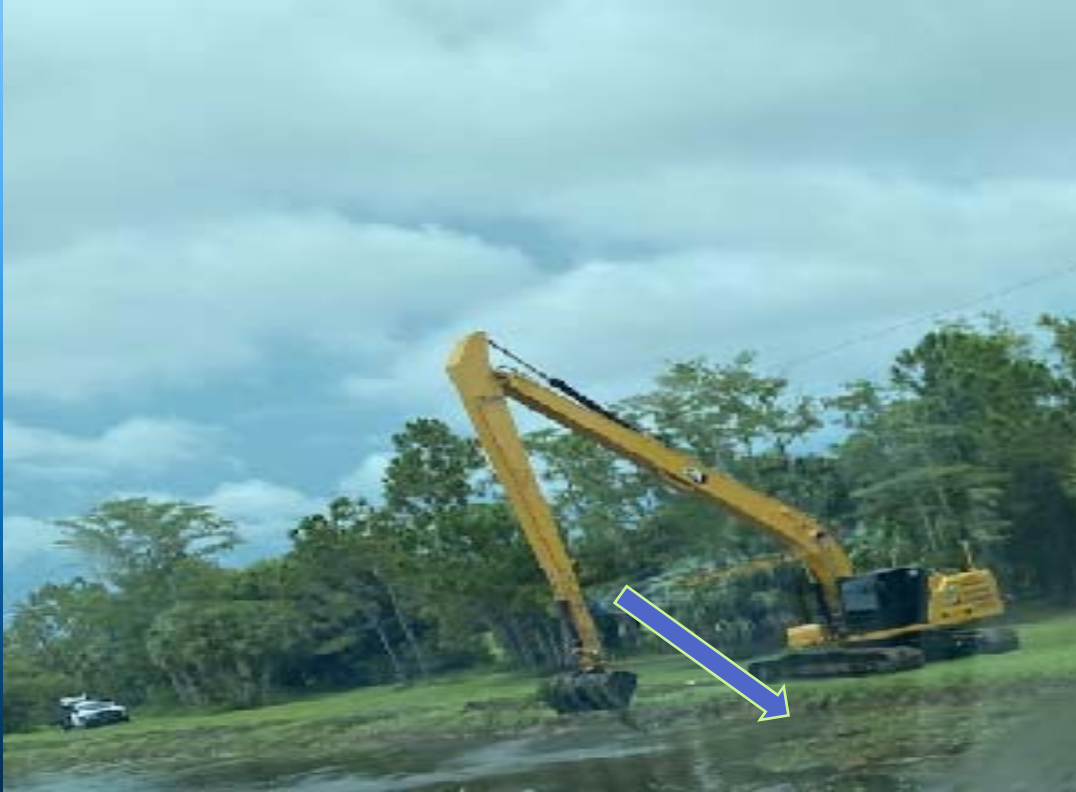
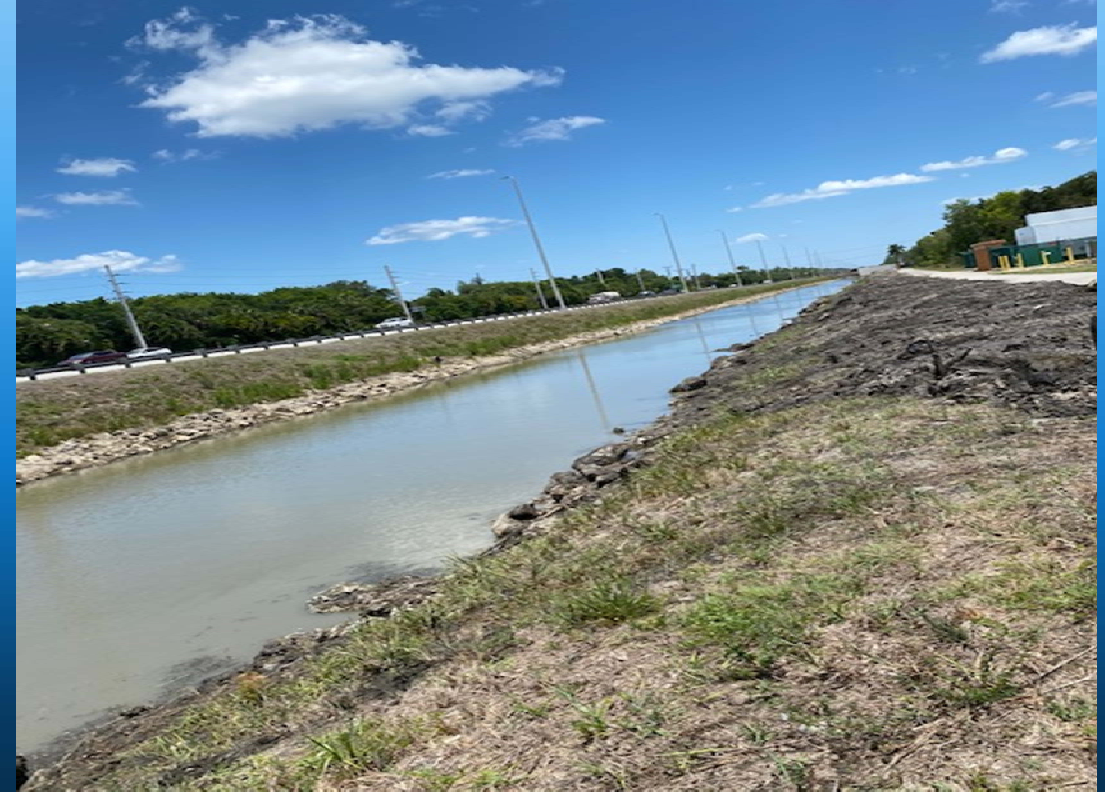
Henderson Canal Vegetation Removal

Before

After

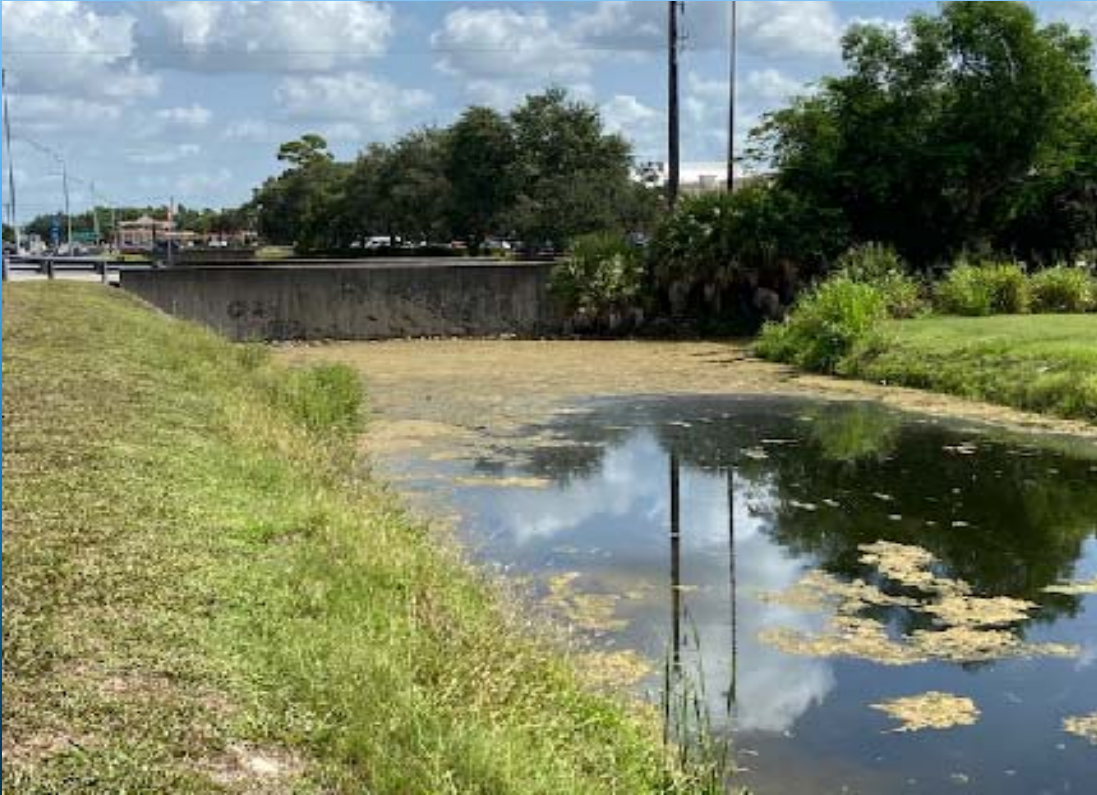
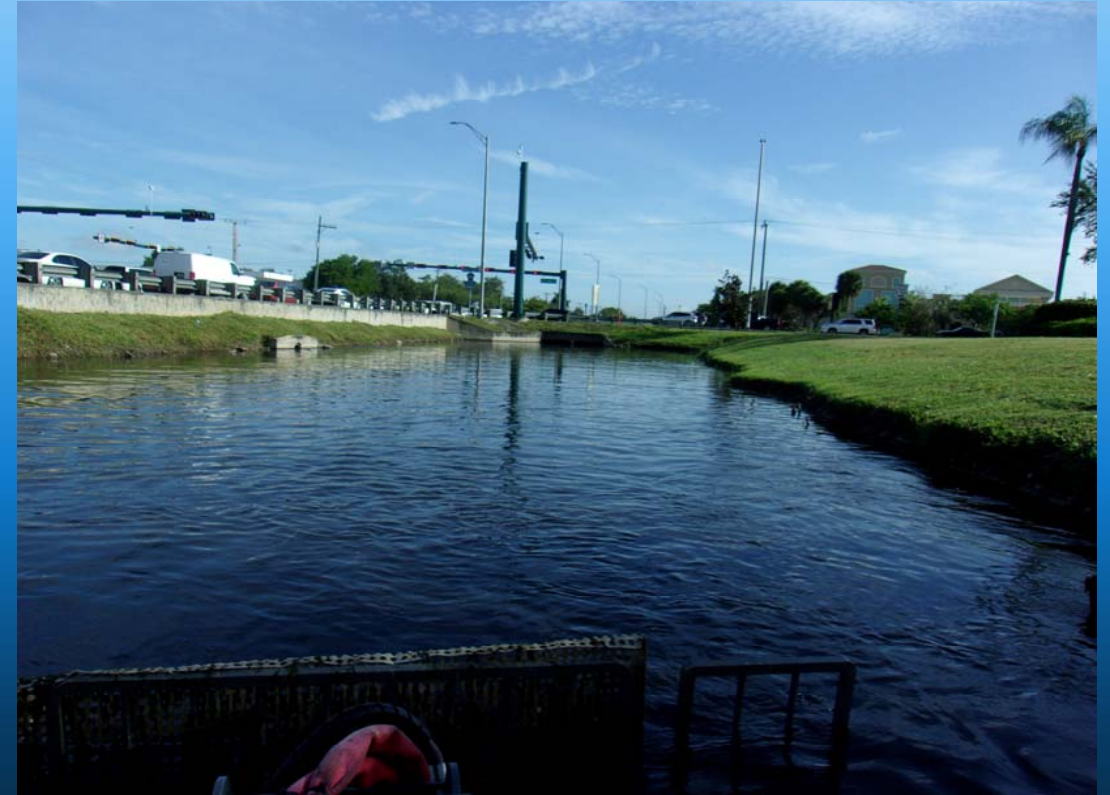
Airport Canal Vegetation Removal

Before

After

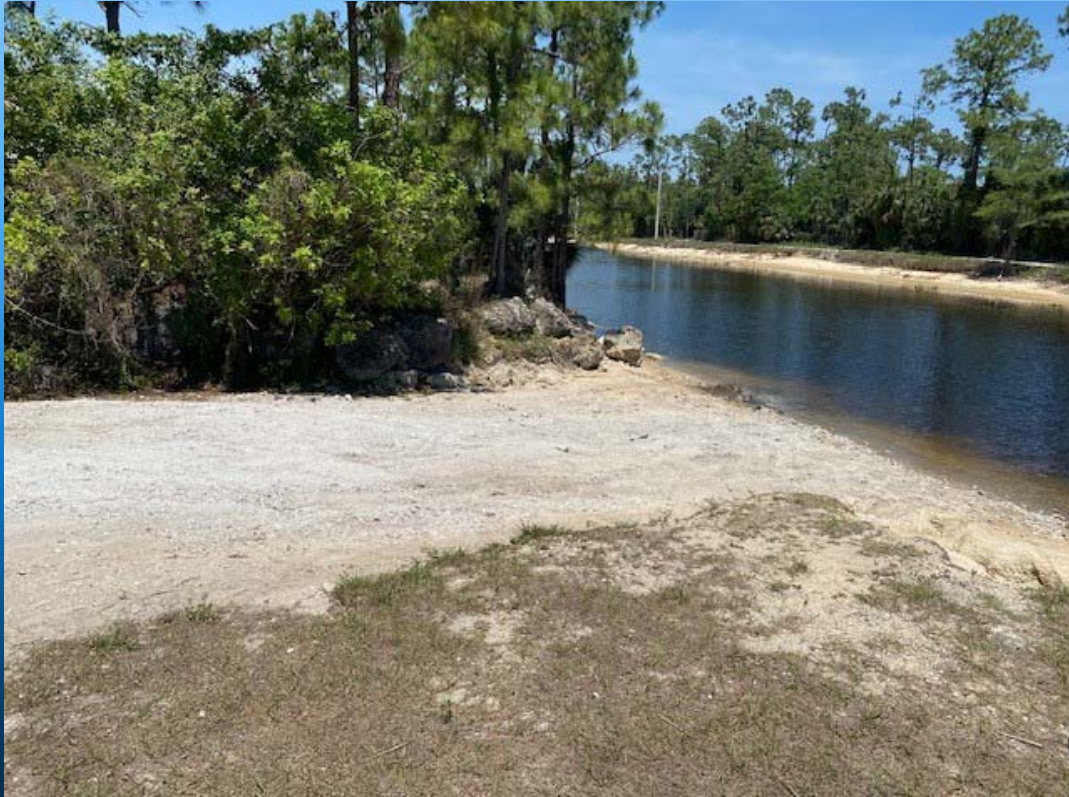
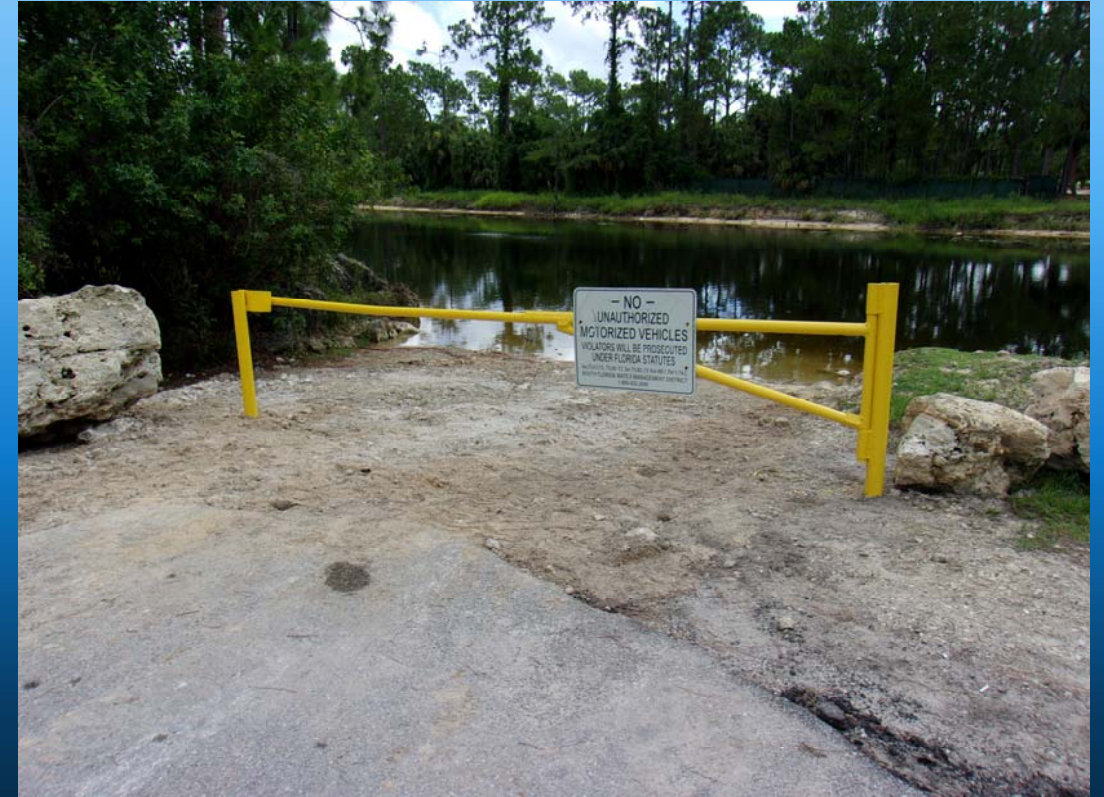
GG Canal Access Ramp # 32 - Bar Gate Installation

Before

After

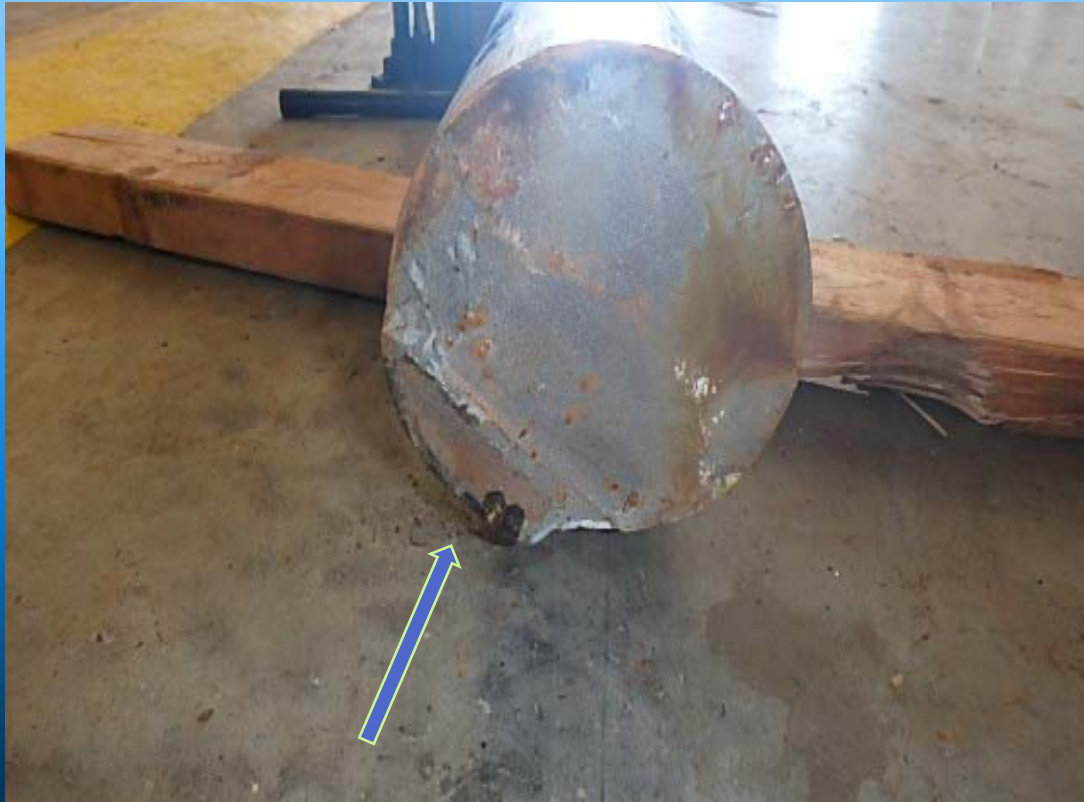
On June 8<sup>th</sup>, 2020 during preventive maintenance inspections a broken shaft was found on main engine #1

Broken Shaft

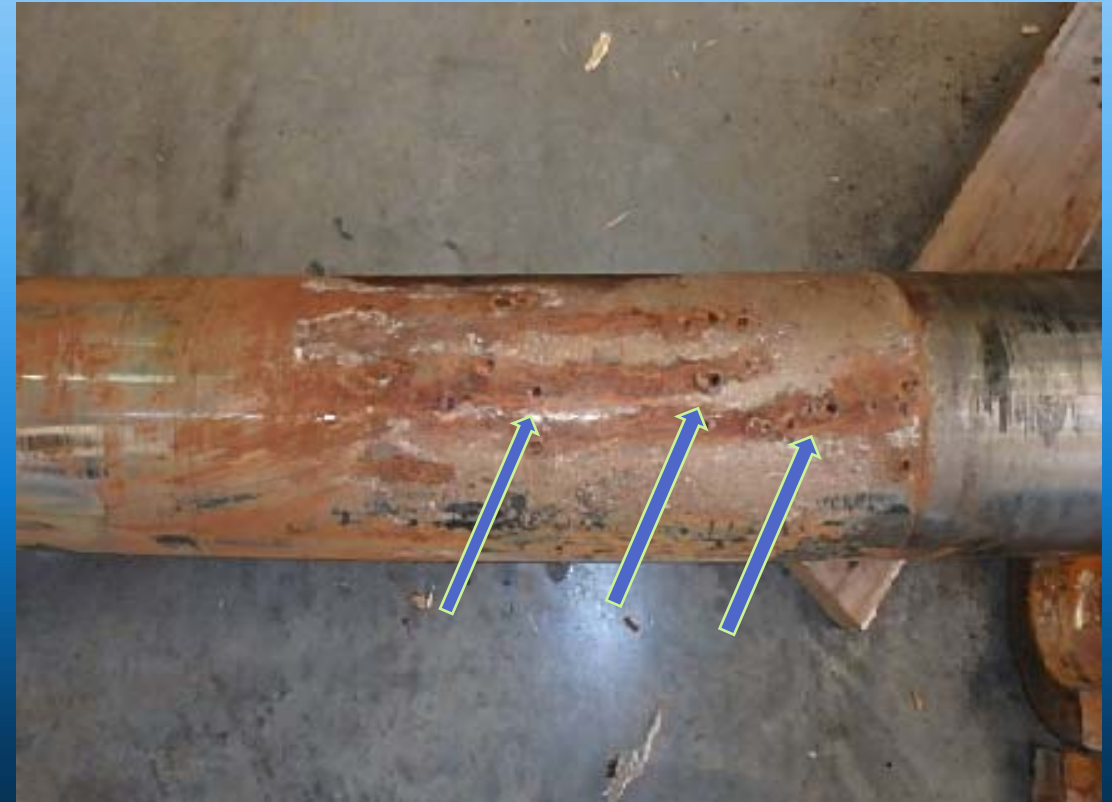
Shaft Deficiencies

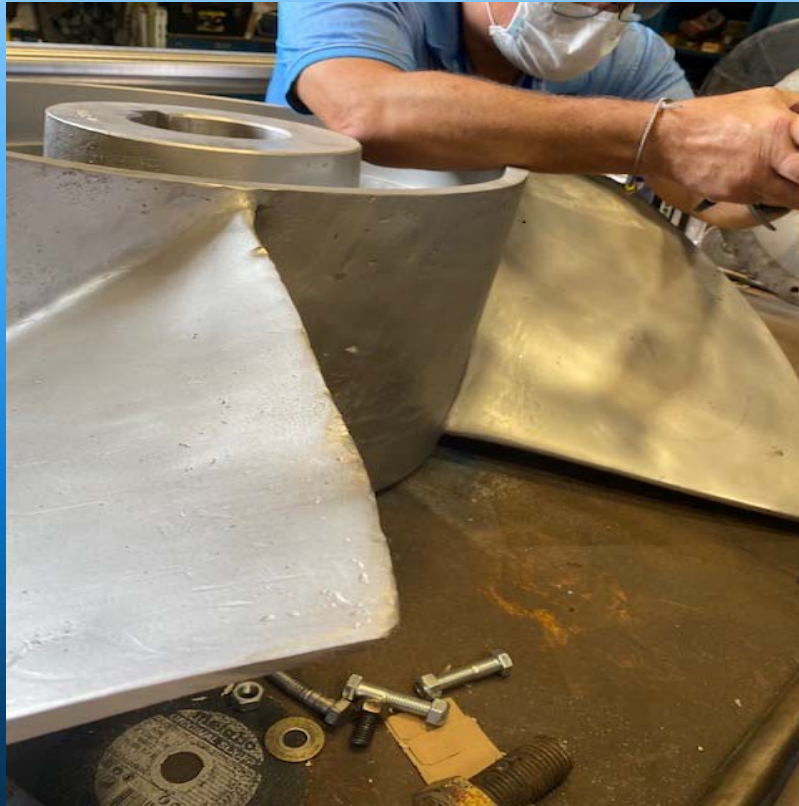
Impeller Repairs
