Appendix 5-1: Annual Permit Report for the Loxahatchee River Watershed Restoration Project, G-160 and G-161 Components

**Permit Report (January 1, 2012–December 31, 2012)
Permit Numbers: EI 50-0128848 and EI 50-0244327**

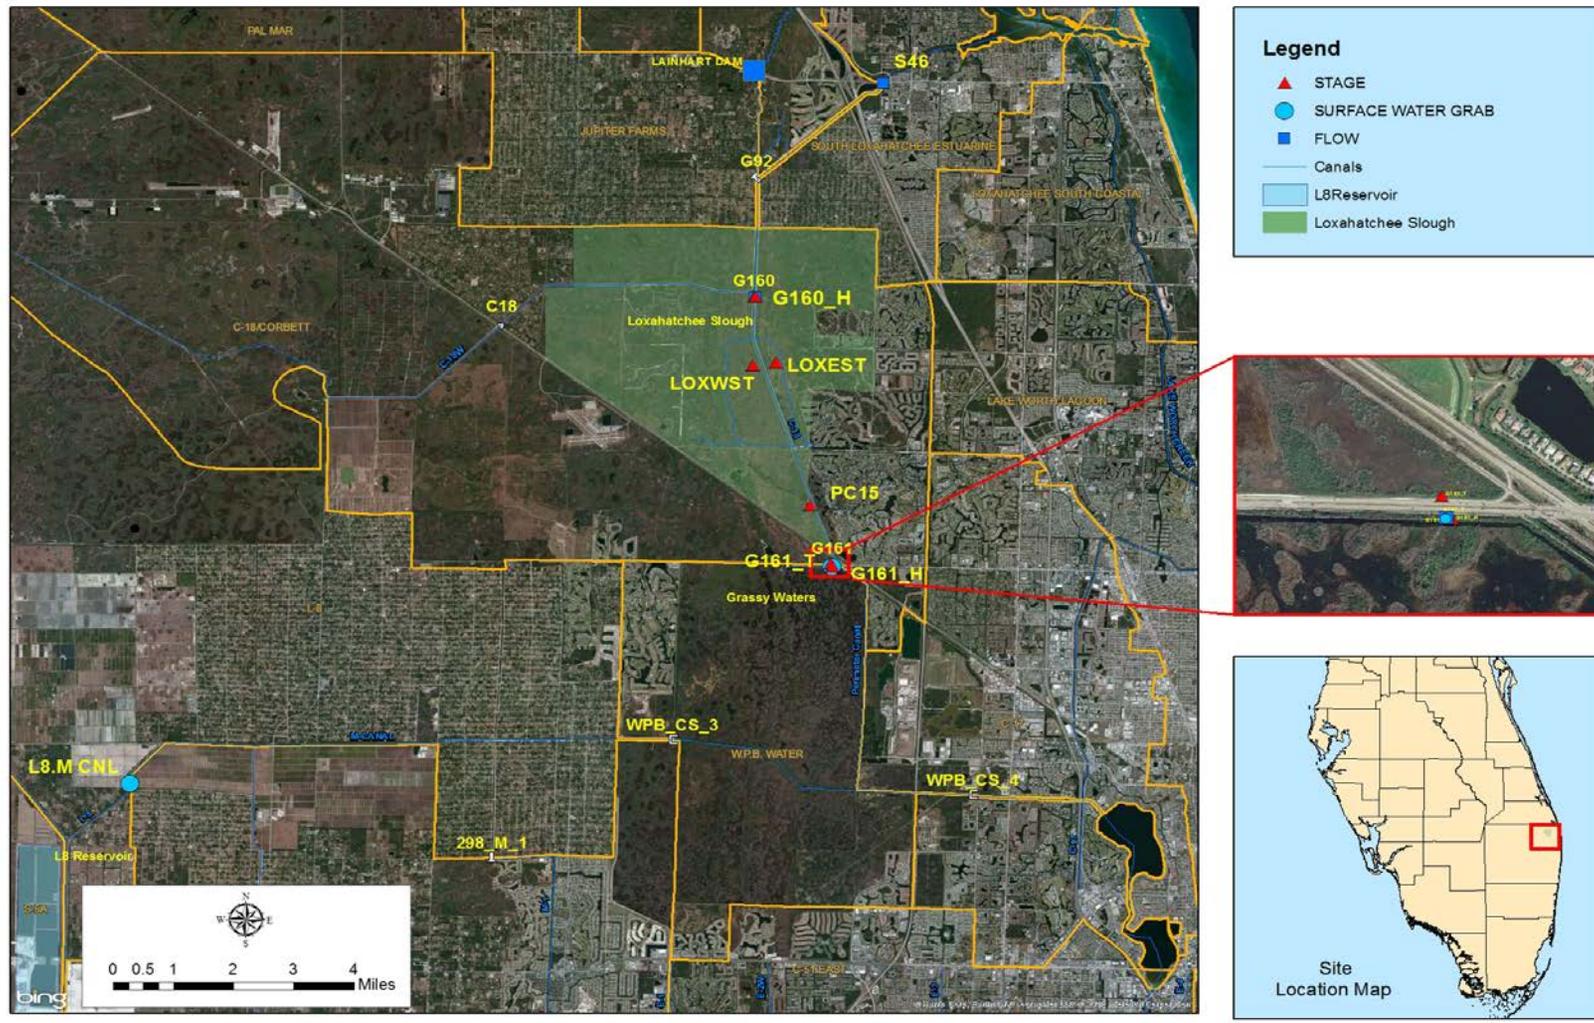
Figure 1. Location of G-160/161 monitoring sites.

Table 3 summarizes the locations of the water quality and flow monitoring sites used in this report. **Figure 1** shows the monitoring locations in the GWP and Loxahatchee Slough areas. This figure also shows the natural areas to be restored by the operation of these structures in conjunction with the availability of regional water of sufficient quantity and quality to provide for restorative flows. Other relevant structures and environmental features include the G-92 culvert, S-46 spillway, water catchment area (GWP), Loxahatchee Slough, NW Fork of the Loxahatchee River, and Loxahatchee Estuary.

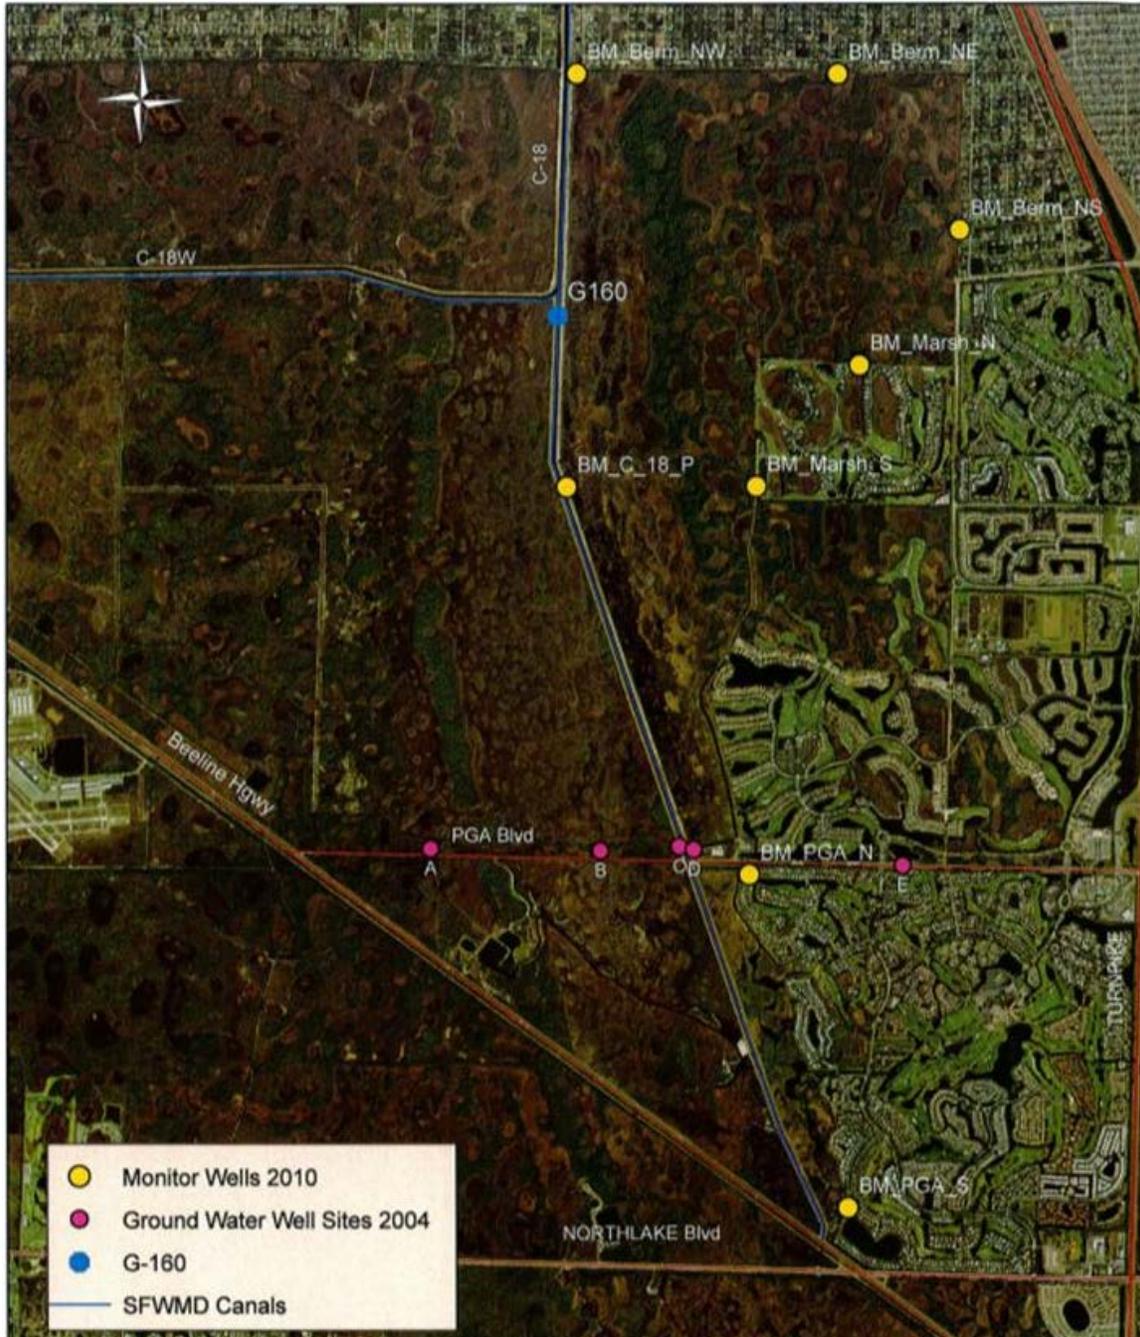
Figure 2. Groundwater monitoring wells near G-160/161.

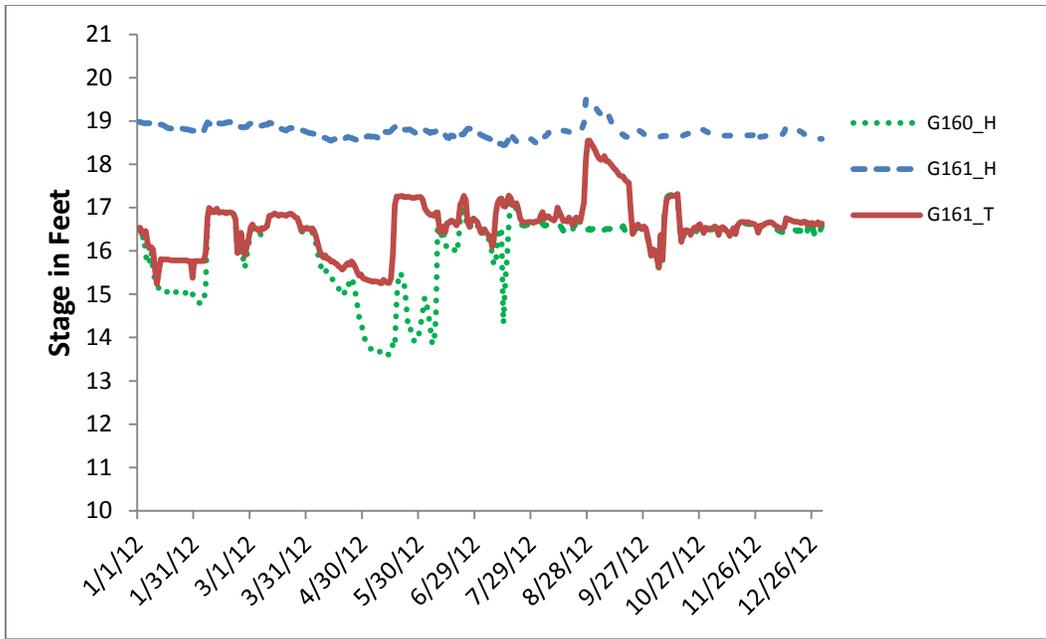
Figure 3a. 2012 daily stages at G160_H and G161.

Stages at G-161 and G-160 and associated sloughs are shown in **Figures 3a** and **3b**. Flows through G-161, G-160, S-46, and at Lainhart Dam are shown in **Figures 4** and **5**. Average, minimum, and maximum flows are presented in **Table 4**. The average daily dry season flow over Lainhart Dam was 75 cfs; the average for the wet season was 159 cfs. Relevant data are included in **Attachment C**. Water quality samples were collected at G-161 and the City of West Palm Beach Control 2 Pump Station in association with the structure operation to comply with Specific Condition 9(IV) of the G-161 ERP, which requires collection and analysis of water quality samples monthly during periods of flow for the following parameters: temperature, dissolved

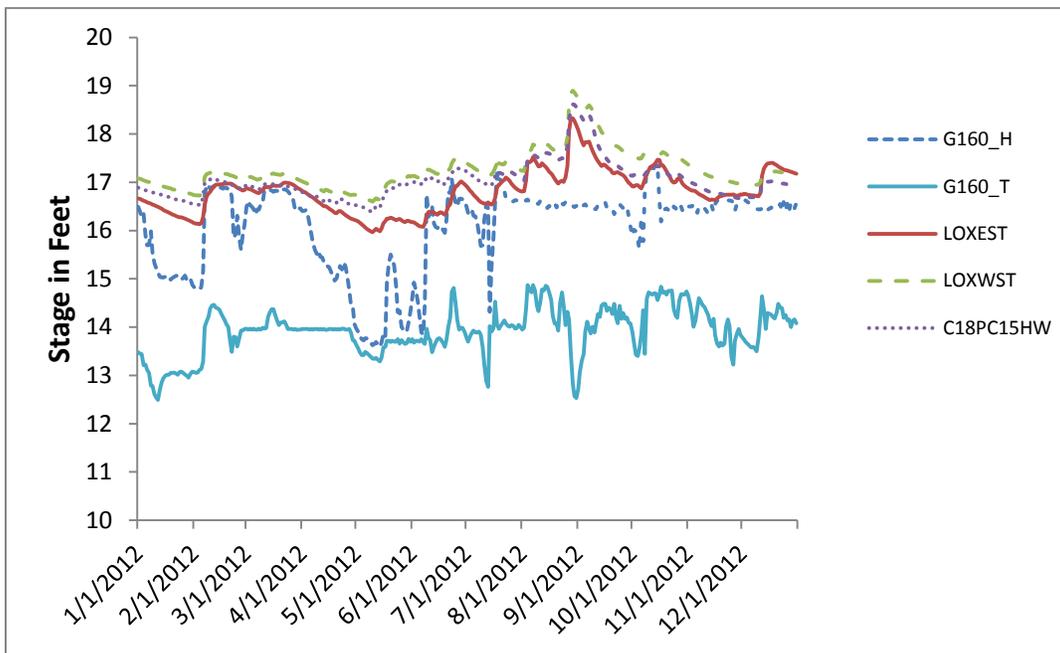
Figure 3b. 2012 daily stages at G-160, LOXEST, LOXWST, and C18PC15HW.

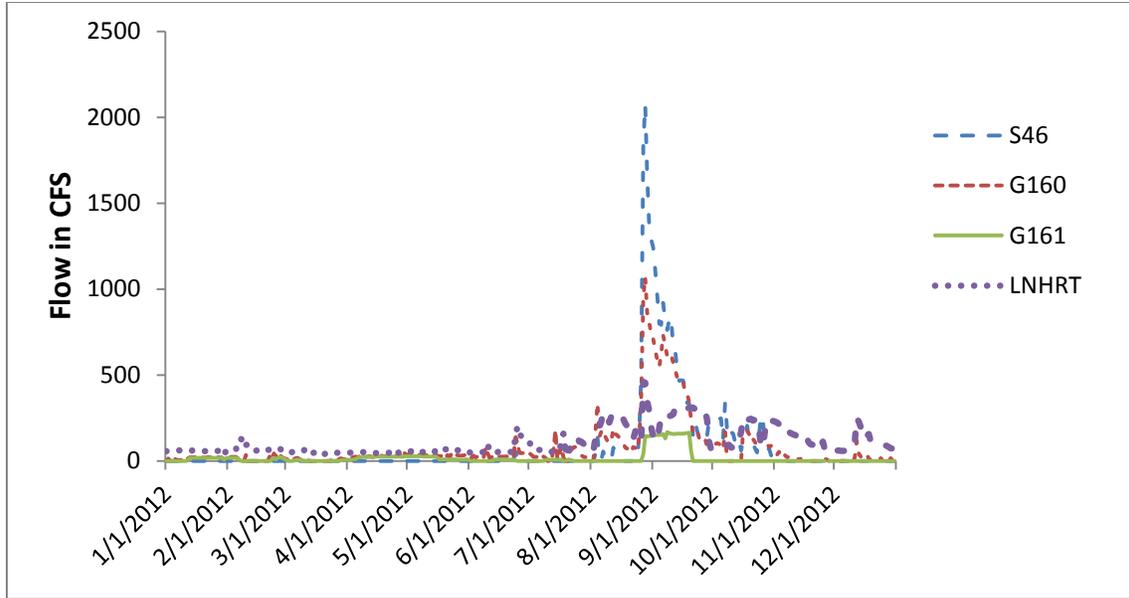
Figure 4. 2012 daily flows at S-46, G-160, G-161, and Lainhart Dam.

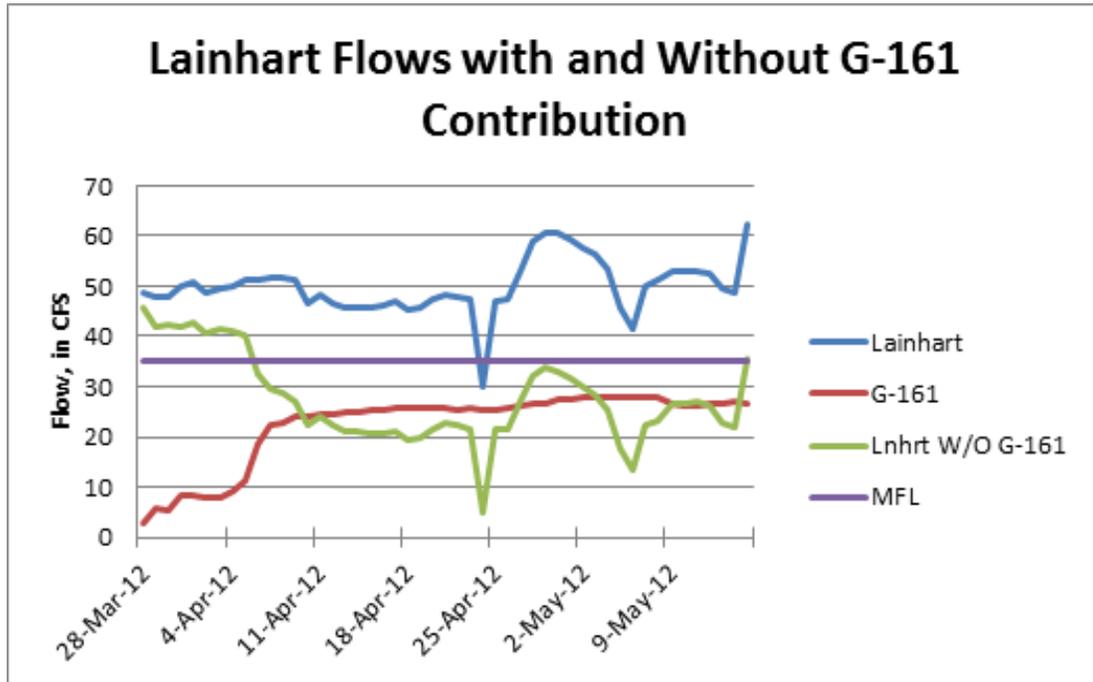
Figure 5. Lainhart dam flows with and without G-161 contribution during 2012.

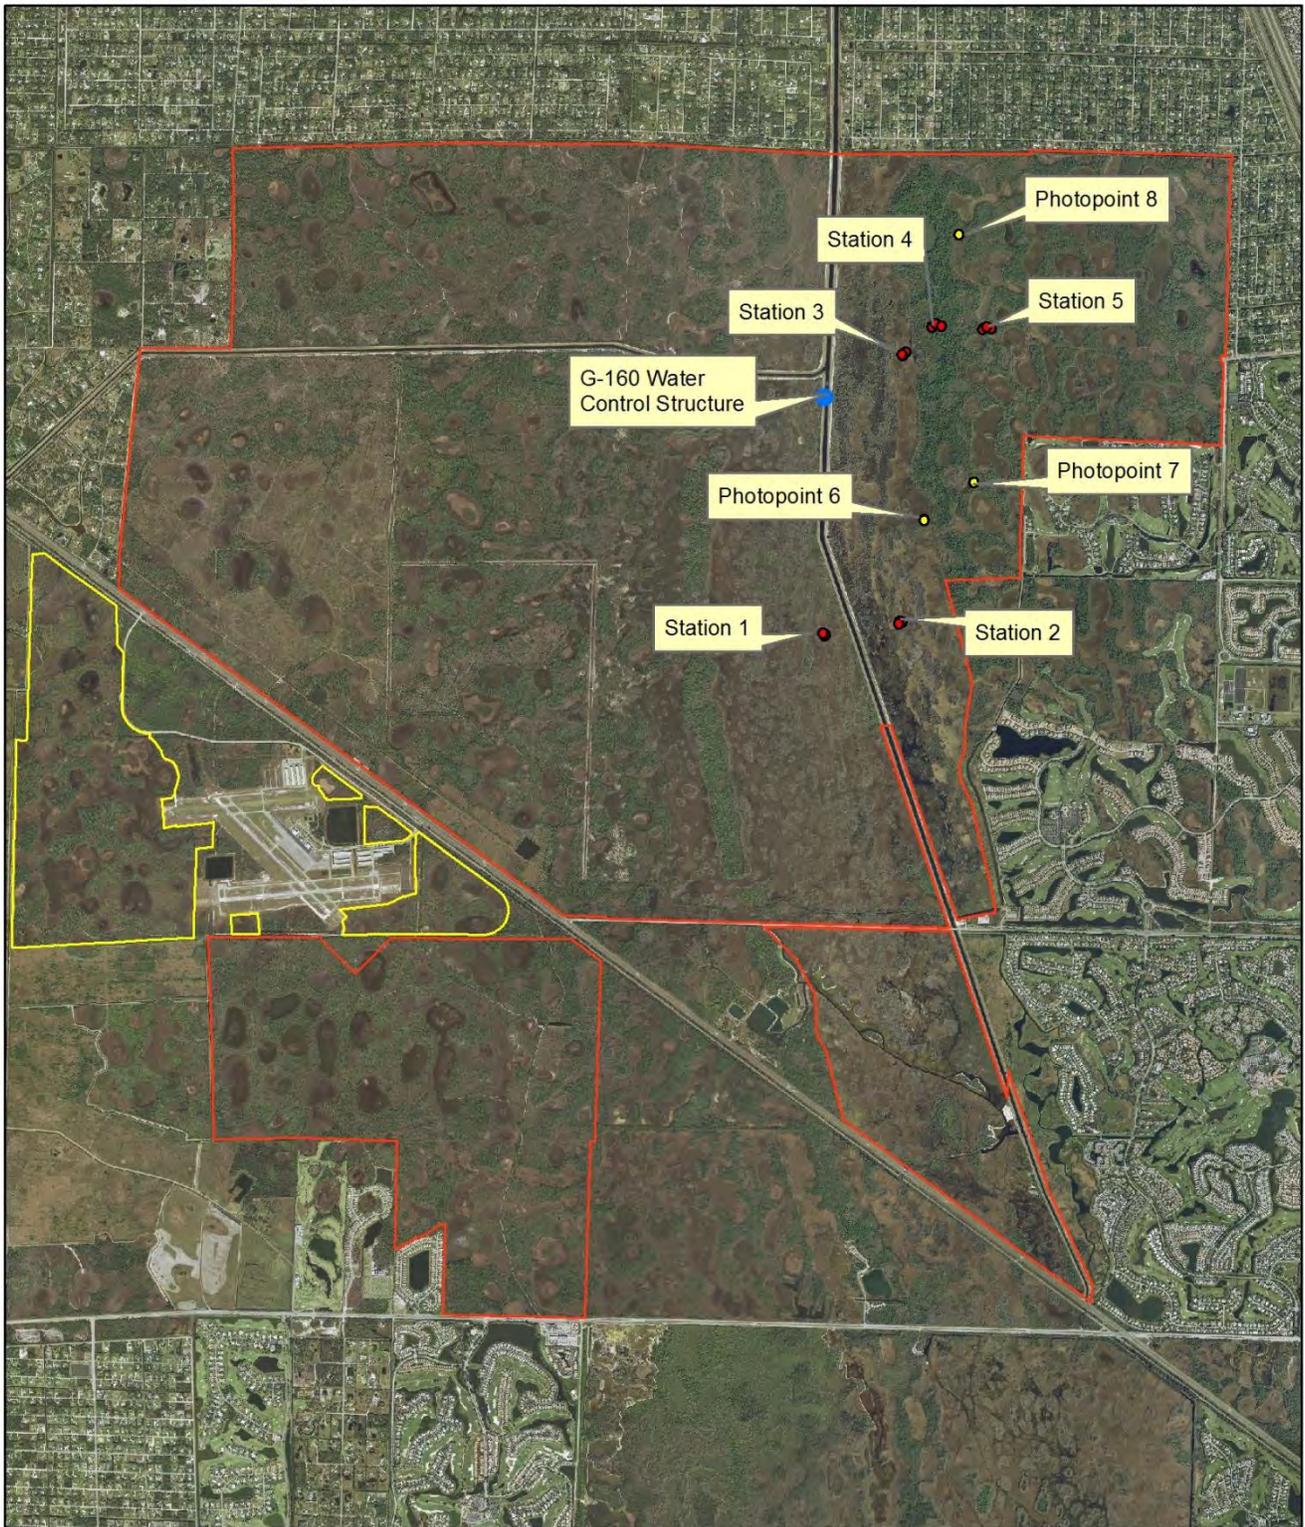
Figure 2: G-160 Vegetation Monitoring Stations in the Loxahatchee Slough Natural Area

A total of five permanent vegetation and two hydrological monitoring stations were established in the Loxahatchee Slough Natural Area at pre-determined locations both east and west of the C-18 canal (see Figure 2). The selected locations are representative of major habitat types found within the Loxahatchee Slough, which are anticipated to be affected by the operation of the G-160 structure. At each of these five locations, three nested vegetation quadrats and one photopoint were established. The vegetation plots were positioned within the given community type using random compass directions and distances that were selected from a random numbers table and paced off as described in the SFWMD Save Our Rivers Environmental Monitoring Protocols (Van Horn and Van Horn 1993). The photopoint was positioned centrally between the three vegetation quadrats at each station. The vegetation plots and photopoints are monitored twice a year, once during the wet season (between August 1- September 15) and once during the dry season (between February 1 and March 15).

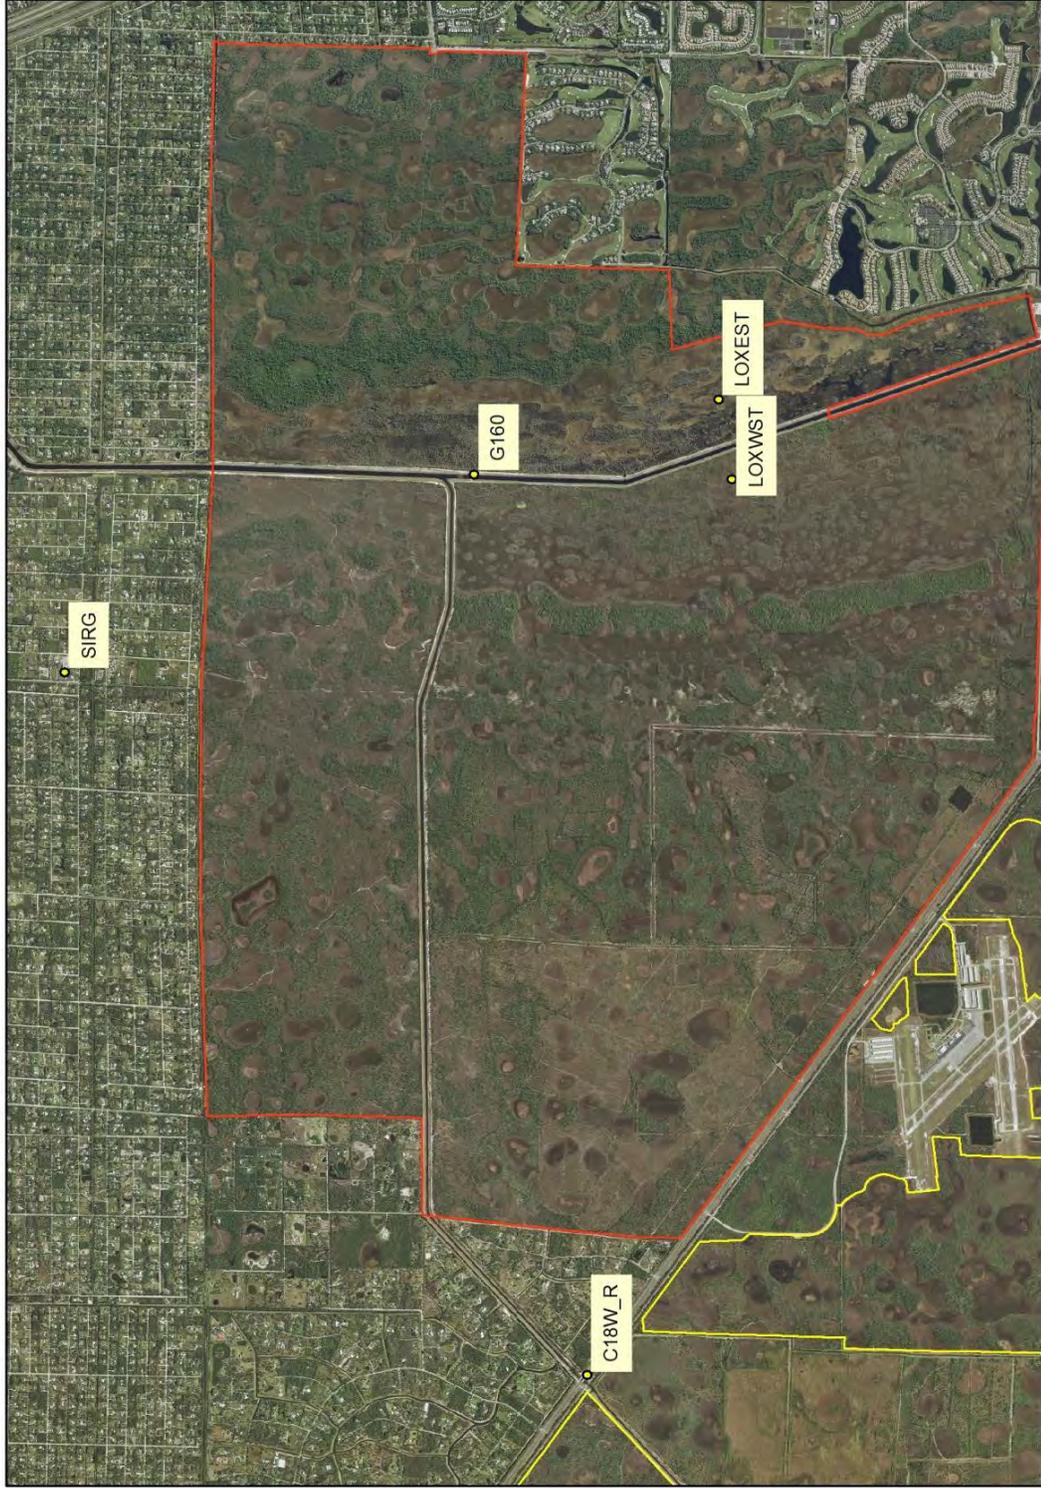
Figure 3: Hydrological Monitoring Stations in the Vicinity and Within the Loxahatchee Slough Natural Area

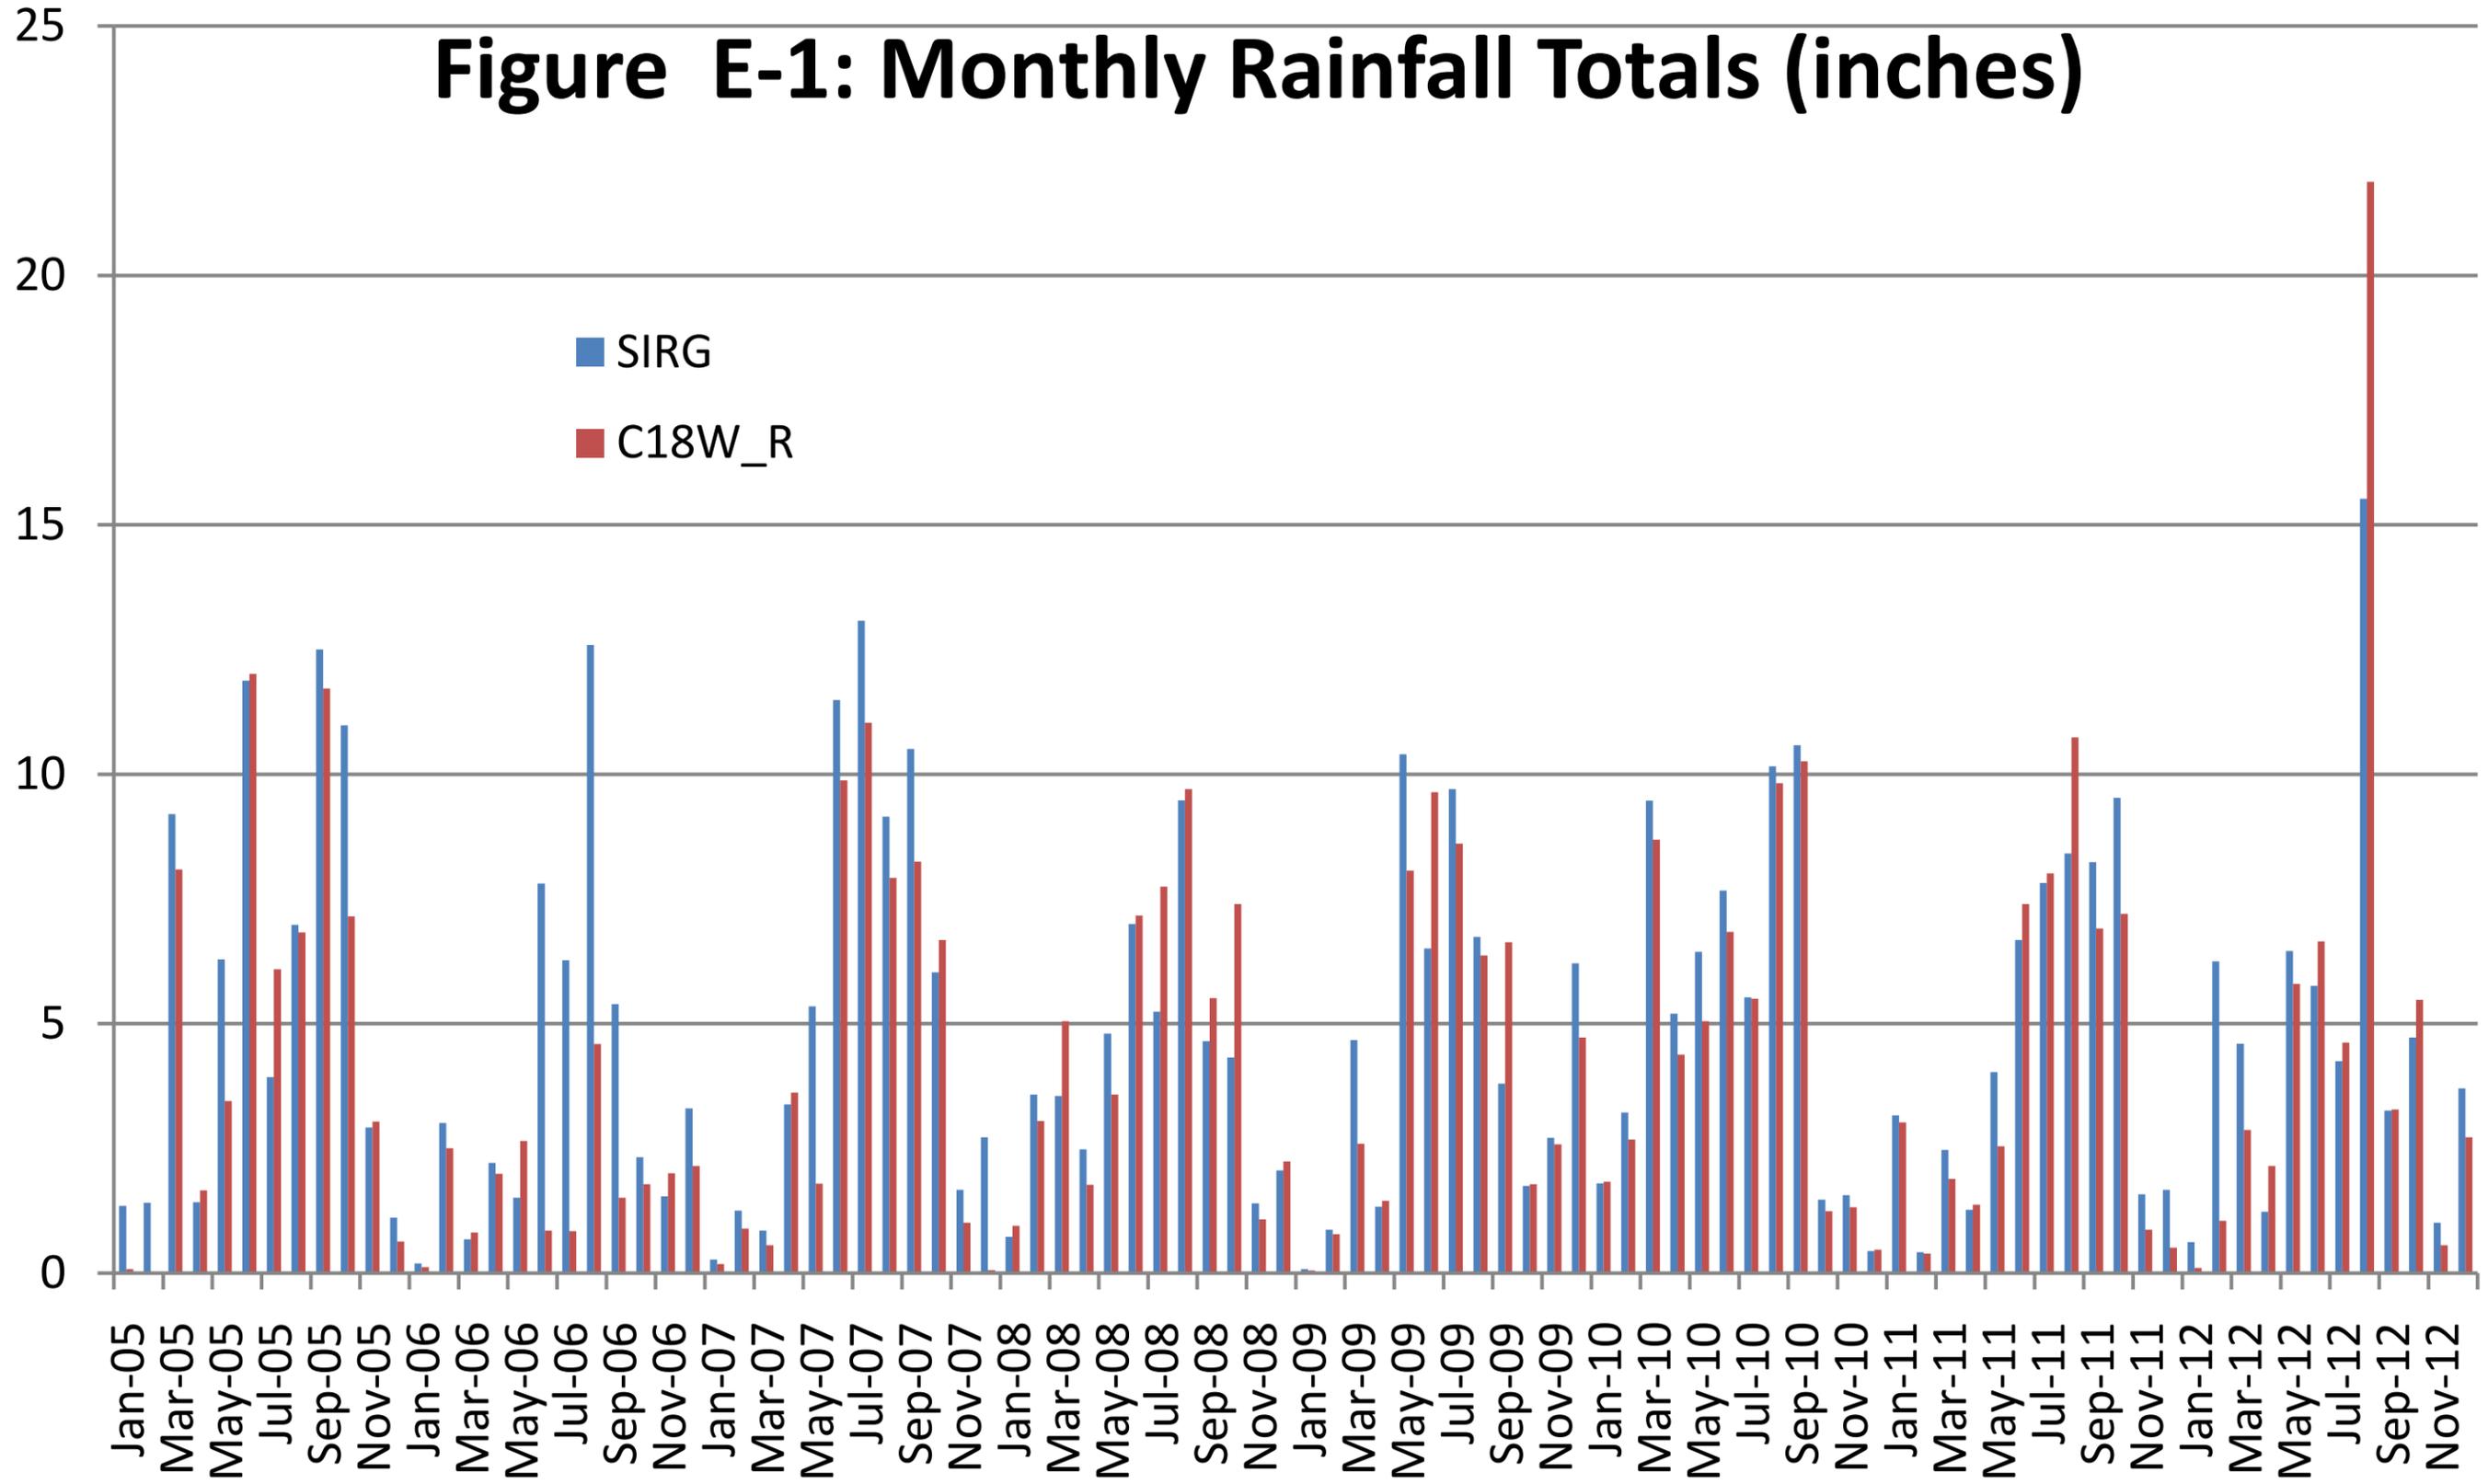
Figure E-1: Monthly Rainfall Totals (inches)

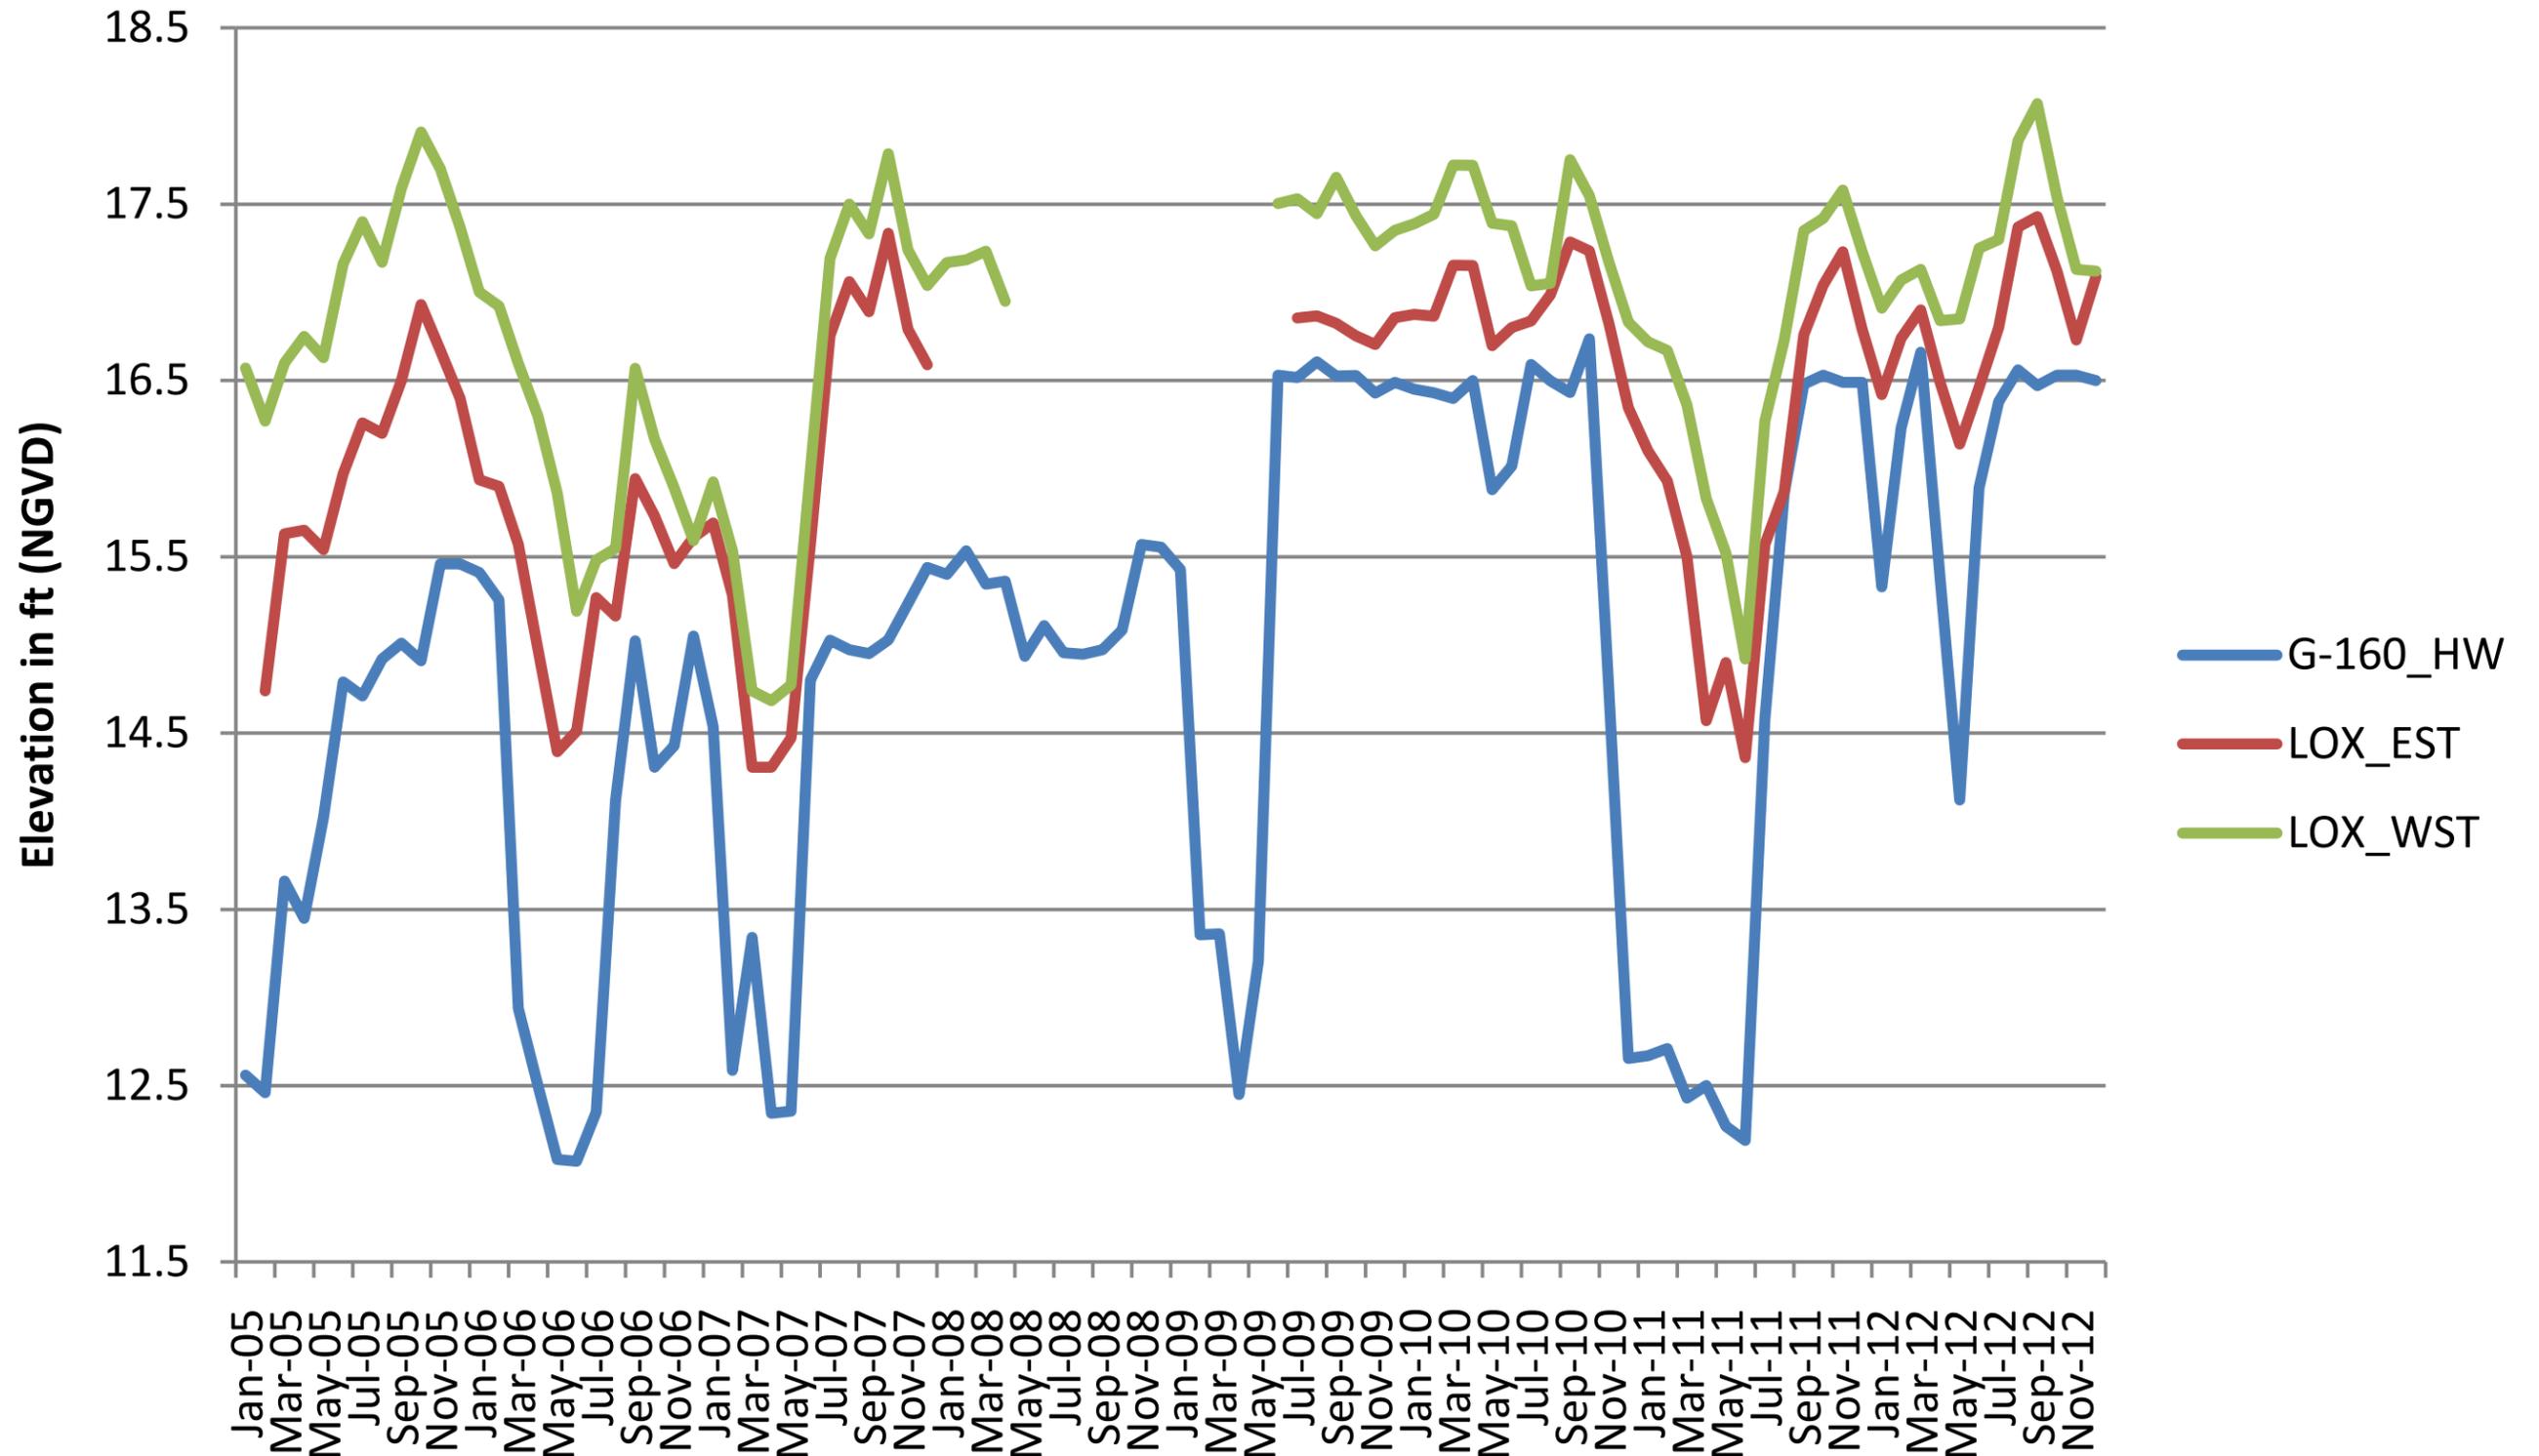
Figure E-2: Water Levels 2005-2012

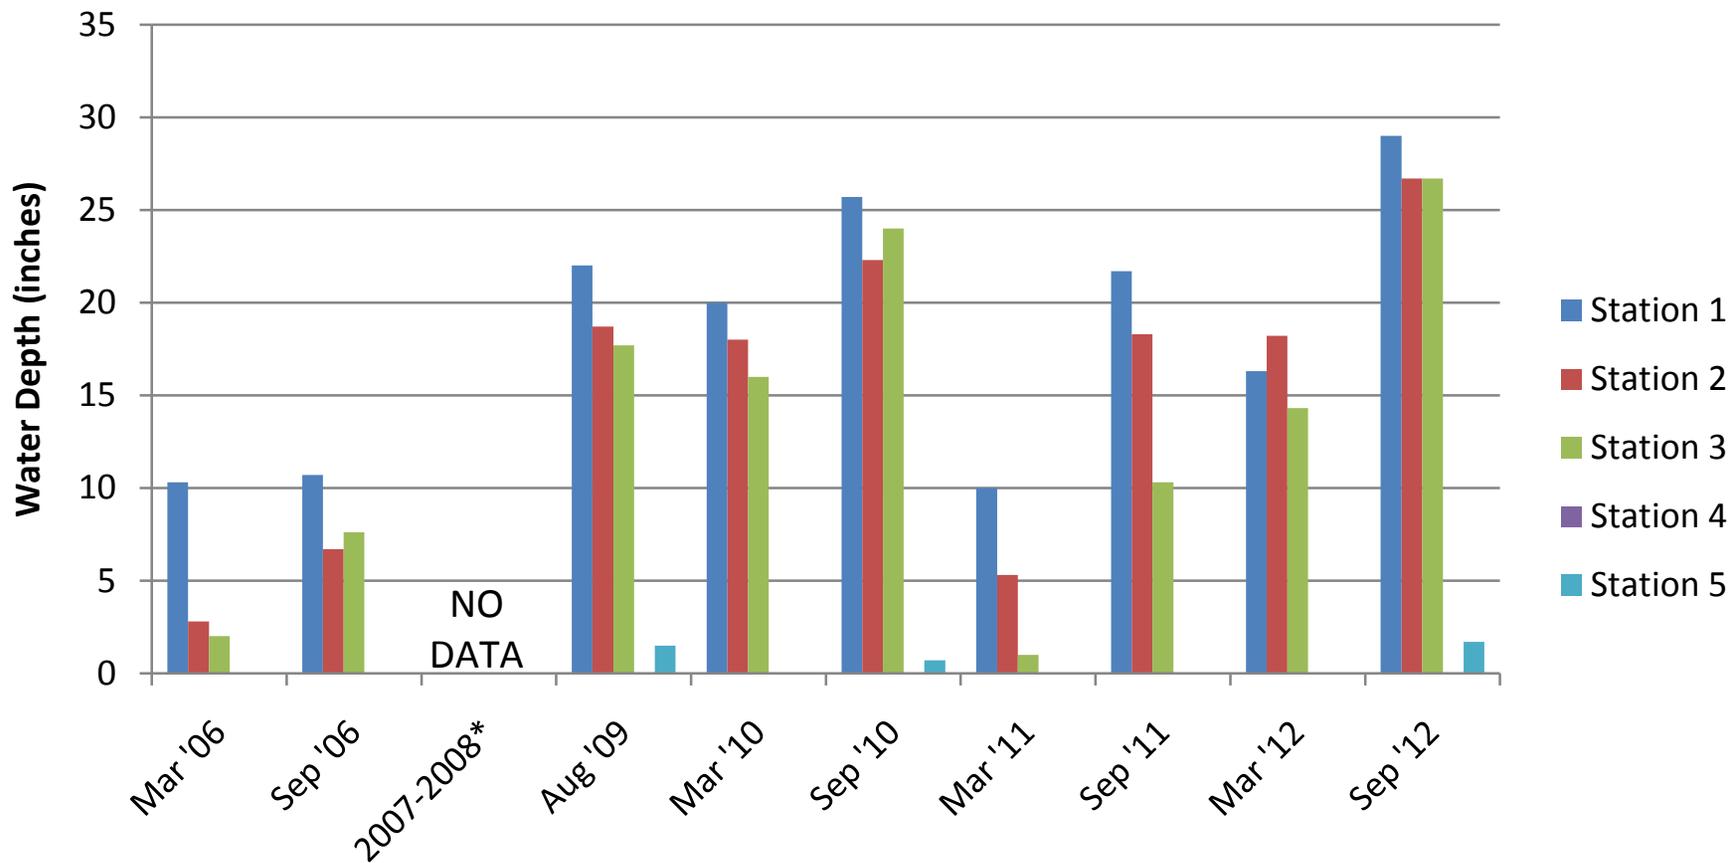
Figure E-3: Water Depths 2006-2012

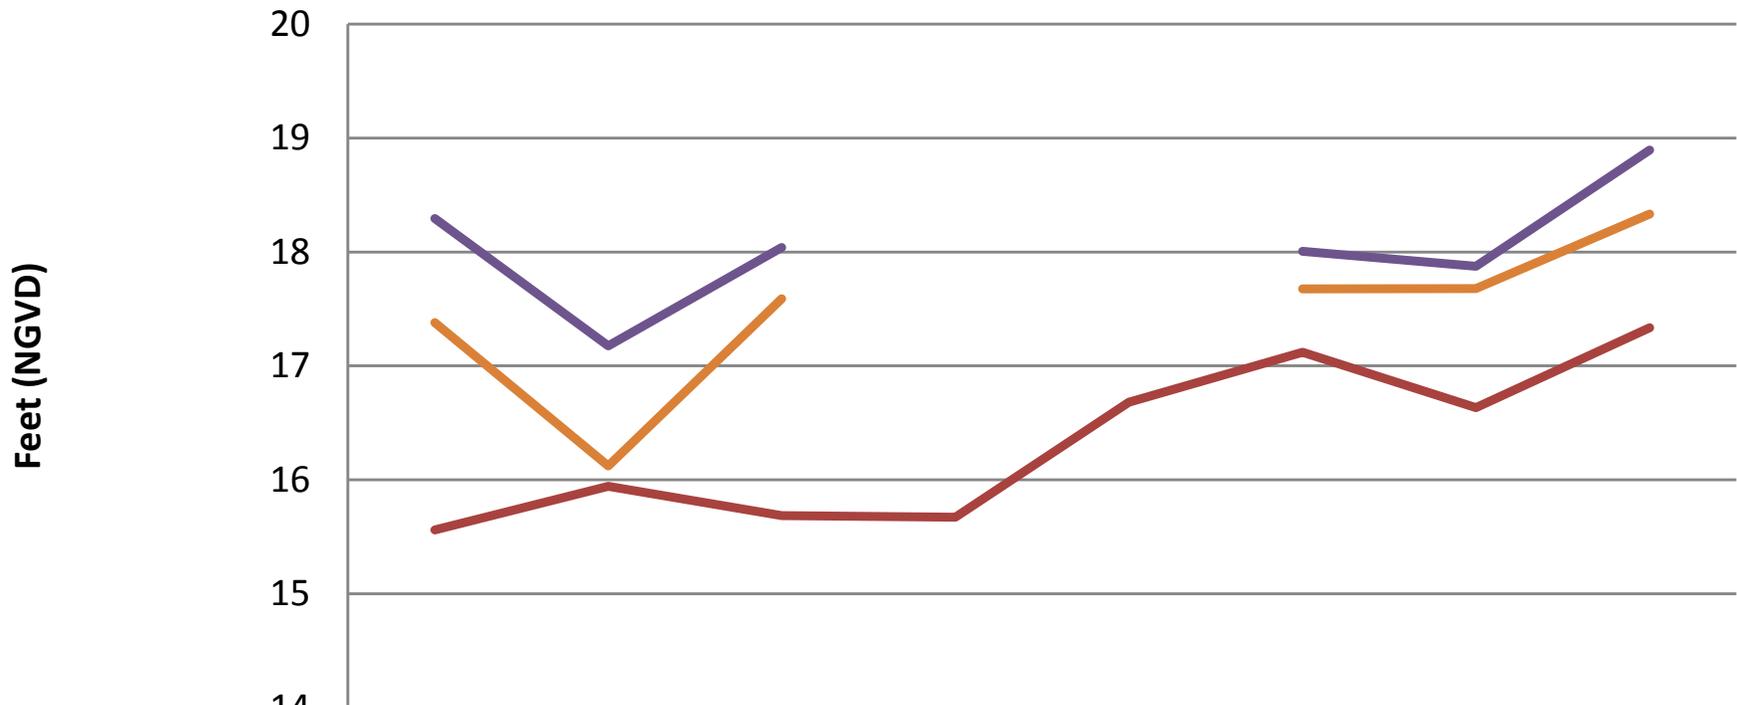
Figure E-4: Maximum Elevations

2005	2006	2007	2008	2009	2010	2011	2012
— G-160 Max	15.559	15.942	15.685	15.673	16.682	17.12	16.634	17.334
— LOXWST Max	18.294	17.176	18.04			18.005	17.873	18.895
— LOXEST Max	17.38	16.122	17.589			17.677	17.679	18.333
