# Kissimmee River Restoration Project Update

**Water Resources Accountability and Collaboration Forum  
West Palm Beach, FL  
March 16, 2020**

# KISSIMMEE RIVER RESTORATION PROJECT

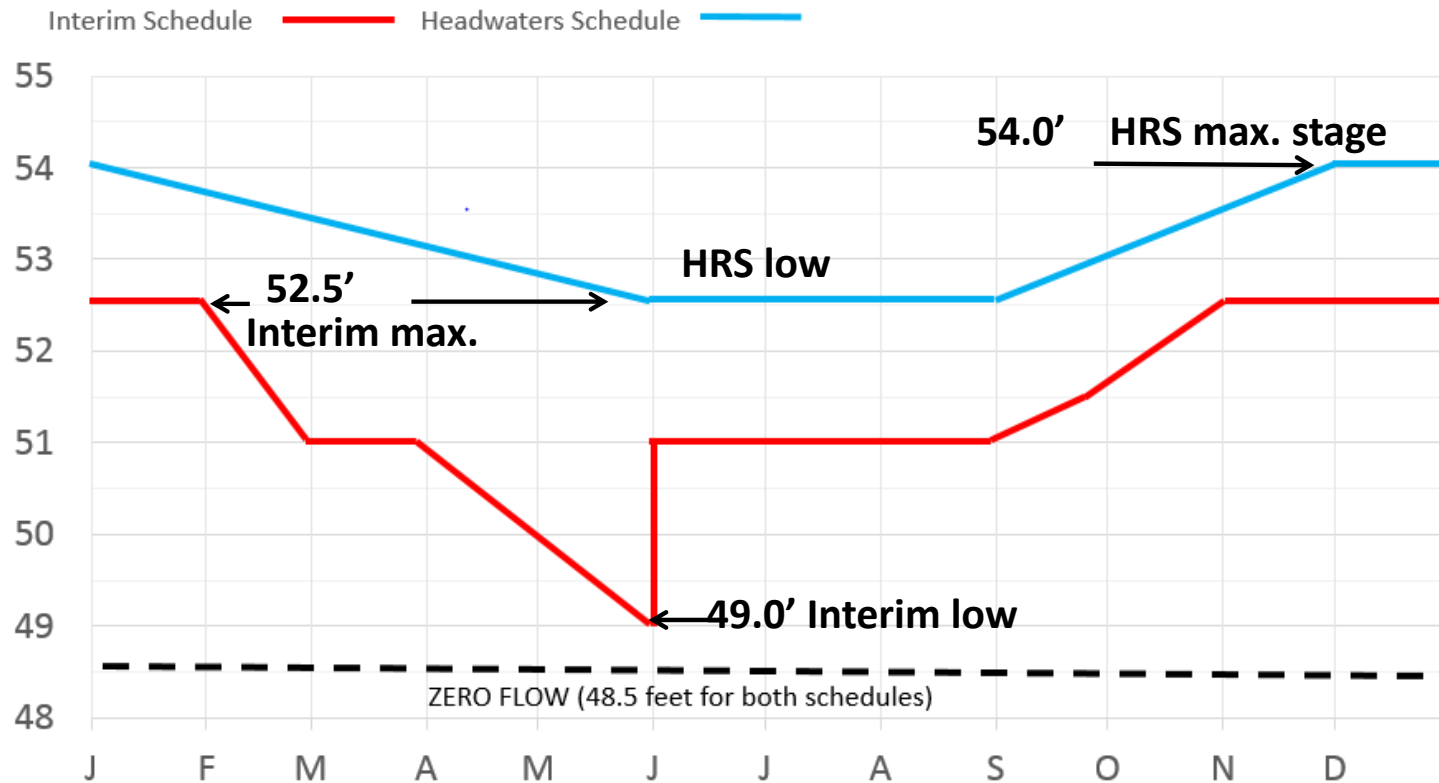
# HYDROLOGICAL RESTORATION INTERIM VS. HEADWATERS REGULATION SCHEDULE @ S65

Hydrologic Restoration has not yet occurred  
Headwaters Revitalization Schedule  
(HRS) is missing link!

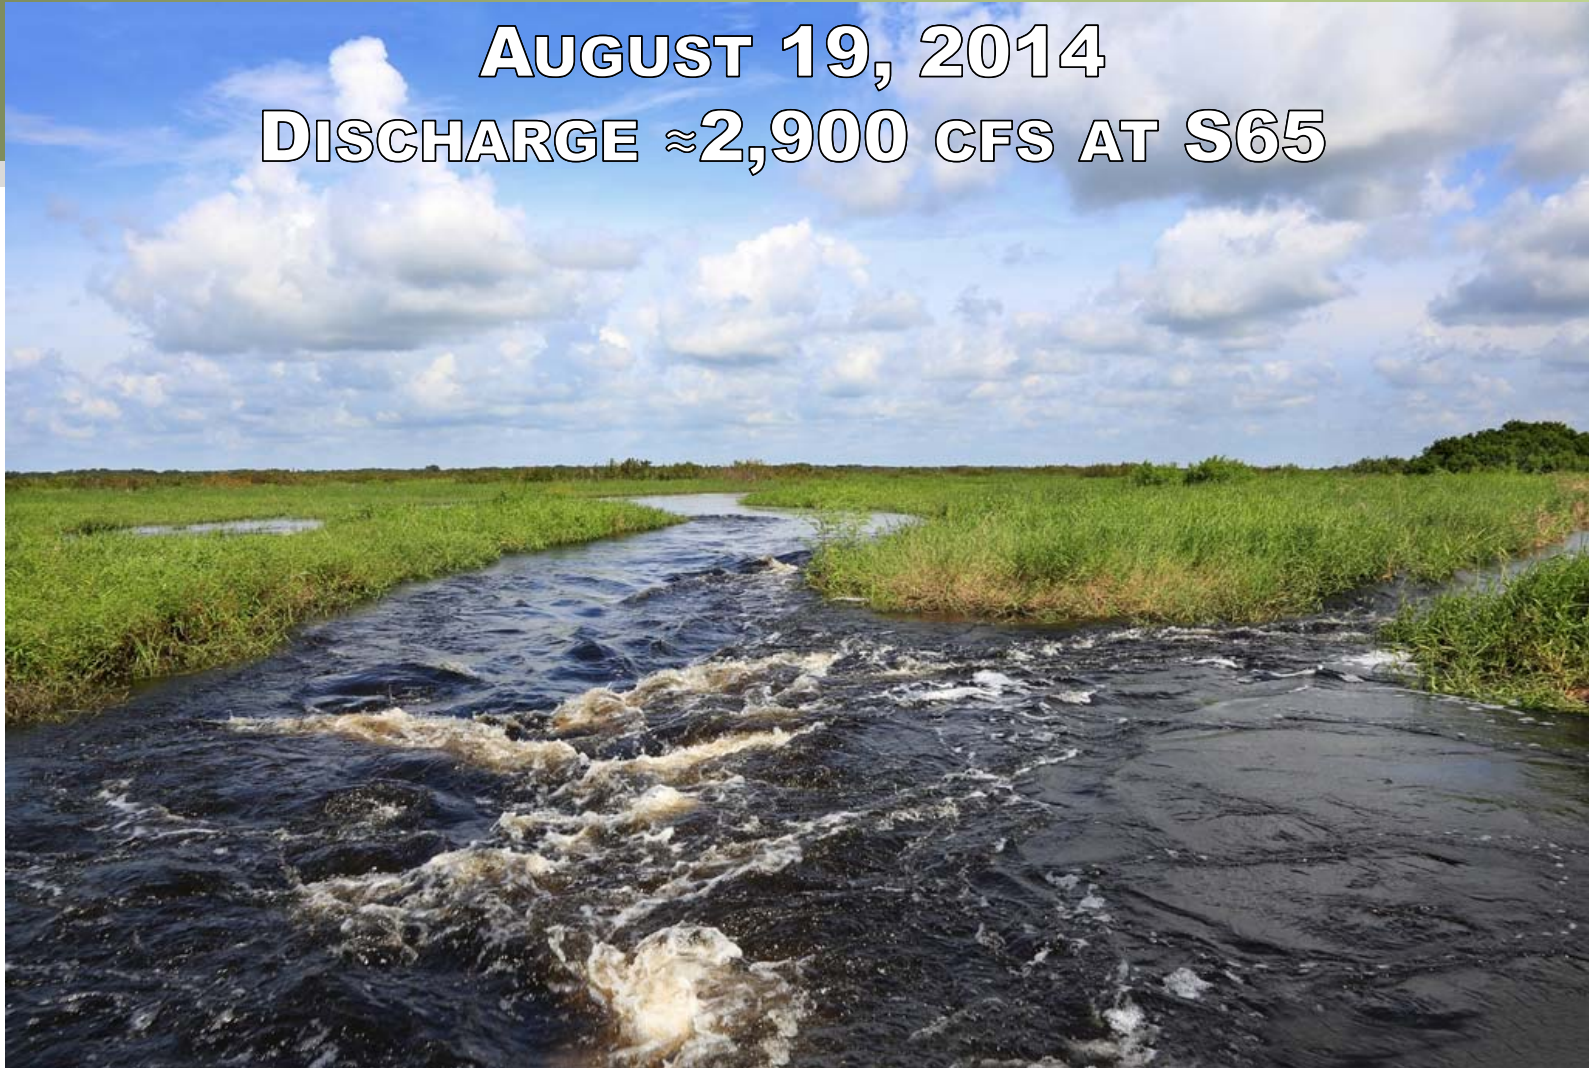
**AUGUST 19, 2014**  
**DISCHARGE  $\approx$ 2,900 CFS AT S65**

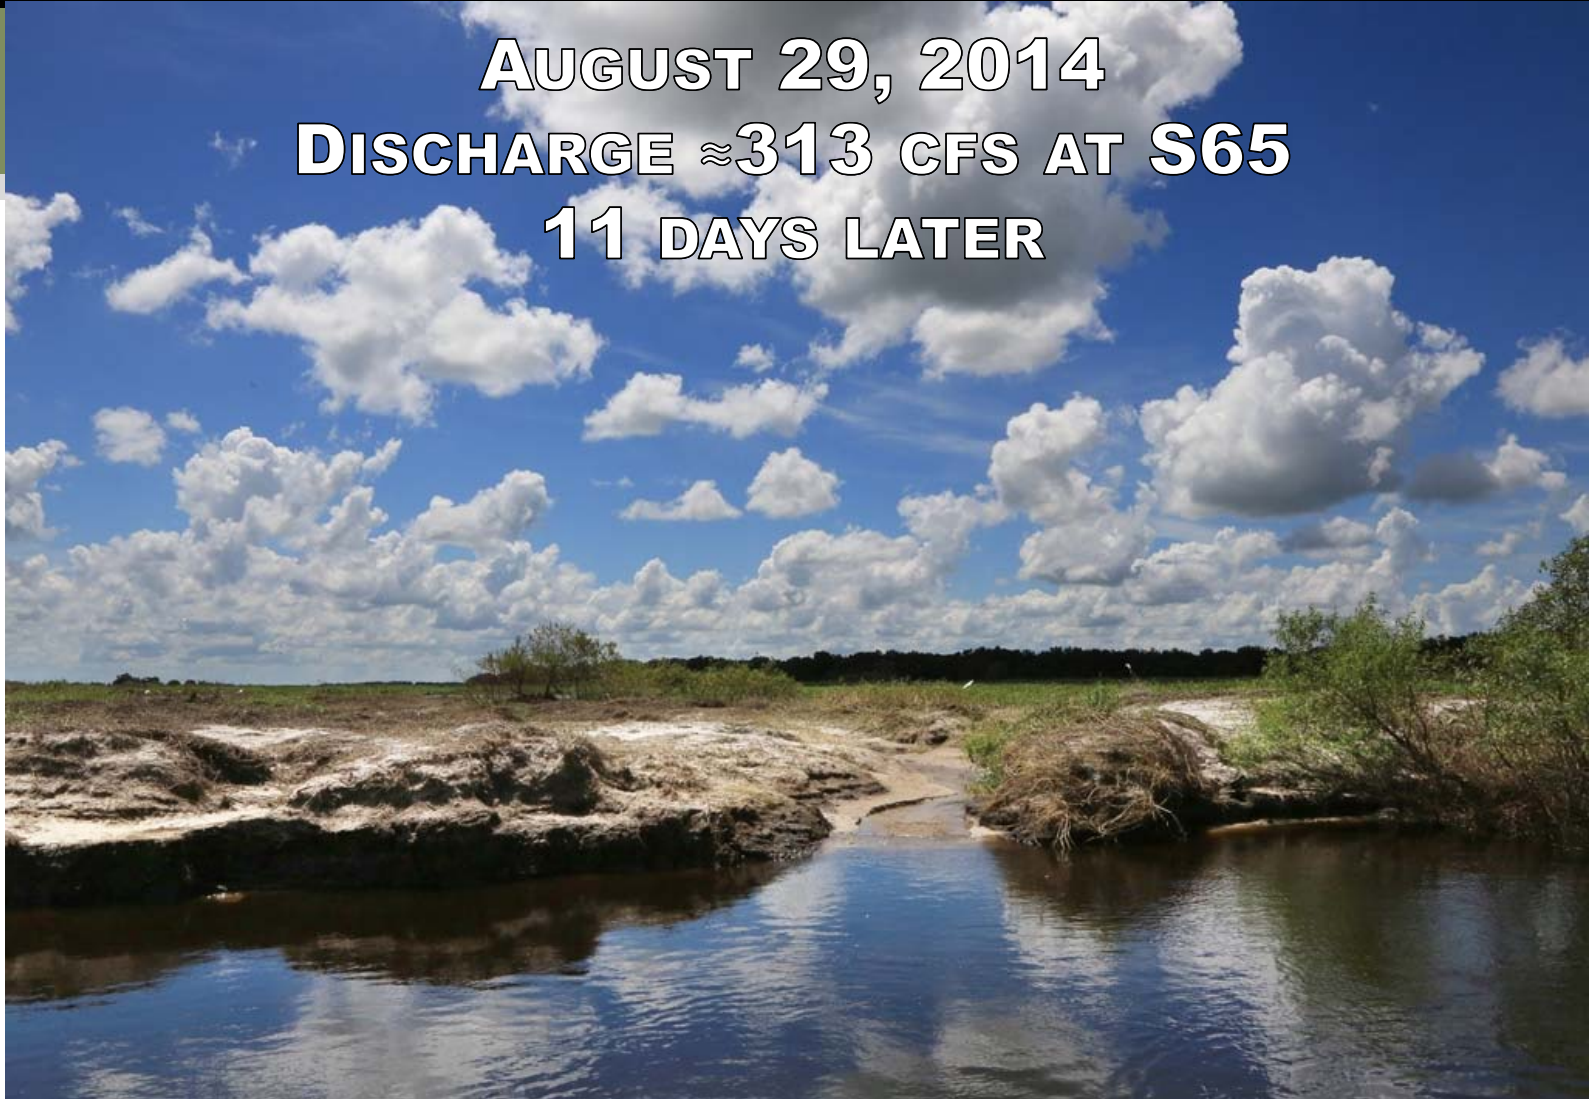
**AUGUST 29, 2014**  
**DISCHARGE  $\approx$ 313 CFS AT S65**  
**11 DAYS LATER**

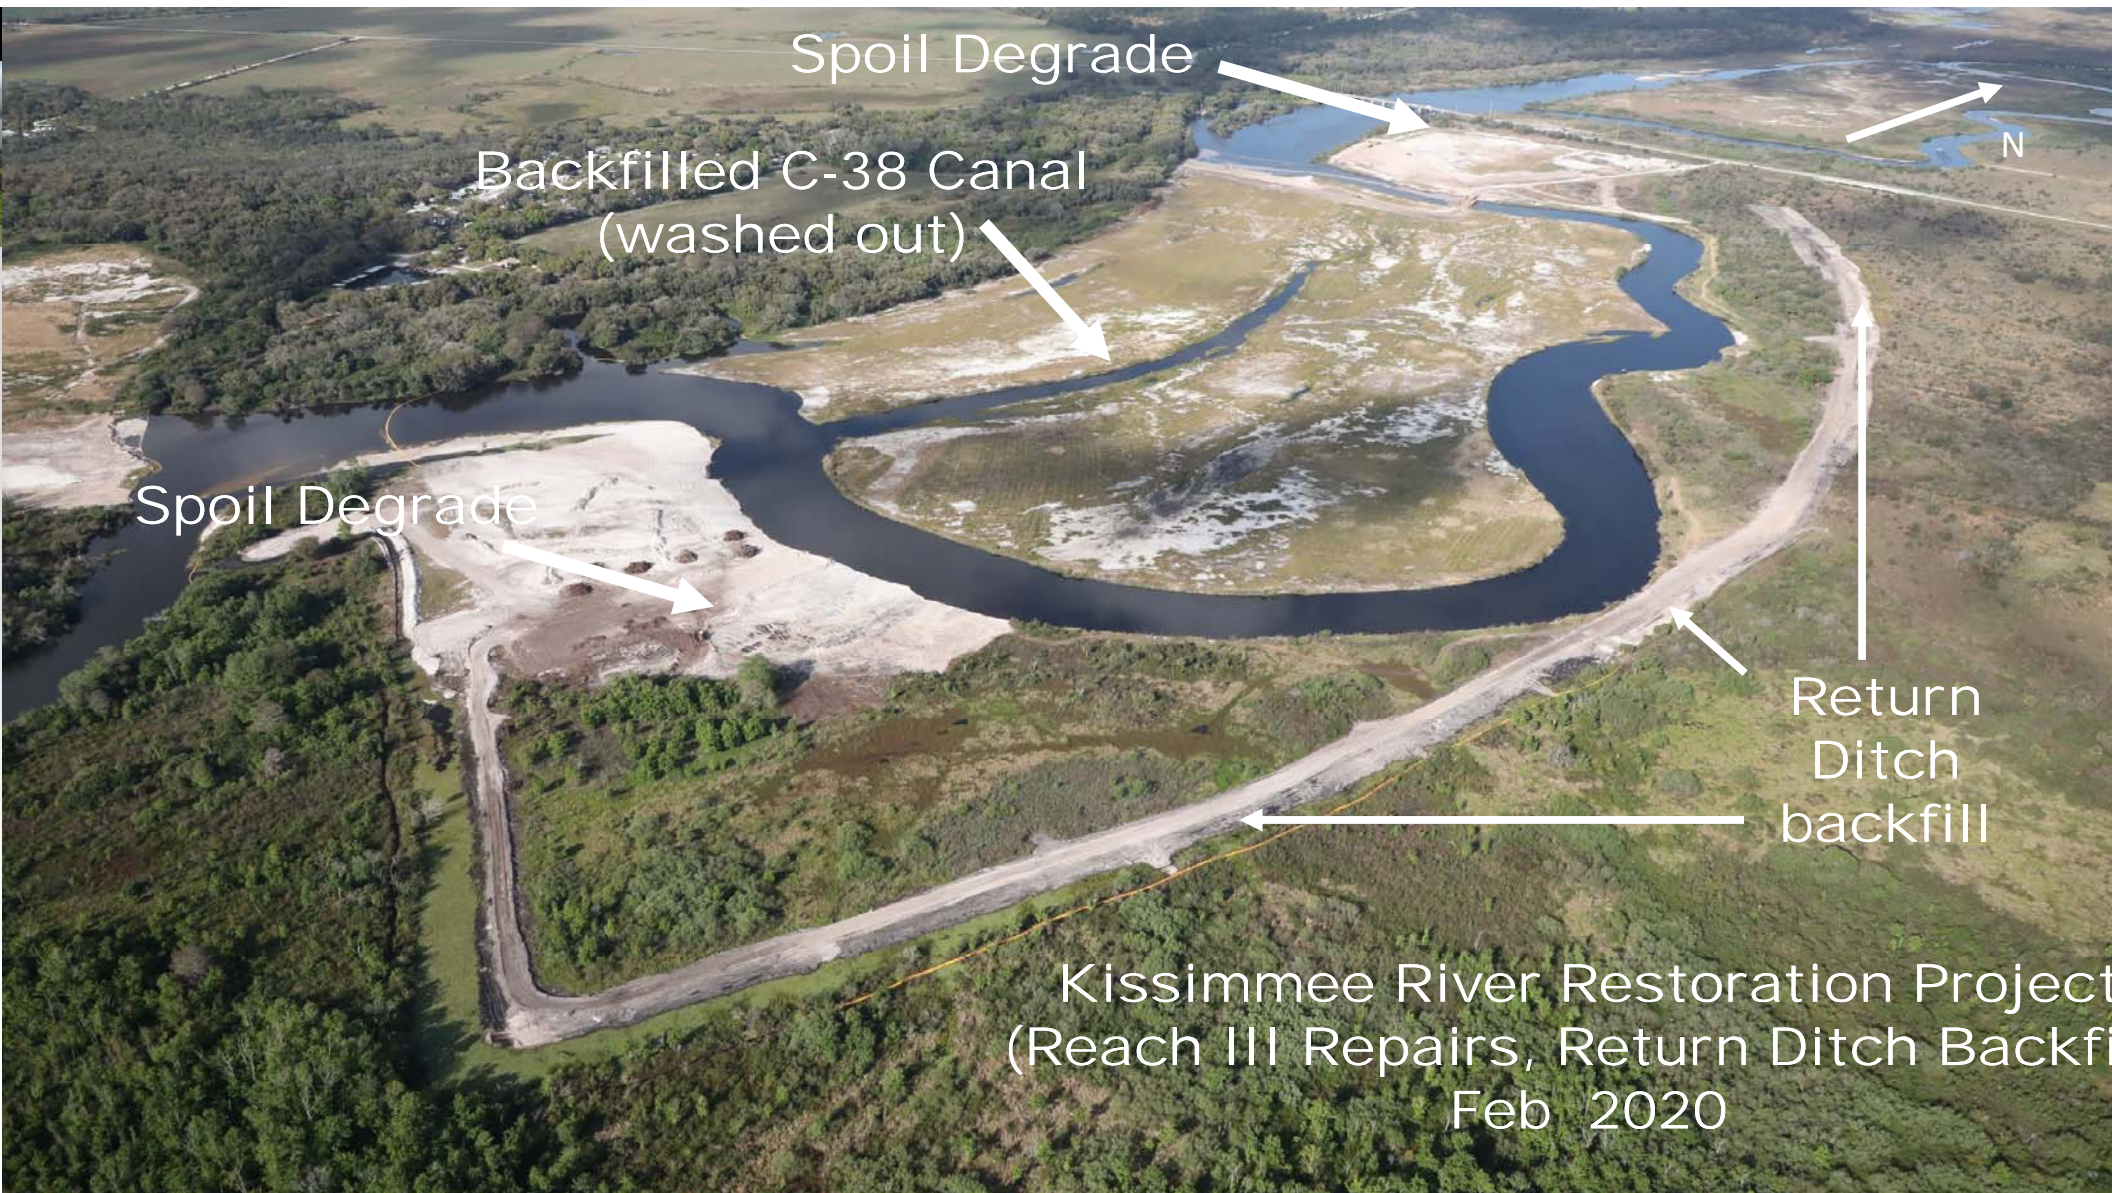
Kissimmee River Restoration  
Project (Reach II Repair, S-65C  
Locks Access Road Degrade,  
Feb 2020

Spoil Degrade

Backfilled C-38 Canal  
(washed out)

Return  
Ditch  
backfill

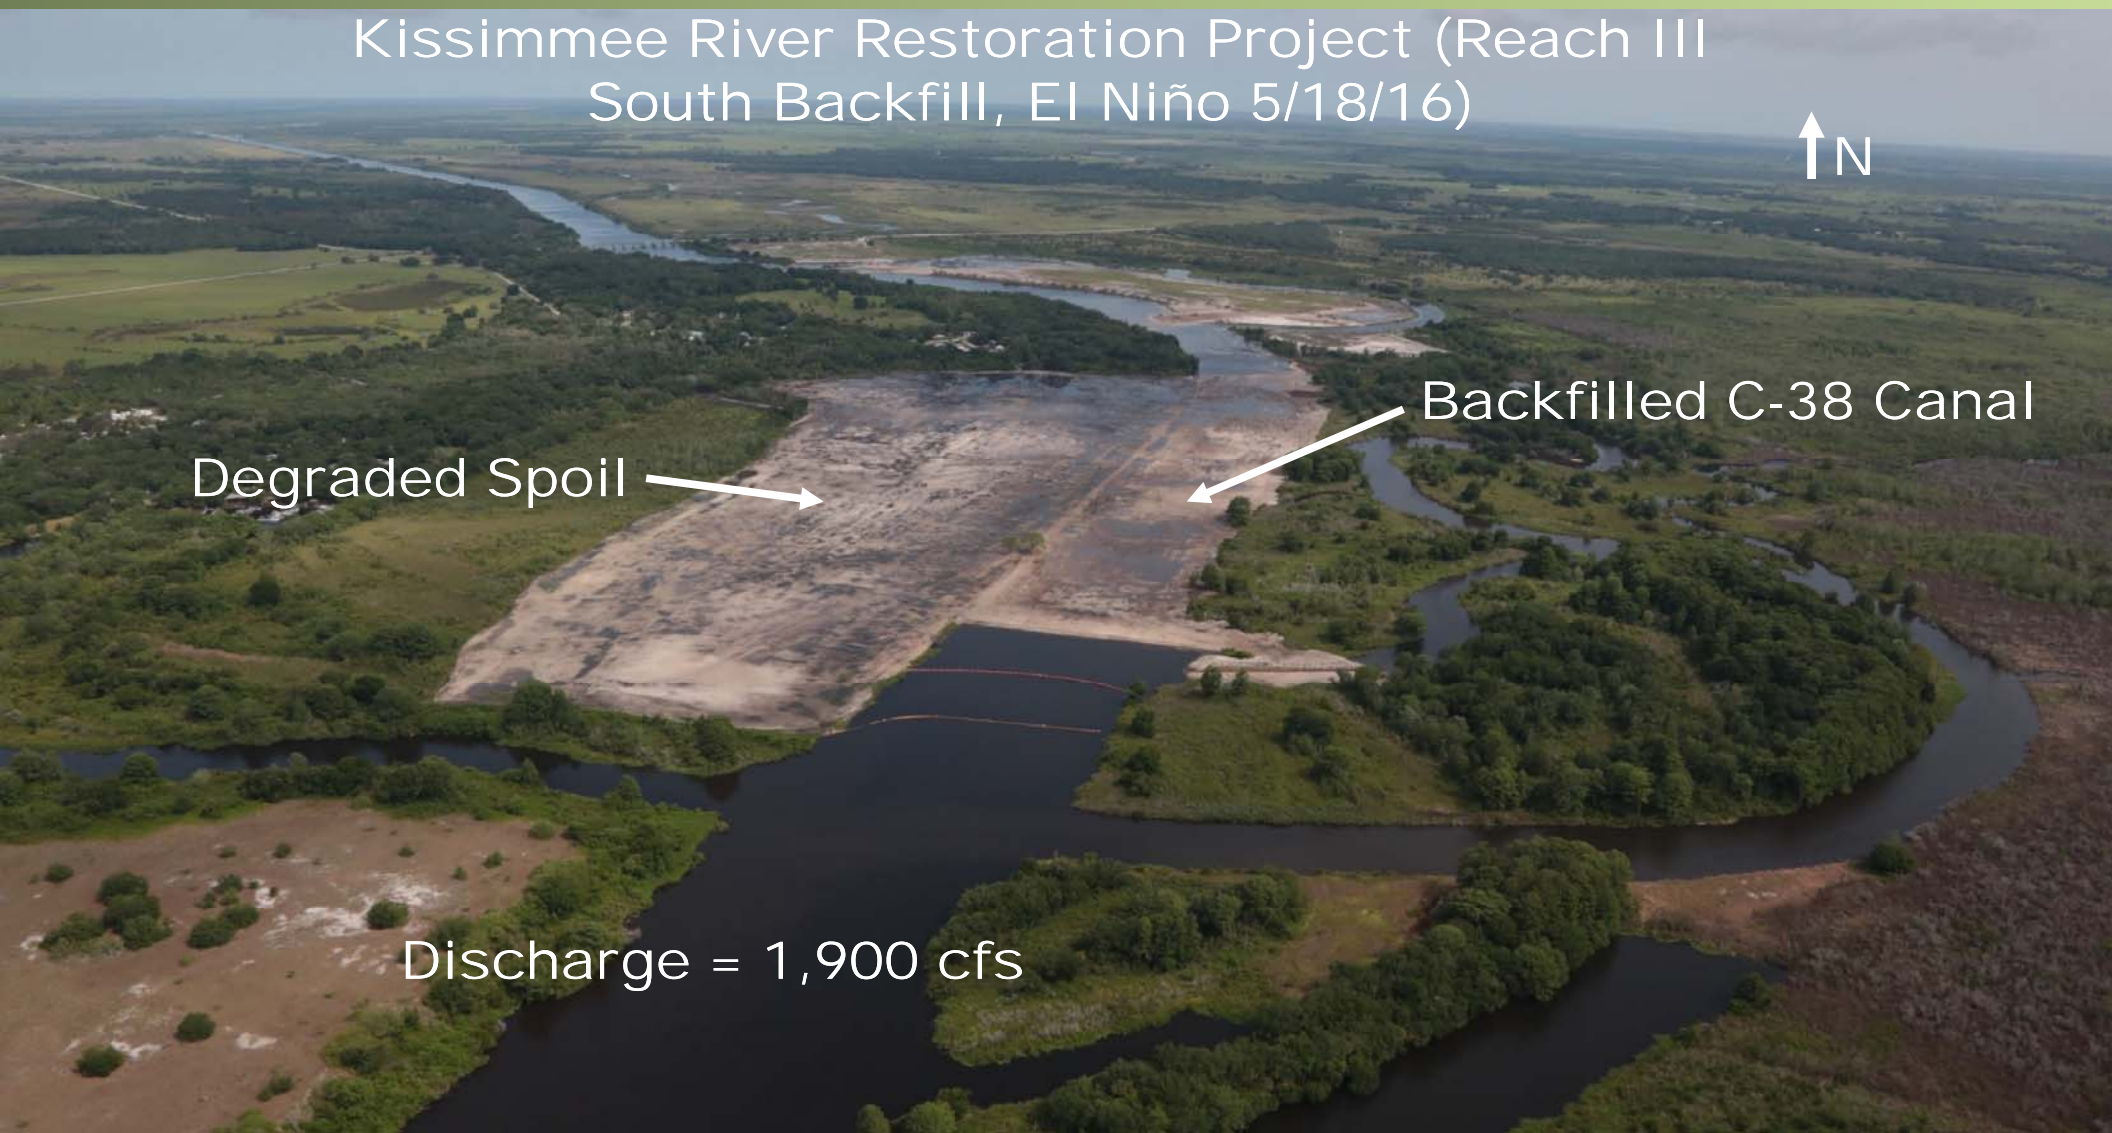
Kissimmee River Restoration Project (Reach III  
South Backfill, El Niño 5/18/16)

Degraded Spoil

Backfilled C-38 Canal

Discharge = 1,900 cfs

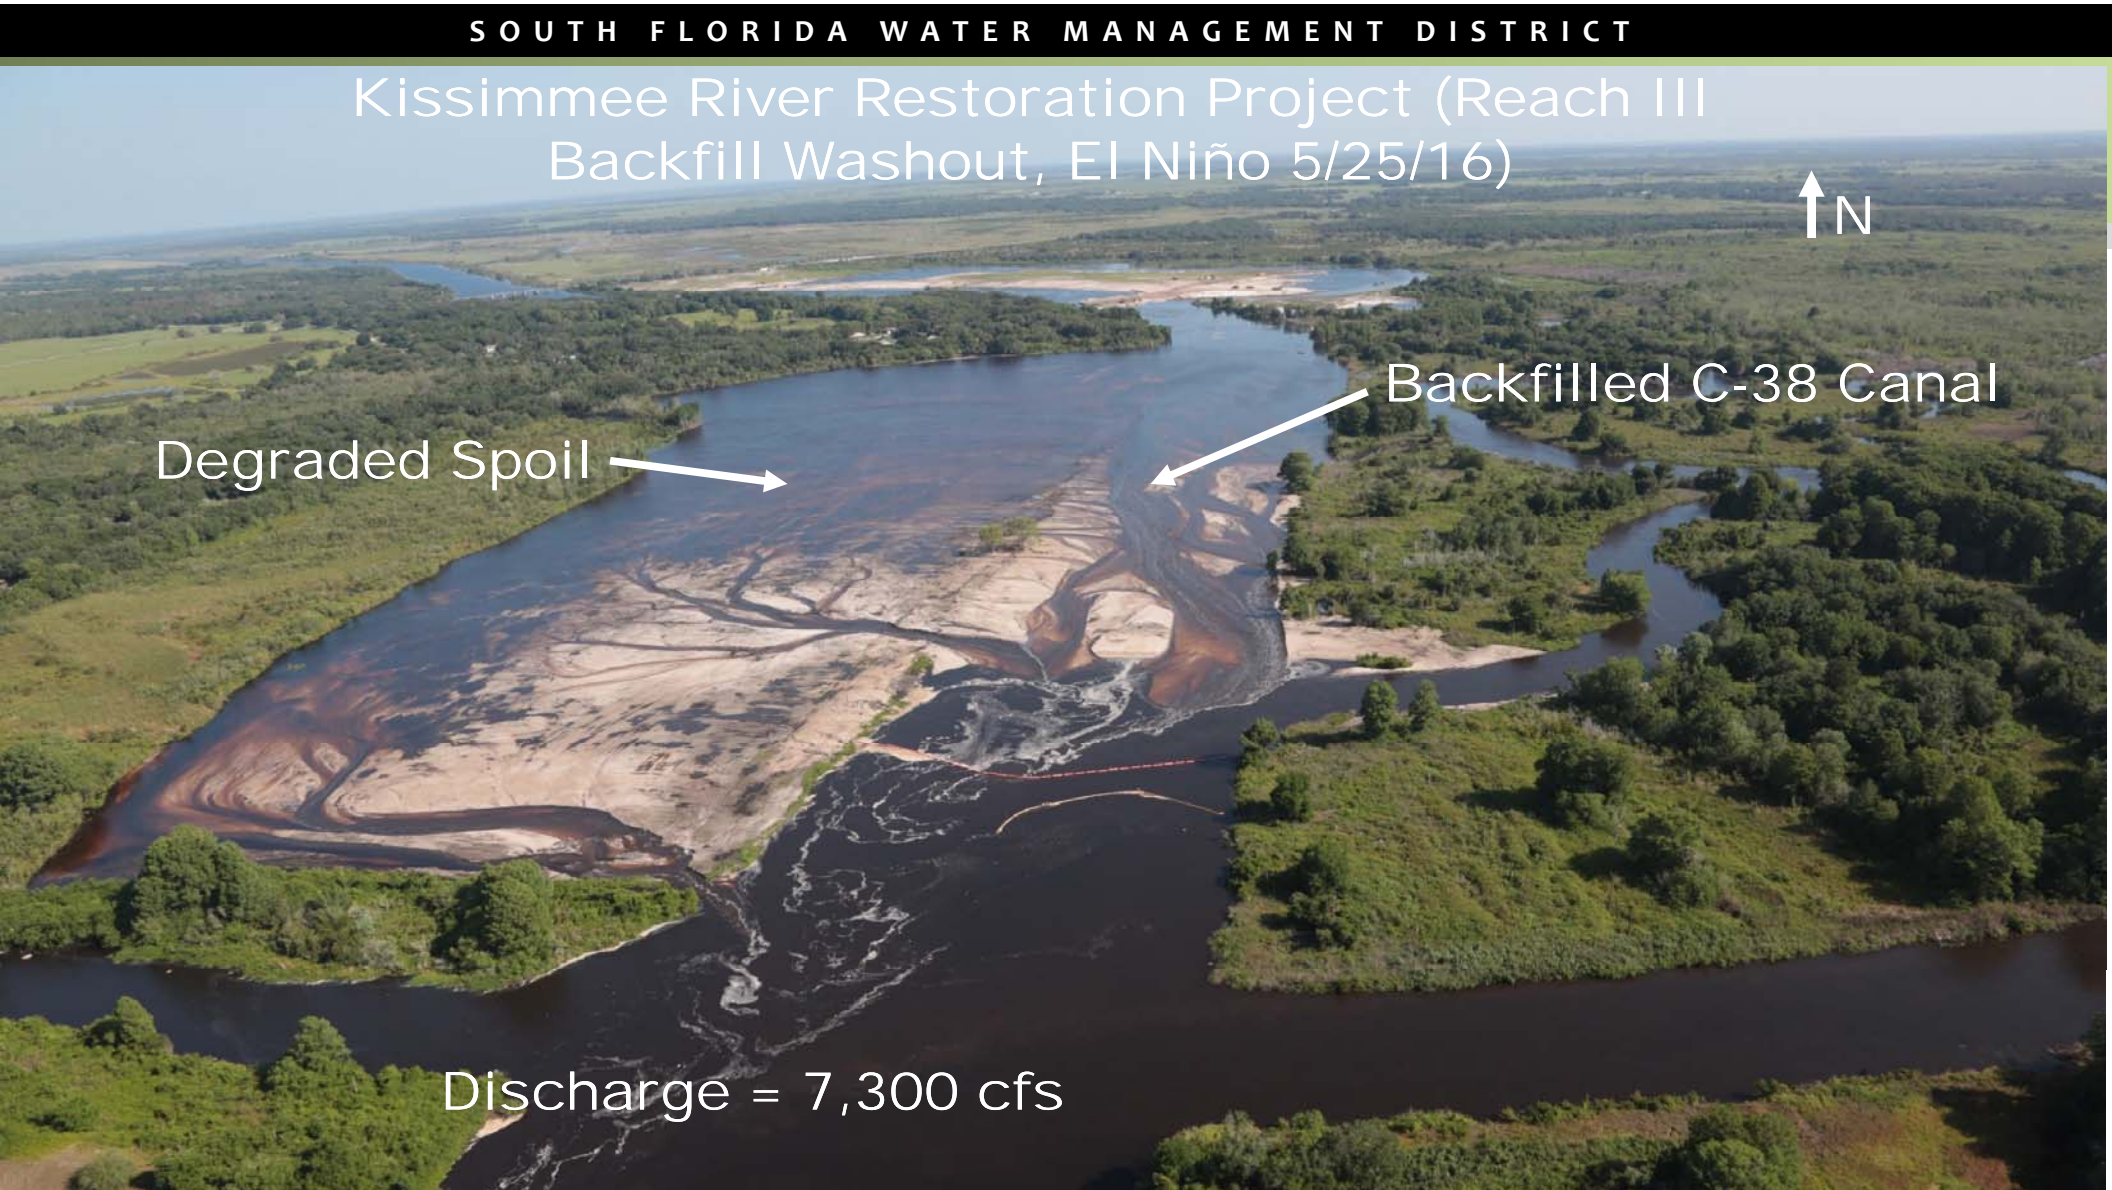
Kissimmee River Restoration Project (Reach III)  
Backfill Washout, El Niño 5/25/16)

Backfilled C-38 Canal

Degraded Spoil

Discharge = 7,300 cfs

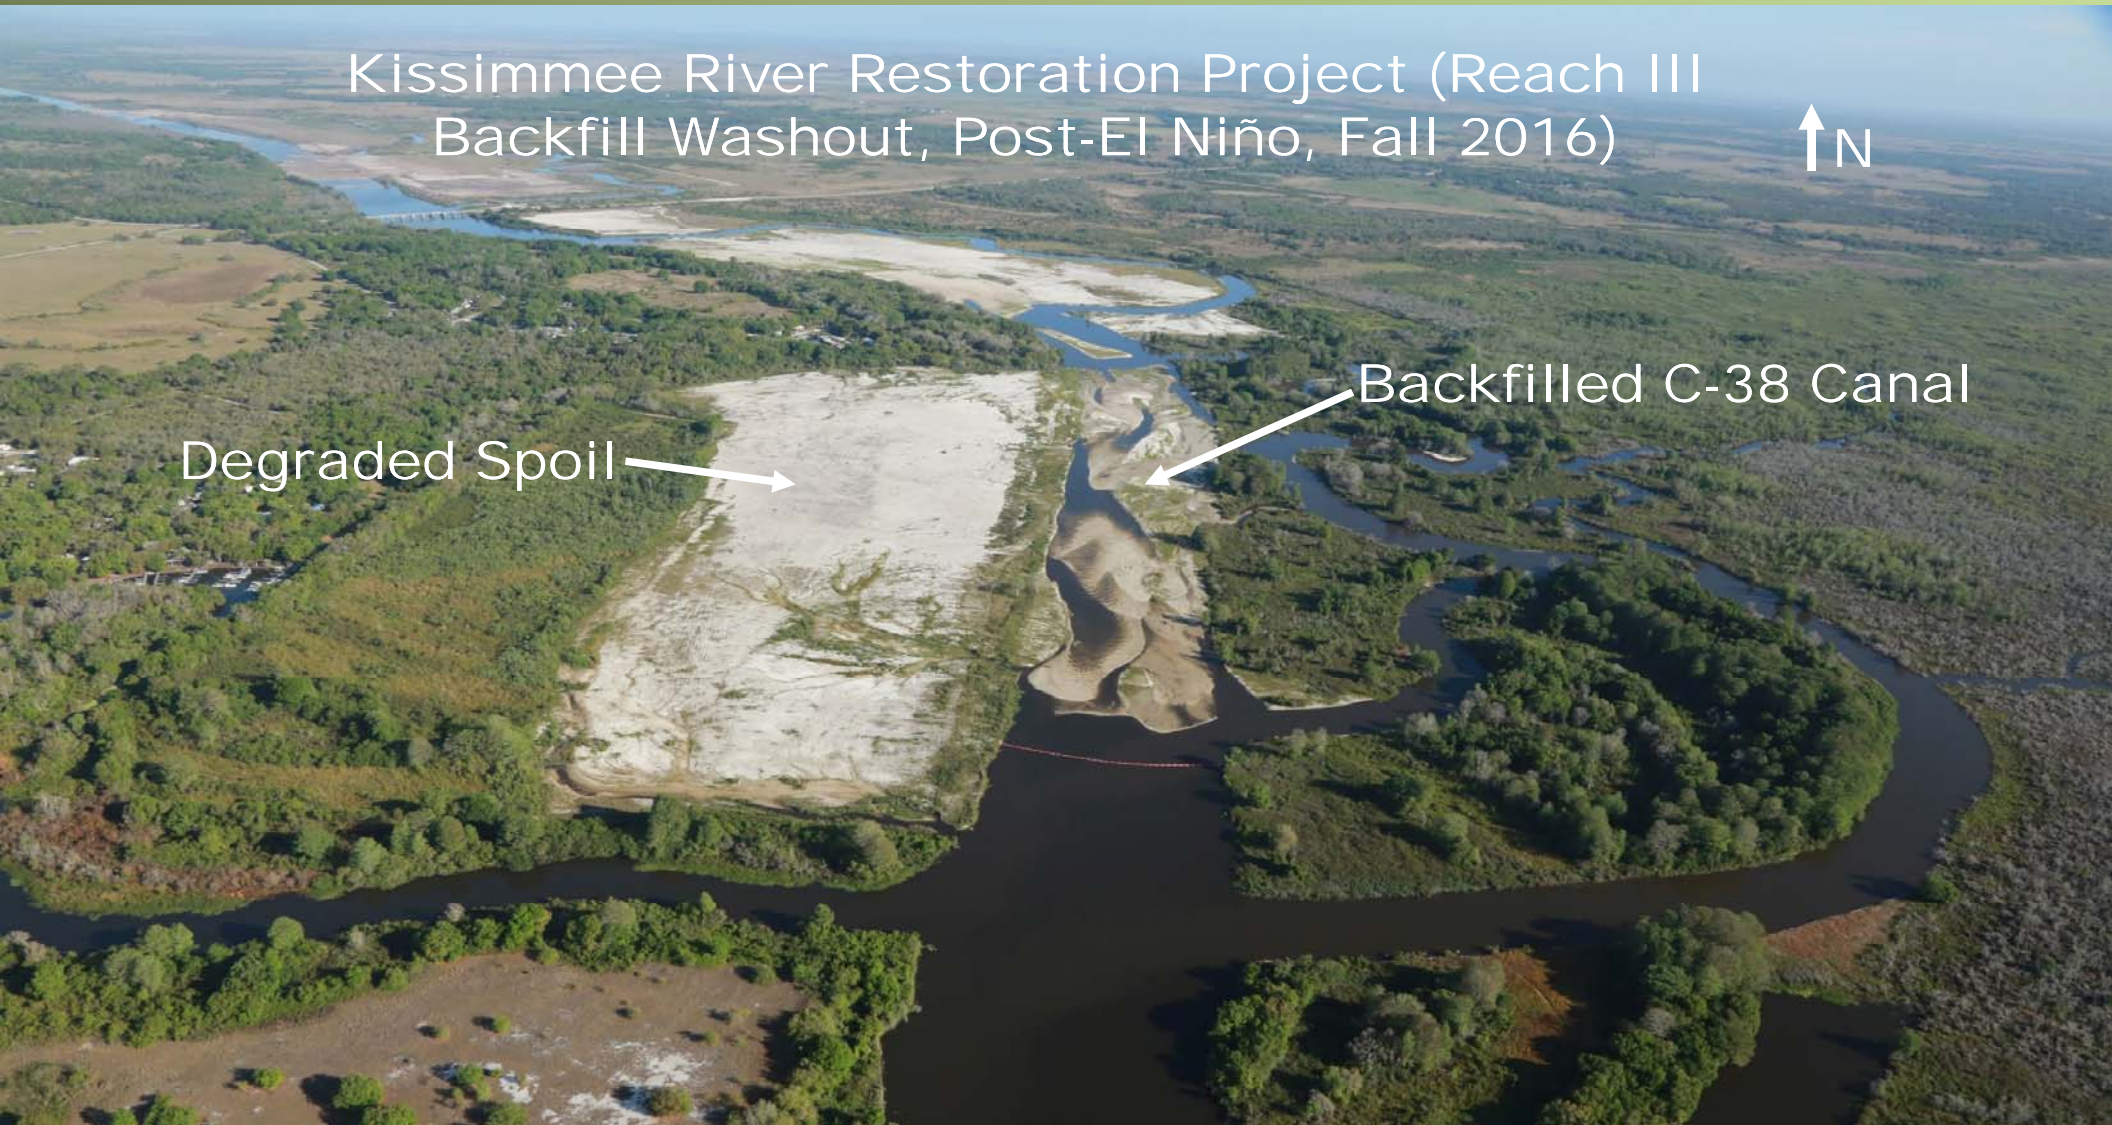
Kissimmee River Restoration Project (Reach III)  
Backfill Washout, Post-El Niño, Fall 2016

Degraded Spoil

Backfilled C-38 Canal

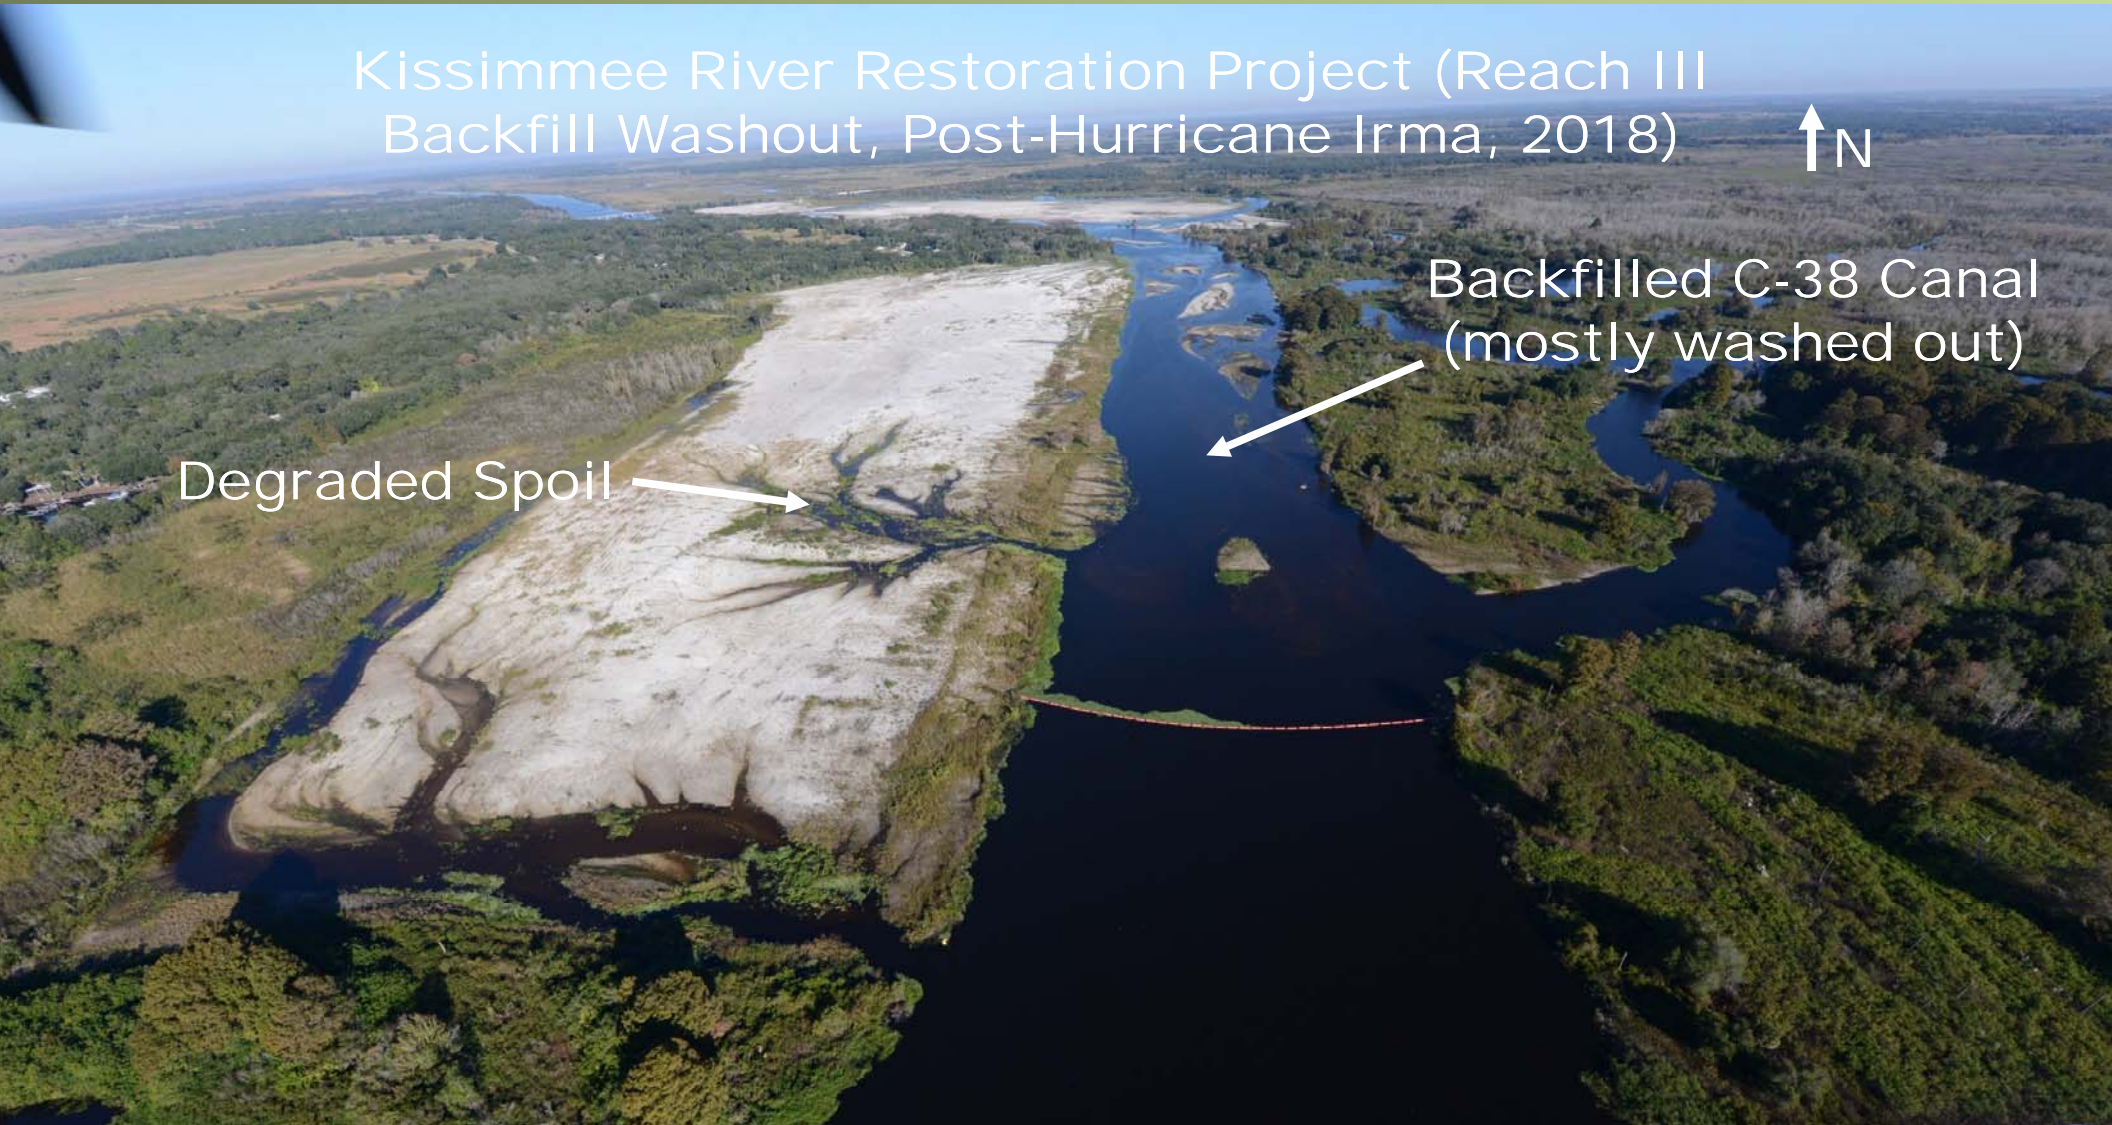
Kissimmee River Restoration Project (Reach III)  
Backfill Washout, Post-Hurricane Irma, 2018

Backfilled C-38 Canal  
(mostly washed out)

Degraded Spoil

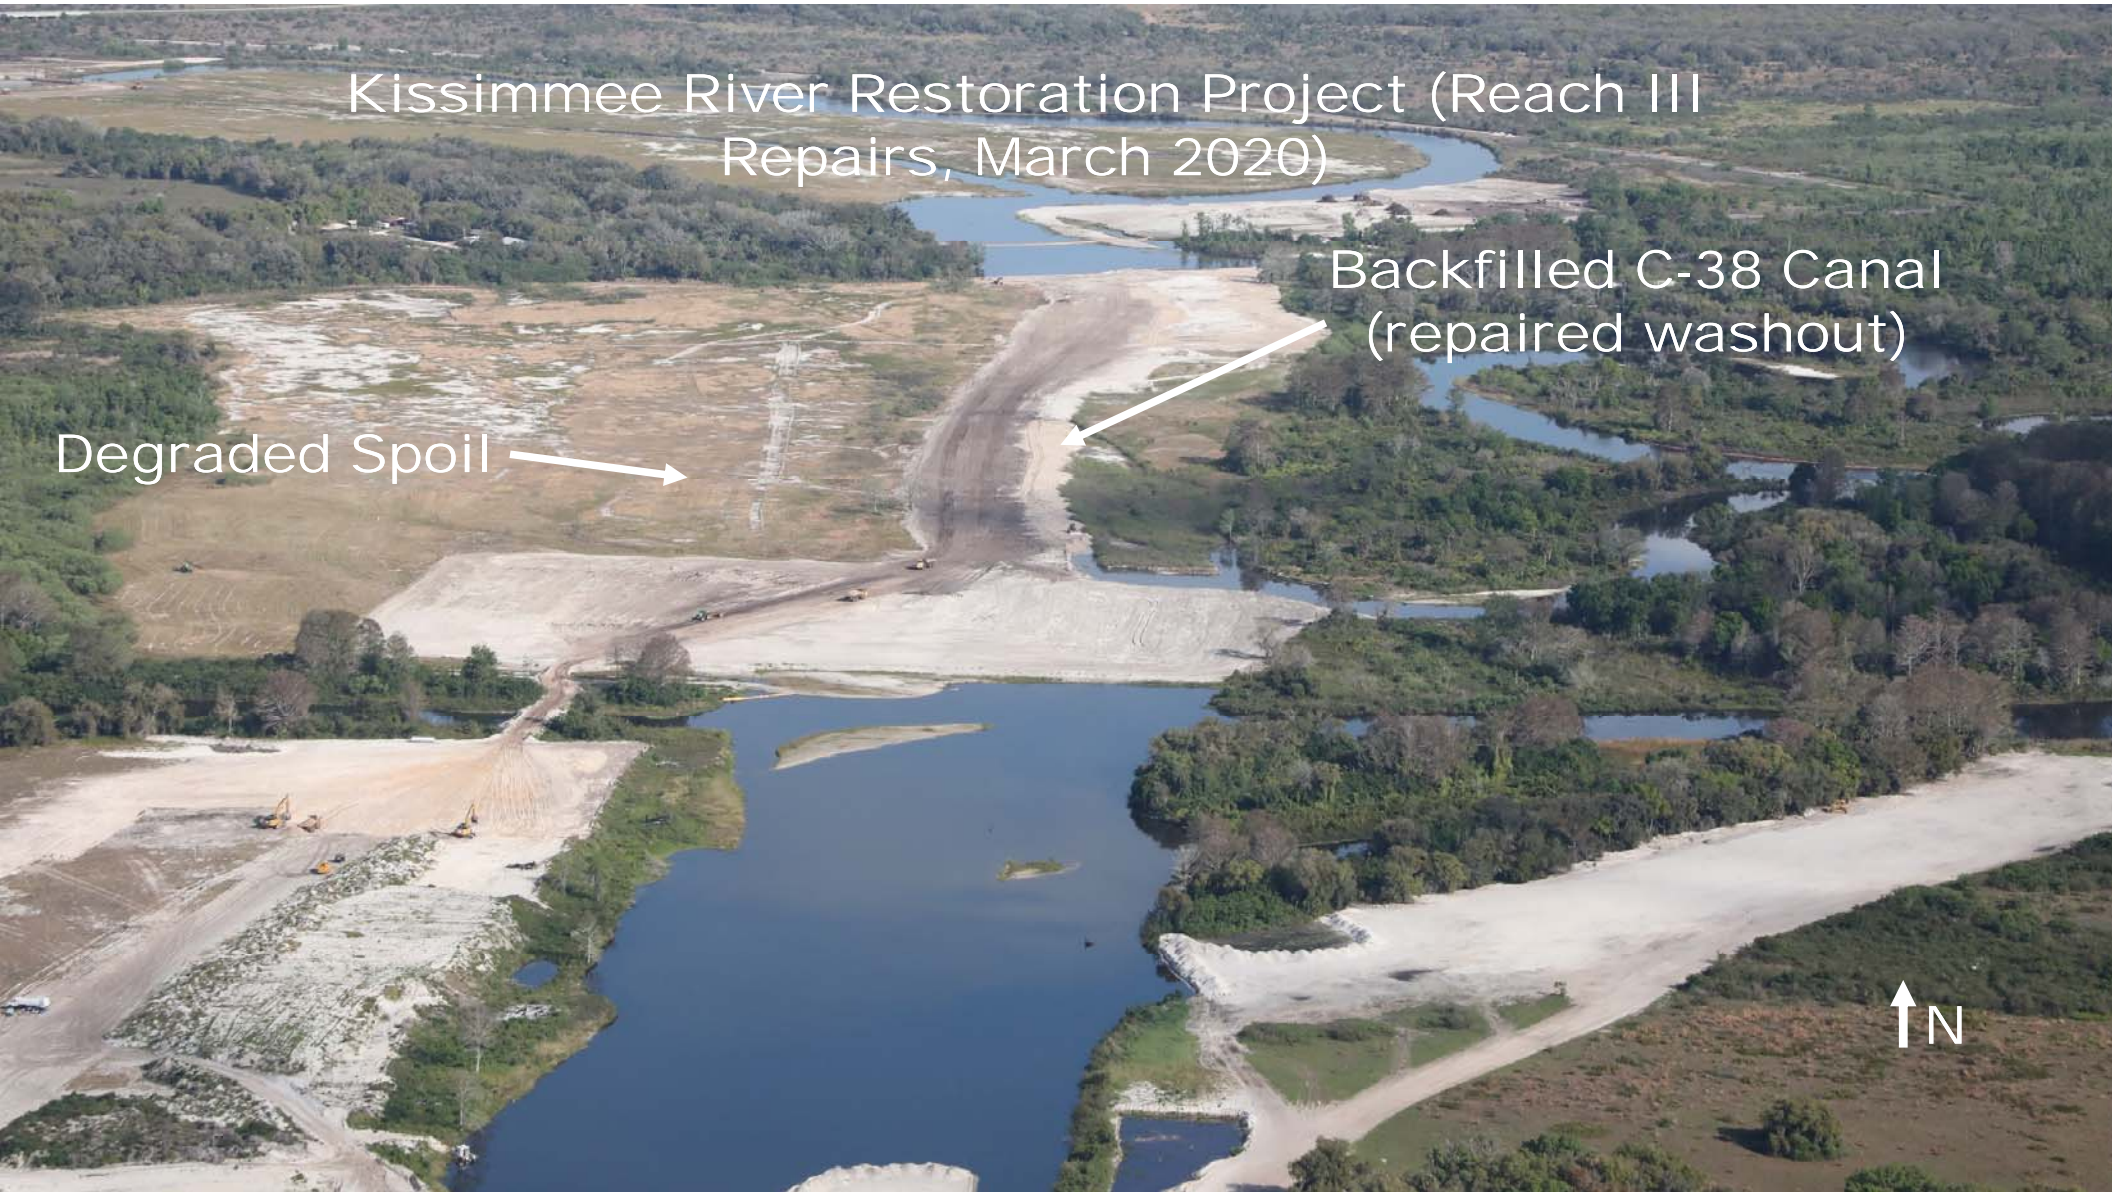
Kissimmee River Restoration Project (Reach III  
Repairs, March 2020)

Backfilled C-38 Canal  
(repaired washout)

Degraded Spoil

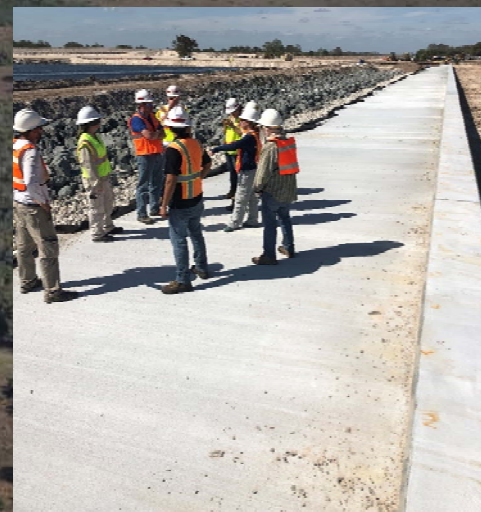
Kissimmee River Restoration  
Project (S-69 Weir, Southern  
Terminus of Restoration  
Project, Feb 2020

Historical  
River Channel

Bypass canal

S-69 Weir
