The Chronology of Historic/Natural Flows, DRAFT System Alterations and Ecological Consequences

Fred H. Sklar, Ph.D., Section Administrator

Everglades Systems Assessment Section
South Florida Water Management District

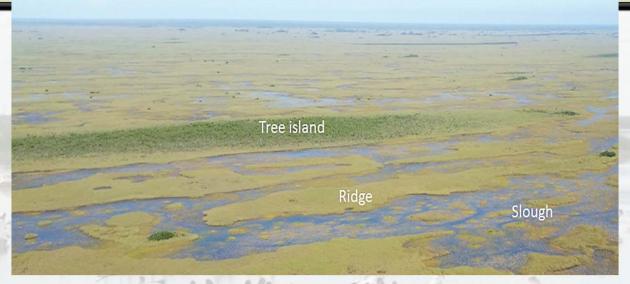
Pre-drainage Characteristics: The importance of the ridge-slough topography

During the wet season, flows distribute nutrients, food and floc (Everglades "topsoil")

During the dry season, wading birds feed in the sloughs and nest in the tree islands

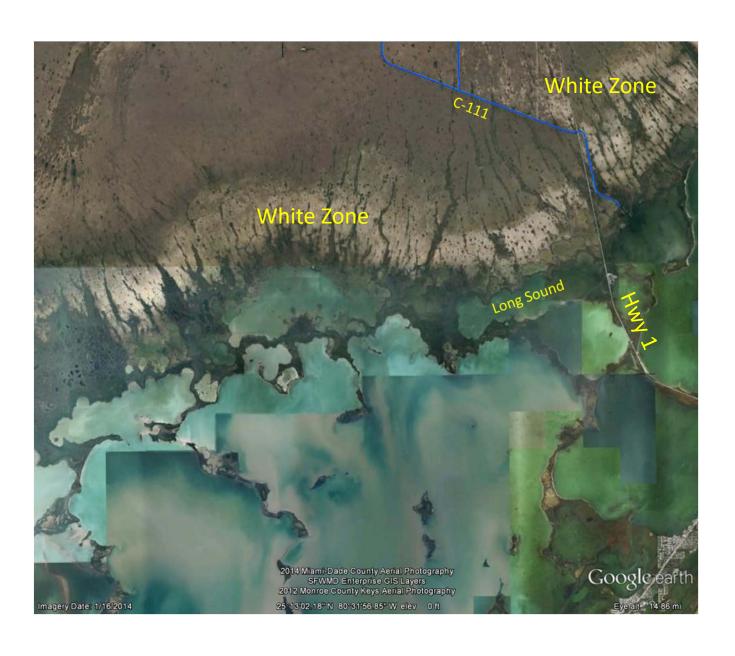
Headwater Reduction Consequence

- Increased salinity in coastal Florida Bay and Biscayne Bay
- 2. Sawgrass replaced by dwarf mangroves
- 3. "White Zone" migration inland.
- 4. Soil oxidation (elevation loss)

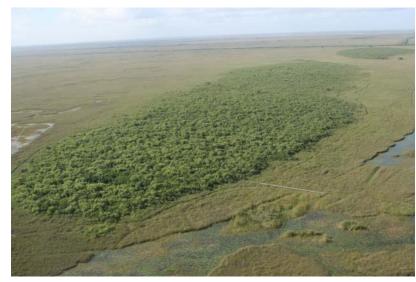
A typical tree island

Some 65% of the tree islands in WCA-3 have either burnt away, oxidized or flooded

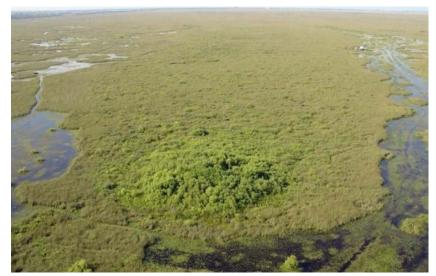
A "ghost" tree island

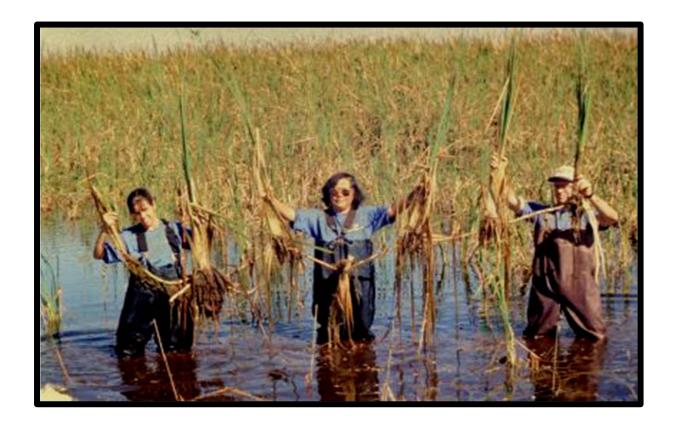
Lost Oligotrophy

Phosphorus enrichment creates a cattail "invasion."
