Governing Board Meeting  
November 12, 2020

# Ecological Conditions Update

**Lawrence Glenn**  
Water Resources Division Director

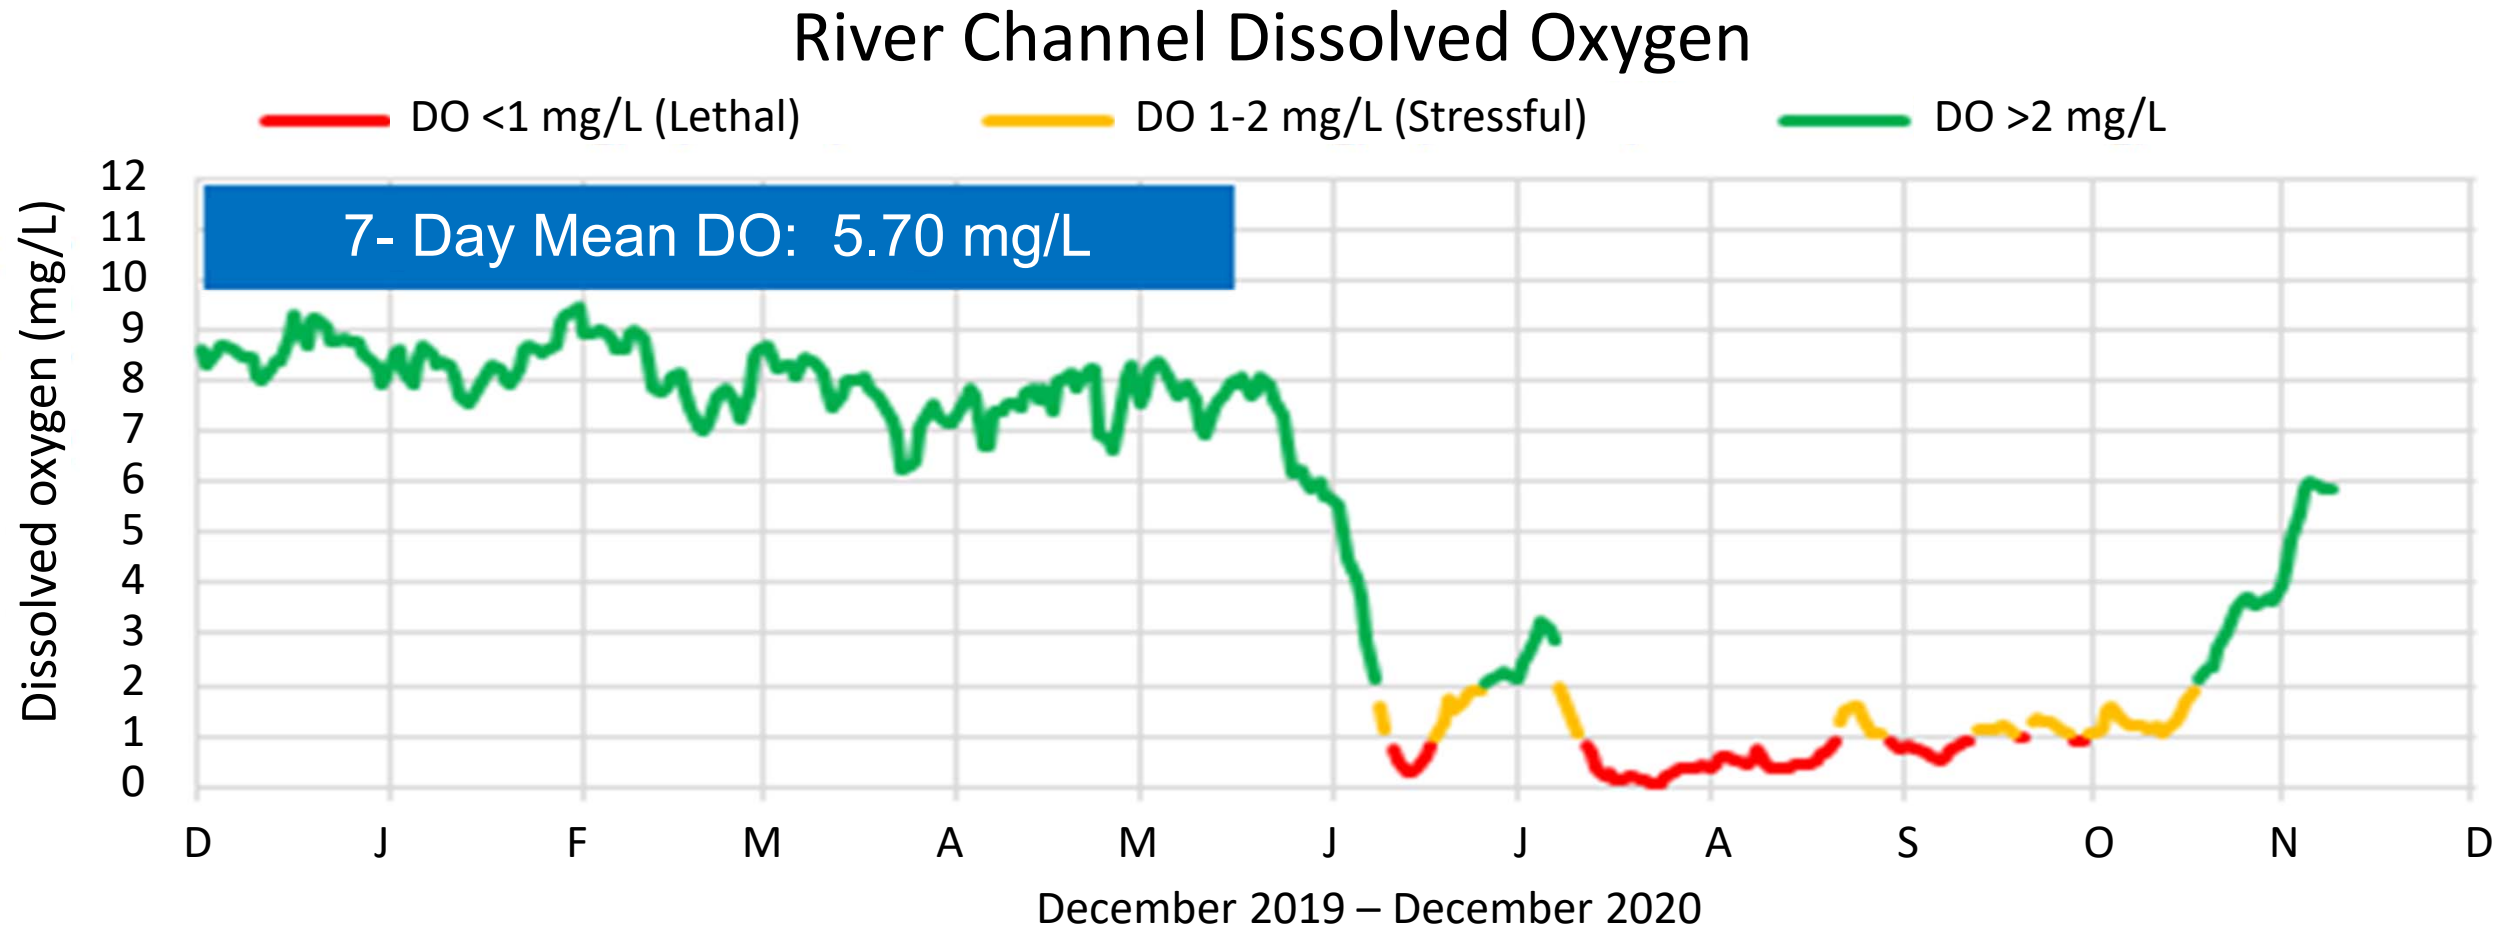
# Kissimmee River (Phases I and II/III Area) Mean Daily Dissolved Oxygen

Data are averaged for PC62, KRBN, PC33, PD62R, and PD42R with and average of 4 stations reporting this week.  
Report Date: 11/10/2020; data are through: 11/08/2020

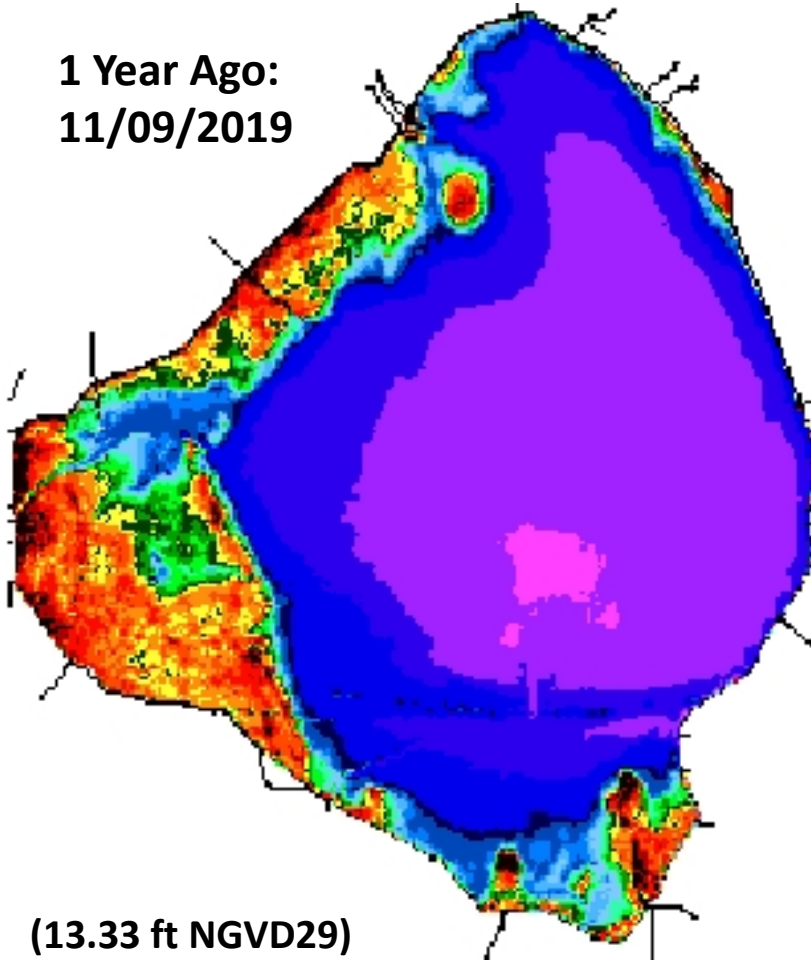
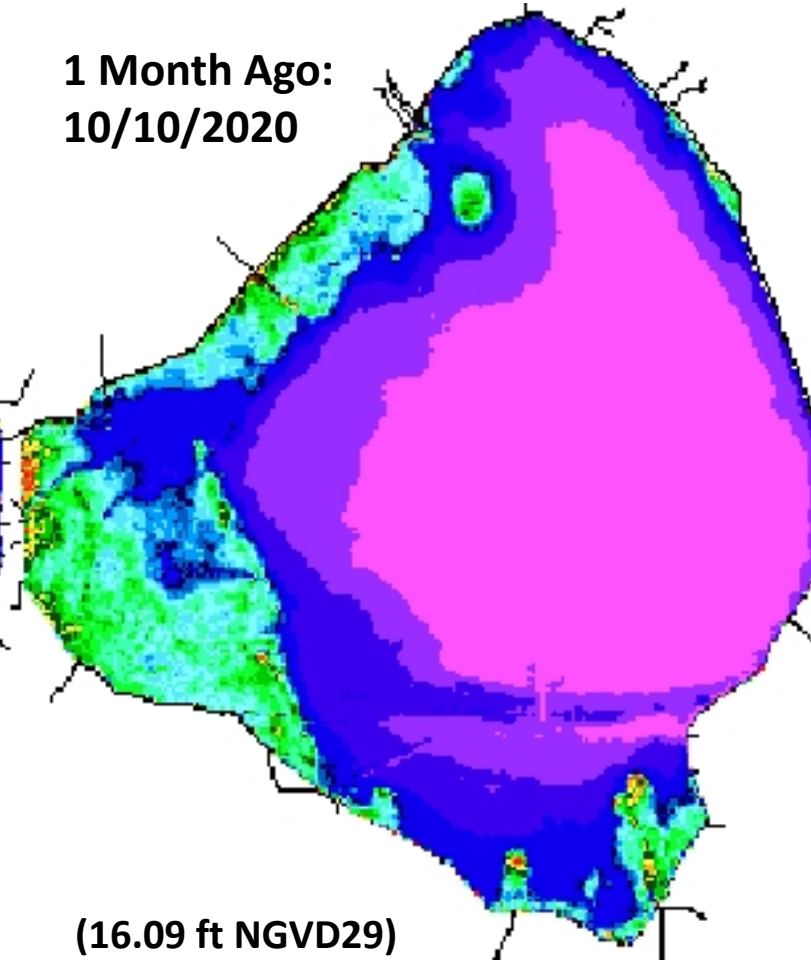
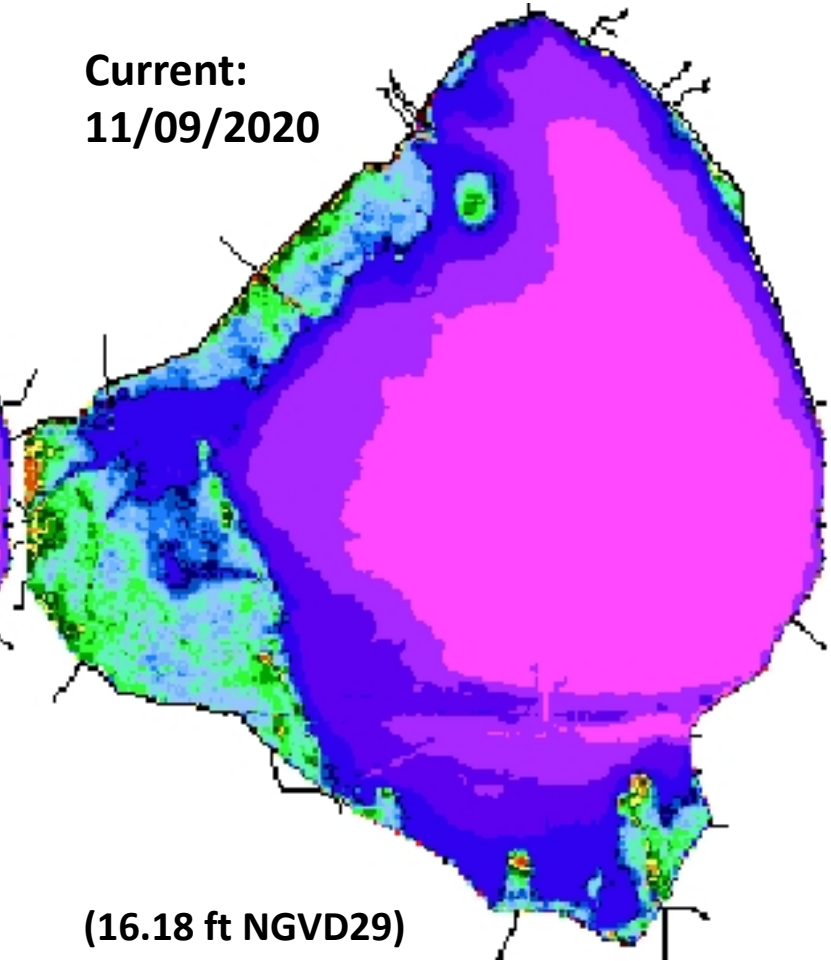
# Lake Okeechobee Water Depth Maps

1 Year Ago:  
11/09/2019

(13.33 ft NGVD29)

1 Month Ago:  
10/10/2020

(16.09 ft NGVD29)

Current:  
11/09/2020

(16.18 ft NGVD29)

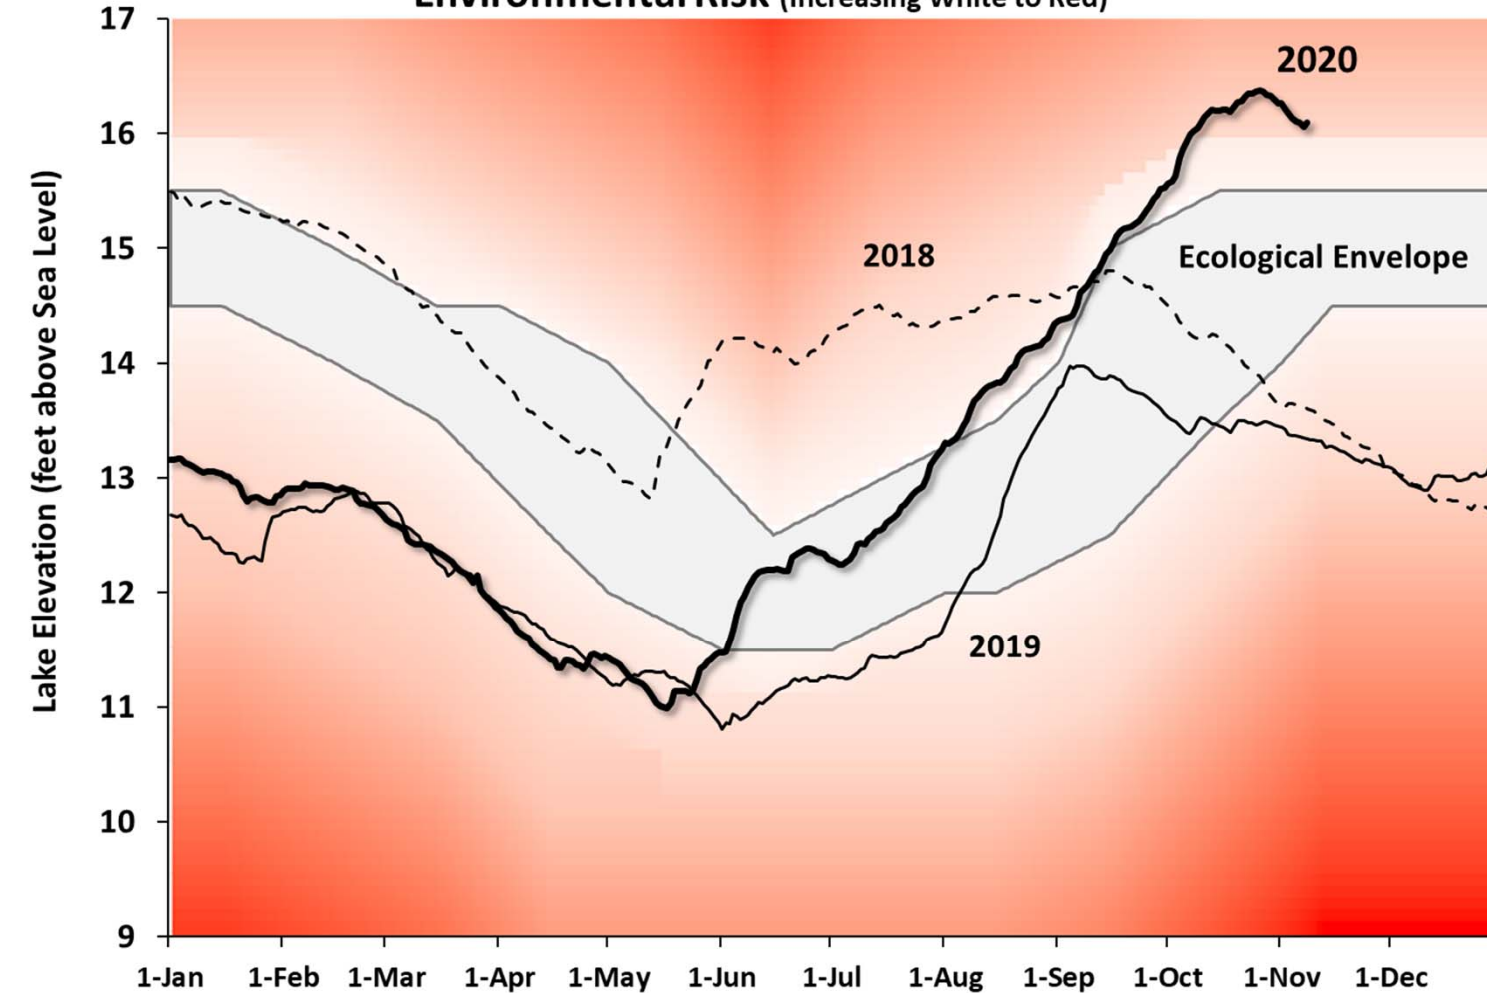
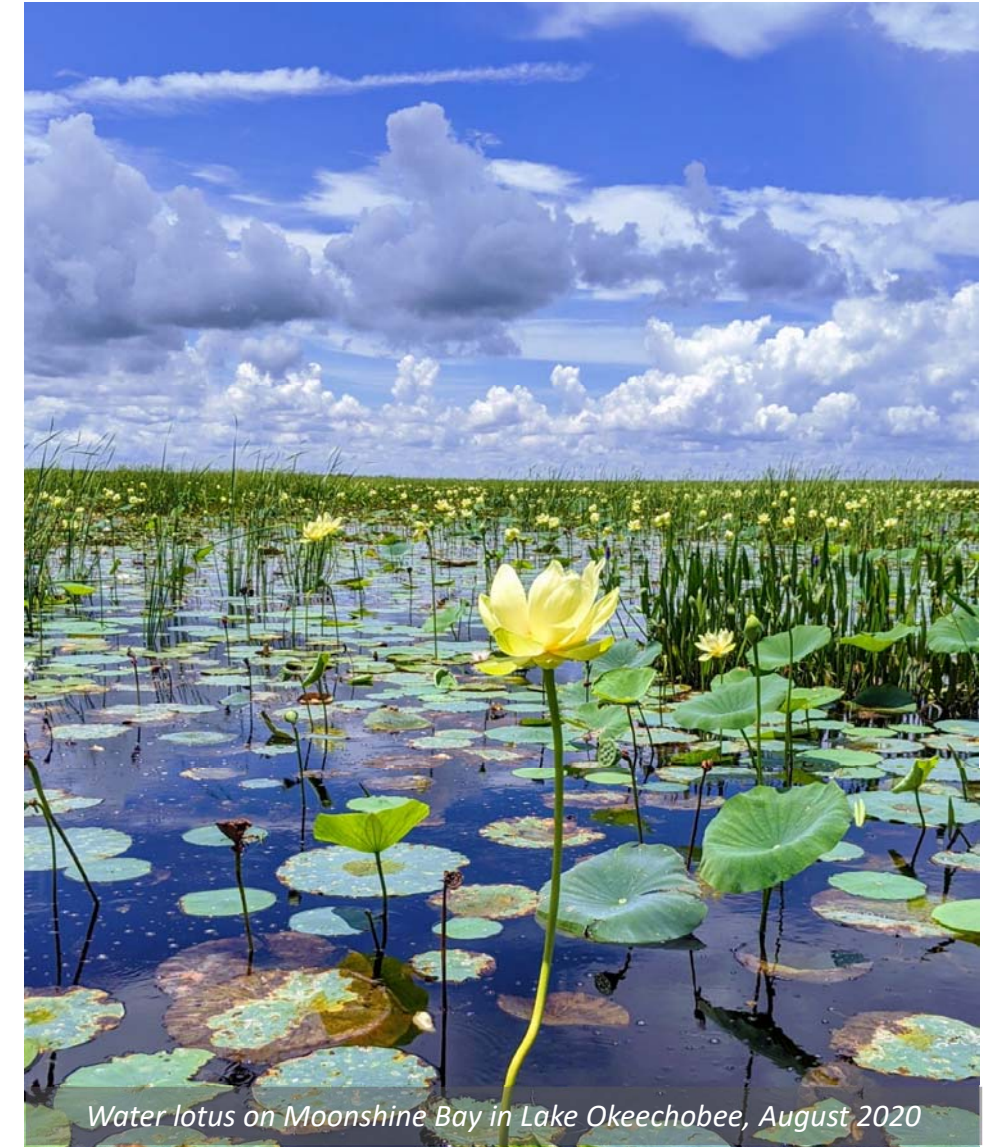
# Lake Okeechobee Stages and Ecological Envelope

Lake Okeechobee Stage vs Ecological Envelope and Environmental Risk (Increasing White to Red)

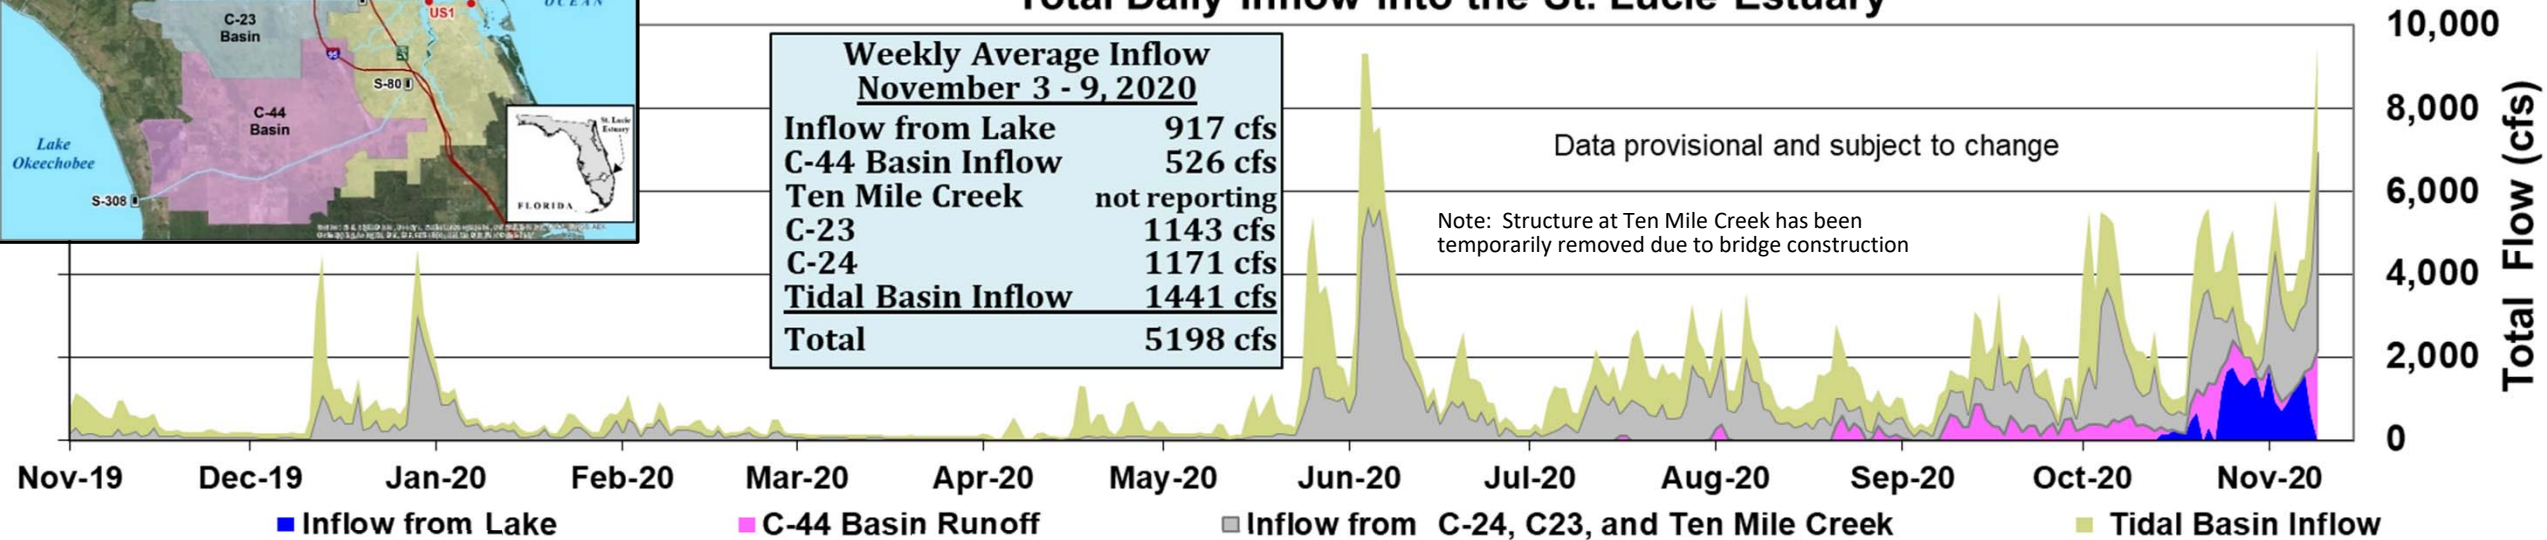
## Total Daily Inflow into the St. Lucie Estuary

### Weekly Average Inflow November 3 - 9, 2020

Inflow from Lake	917 cfs
C-44 Basin Inflow	526 cfs
Ten Mile Creek	not reporting
C-23	1143 cfs
C-24	1171 cfs
Tidal Basin Inflow	1441 cfs
<b>Total</b>	<b>5198 cfs</b>

Note: Structure at Ten Mile Creek has been temporarily removed due to bridge construction

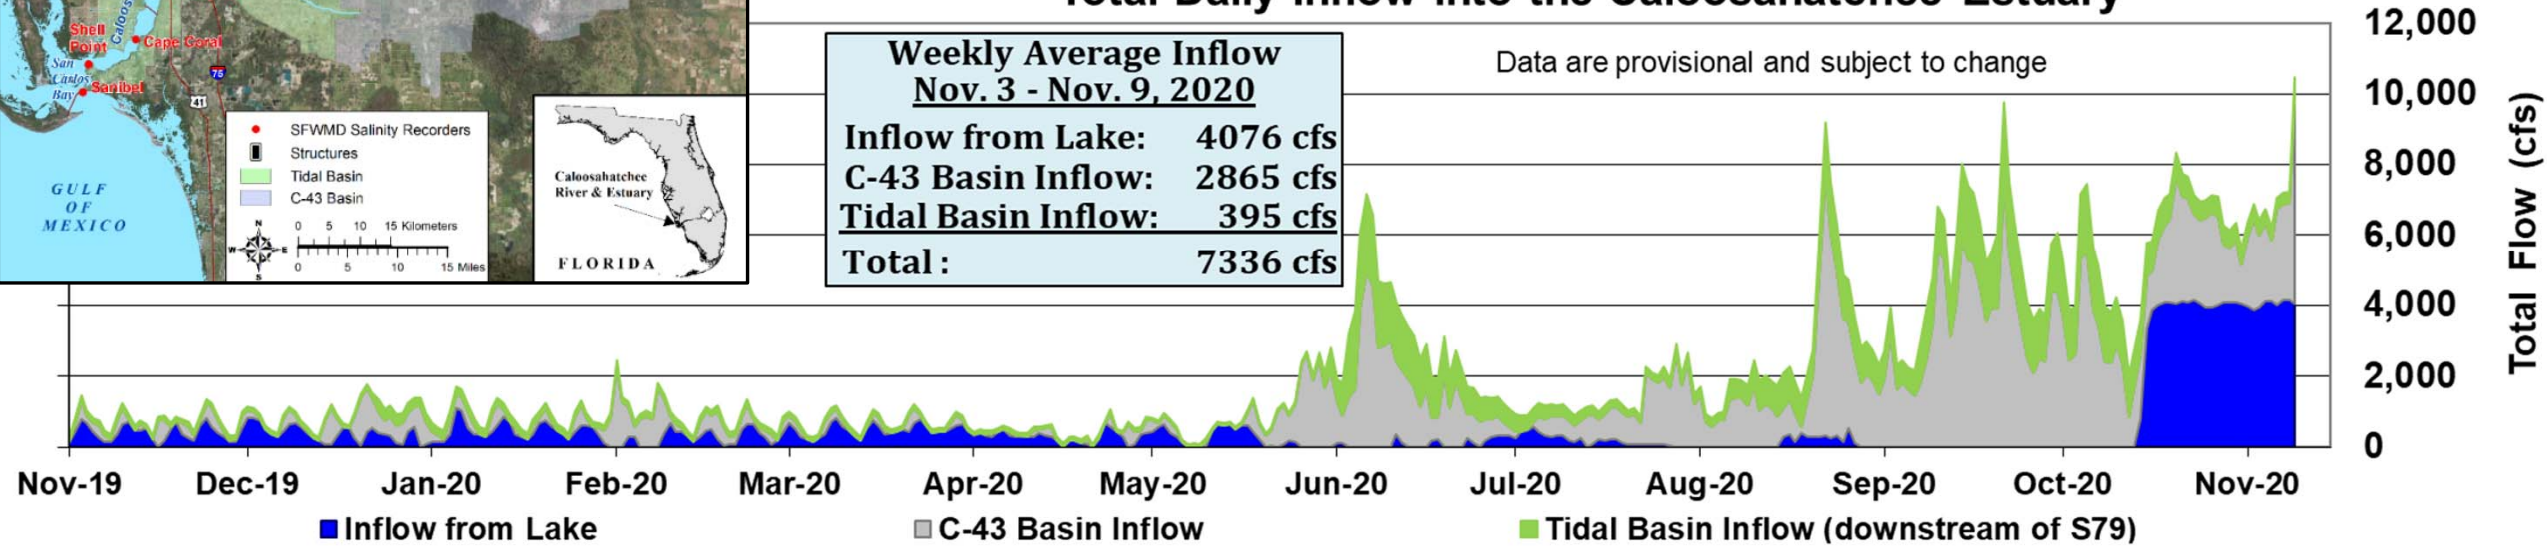
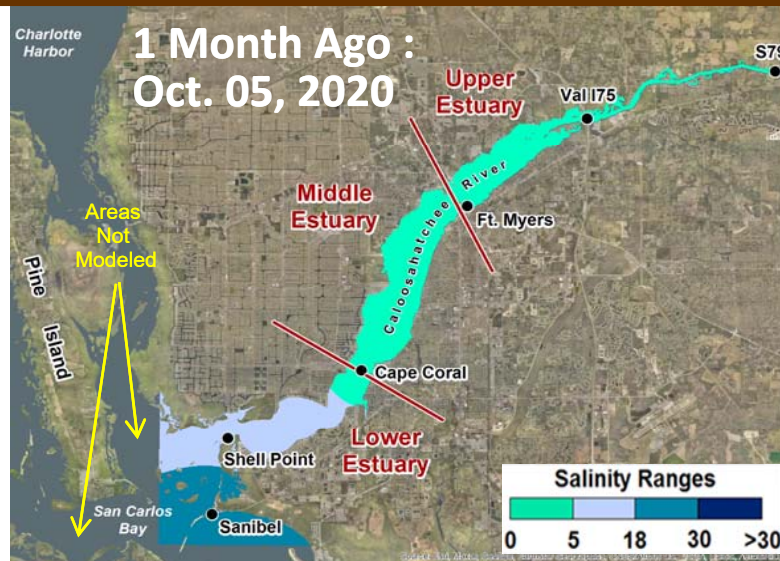
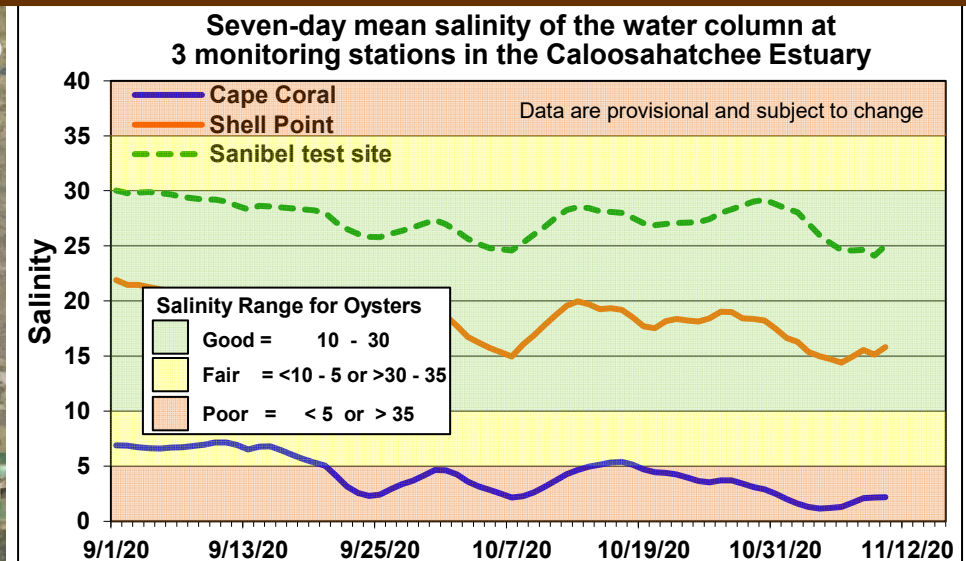
## Total Daily Inflow into the Caloosahatchee Estuary

**Weekly Average Inflow**  
**Nov. 3 - Nov. 9, 2020**

**Inflow from Lake: 4076 cfs**  
**C-43 Basin Inflow: 2865 cfs**  
**Tidal Basin Inflow: 395 cfs**  
**Total: 7336 cfs**

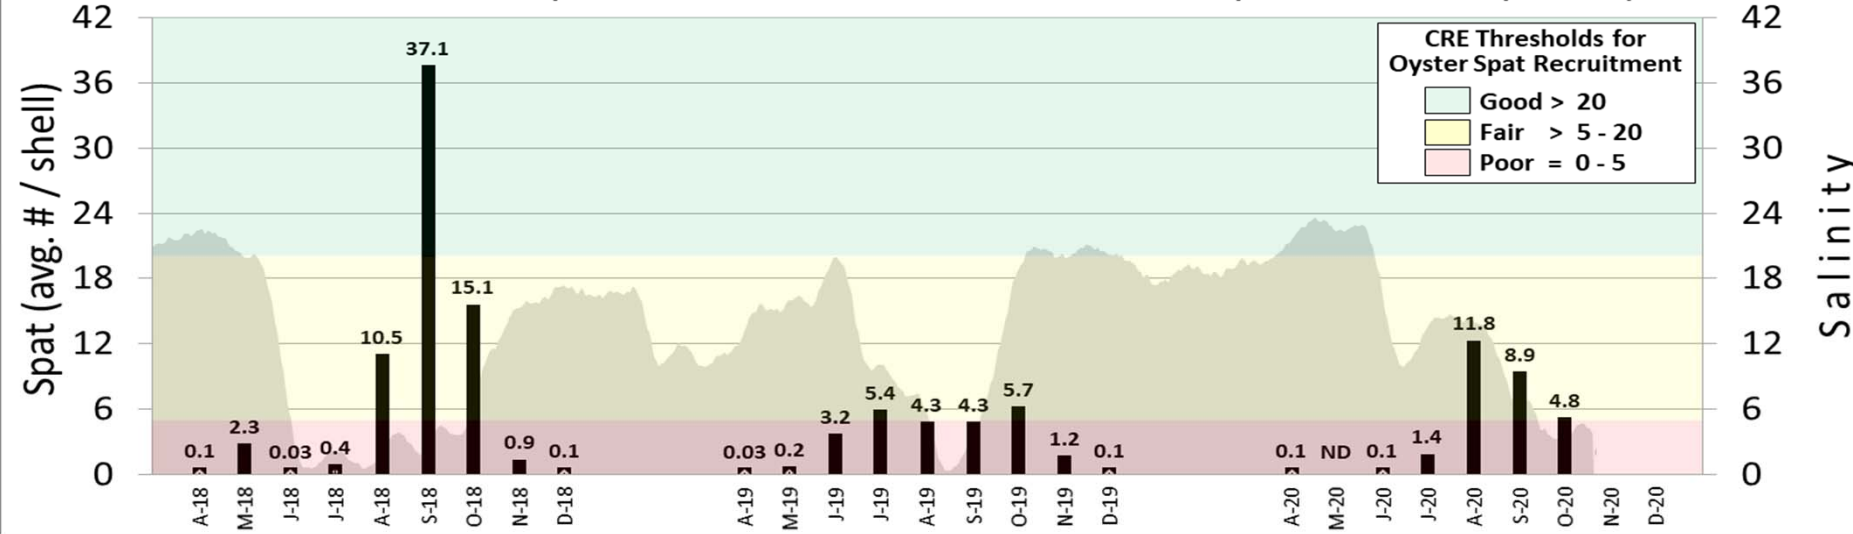
2018 - 2020 Iona Cove Oyster Recruitment Season and 14 day mean Salinity at Cape Coral

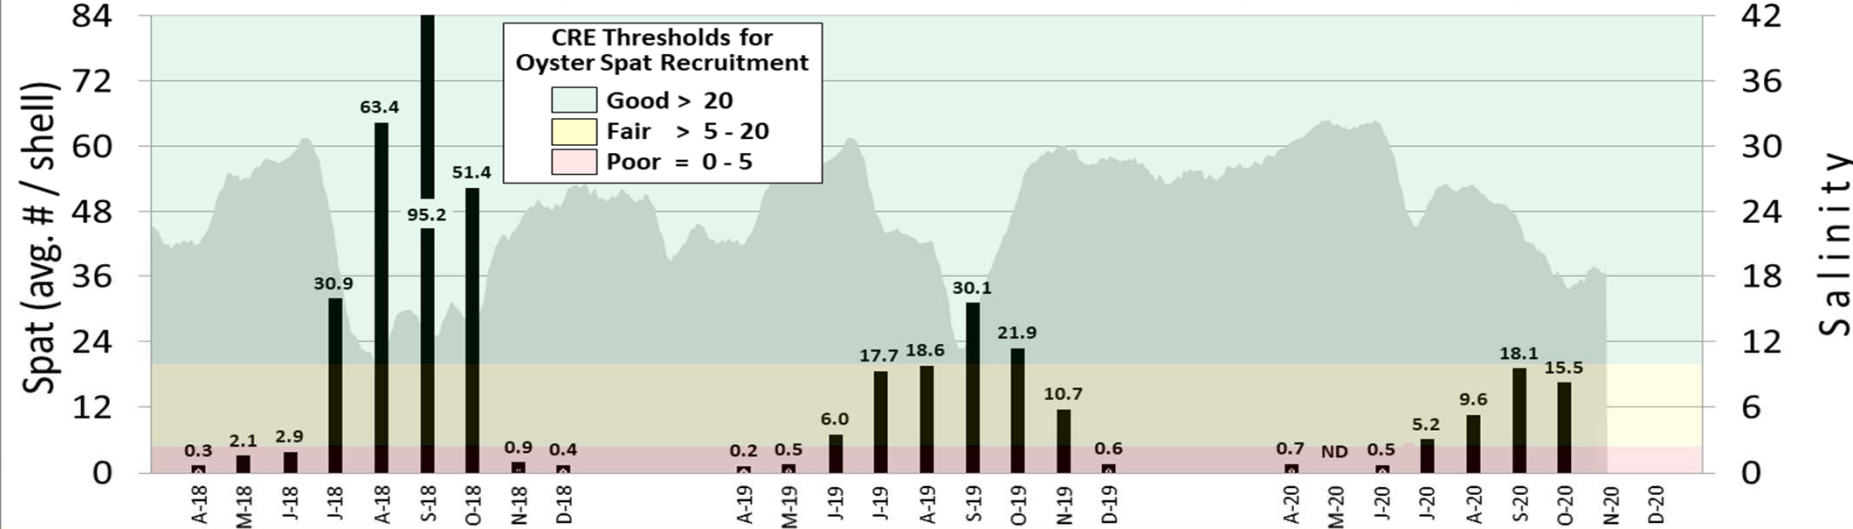
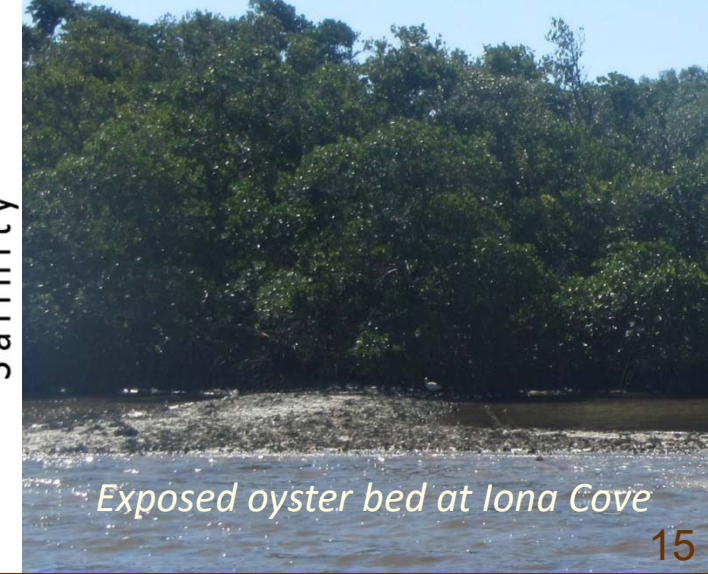
2018 - 2020 Bird Island Oyster Recruitment Season and 14 day mean Salinity at Shell Point

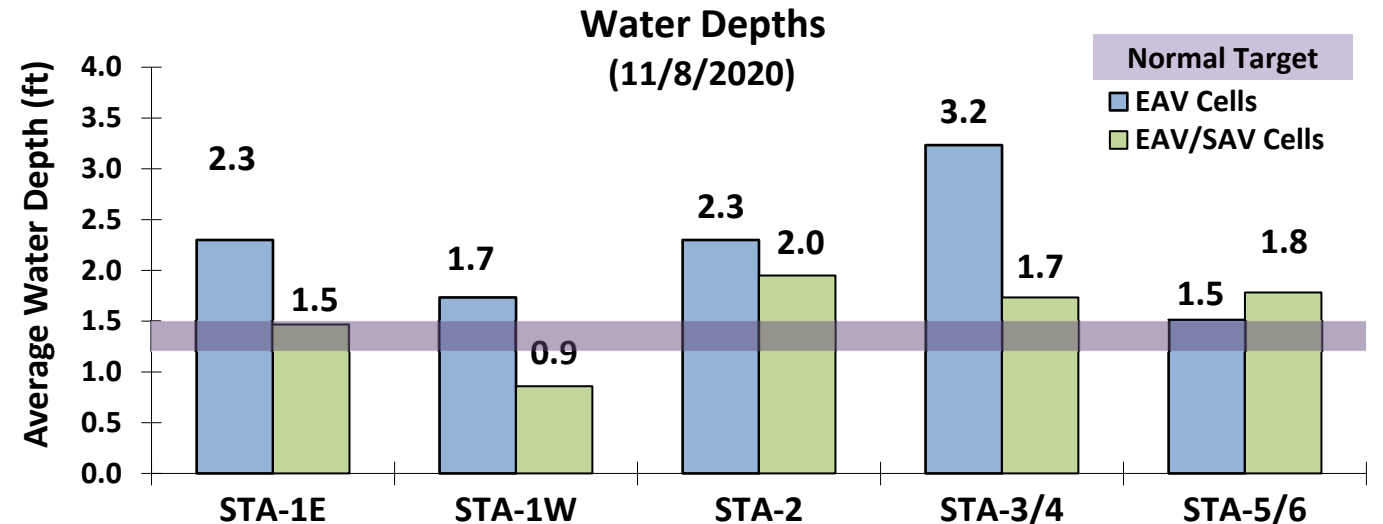
- STAs treated basin runoff and Lake Okeechobee releases in October
- Total Inflows to STAs in WY2021  
~1,228,000 ac-ft
- Lake Okeechobee releases to STAs/FEBs in WY2021 95,000 ac-ft (8% of total)
- Extensive vegetation management activities underway to address stressed and highly stressed vegetation especially in EAV cells
- Most treatment cells are at or above target depth

*Includes preliminary data; Emergent Aquatic Vegetation (EAV); Submerged Aquatic Vegetation (SAV)*

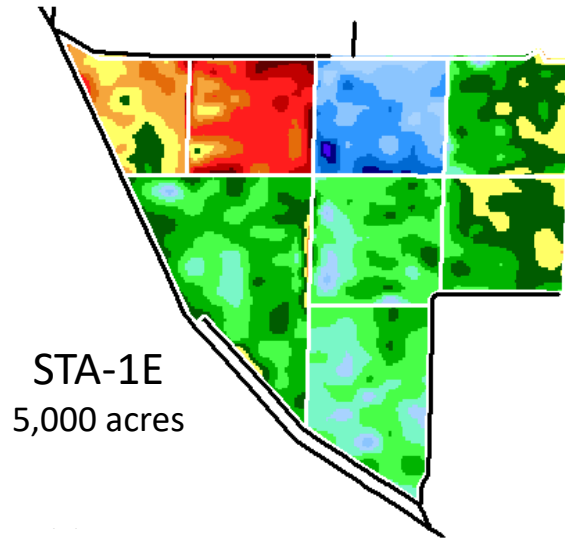
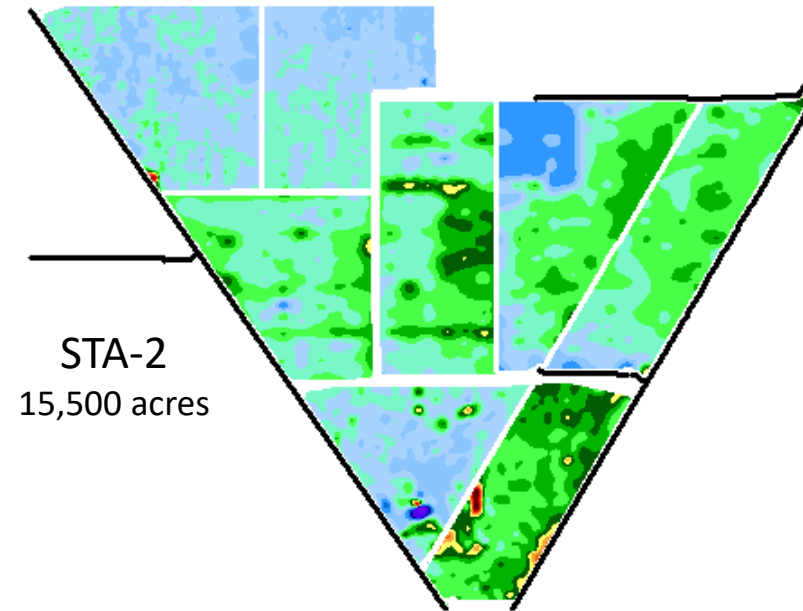
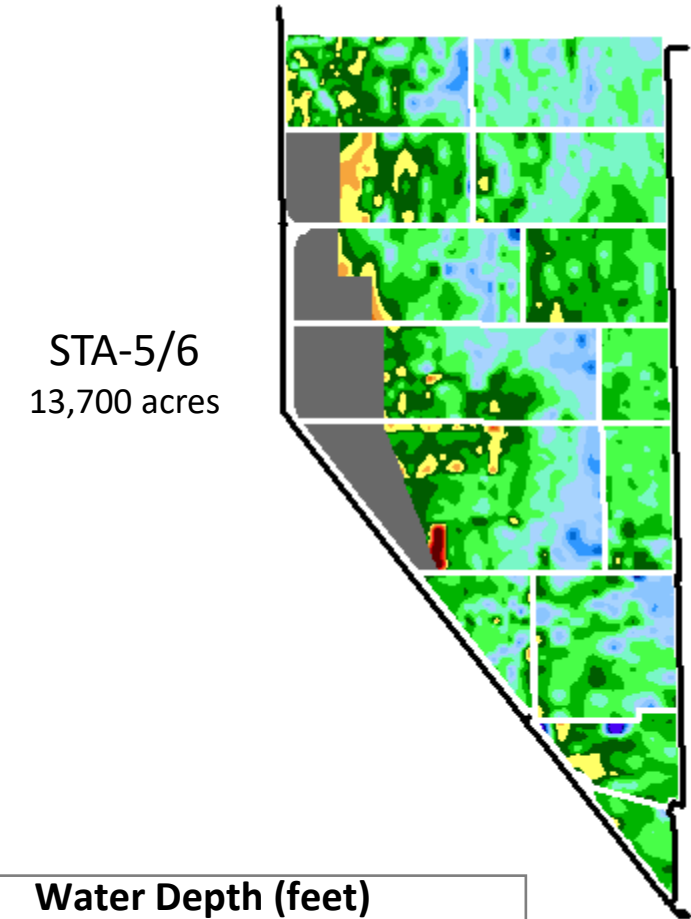
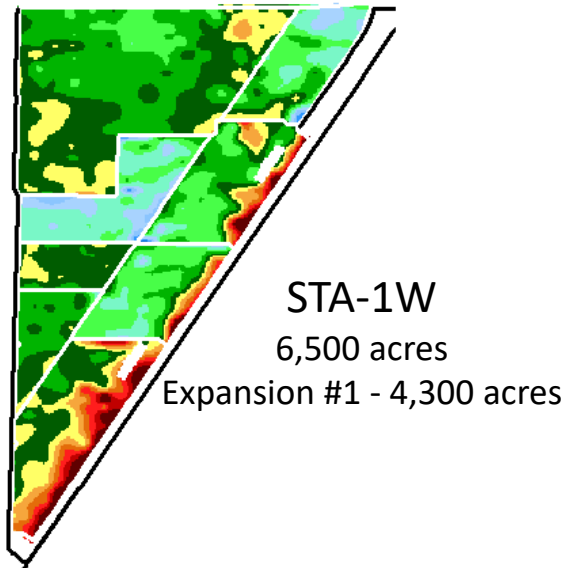
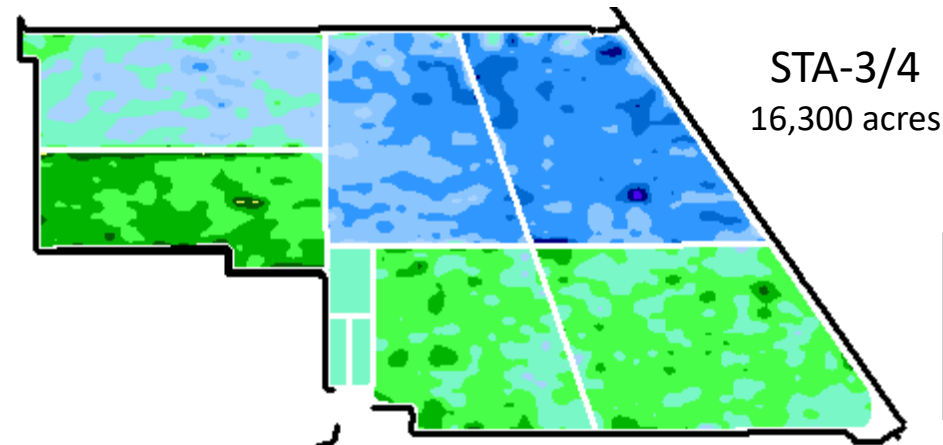
# Everglades Stormwater Treatment Areas

Daily Average Water Depths on 11/8/2020

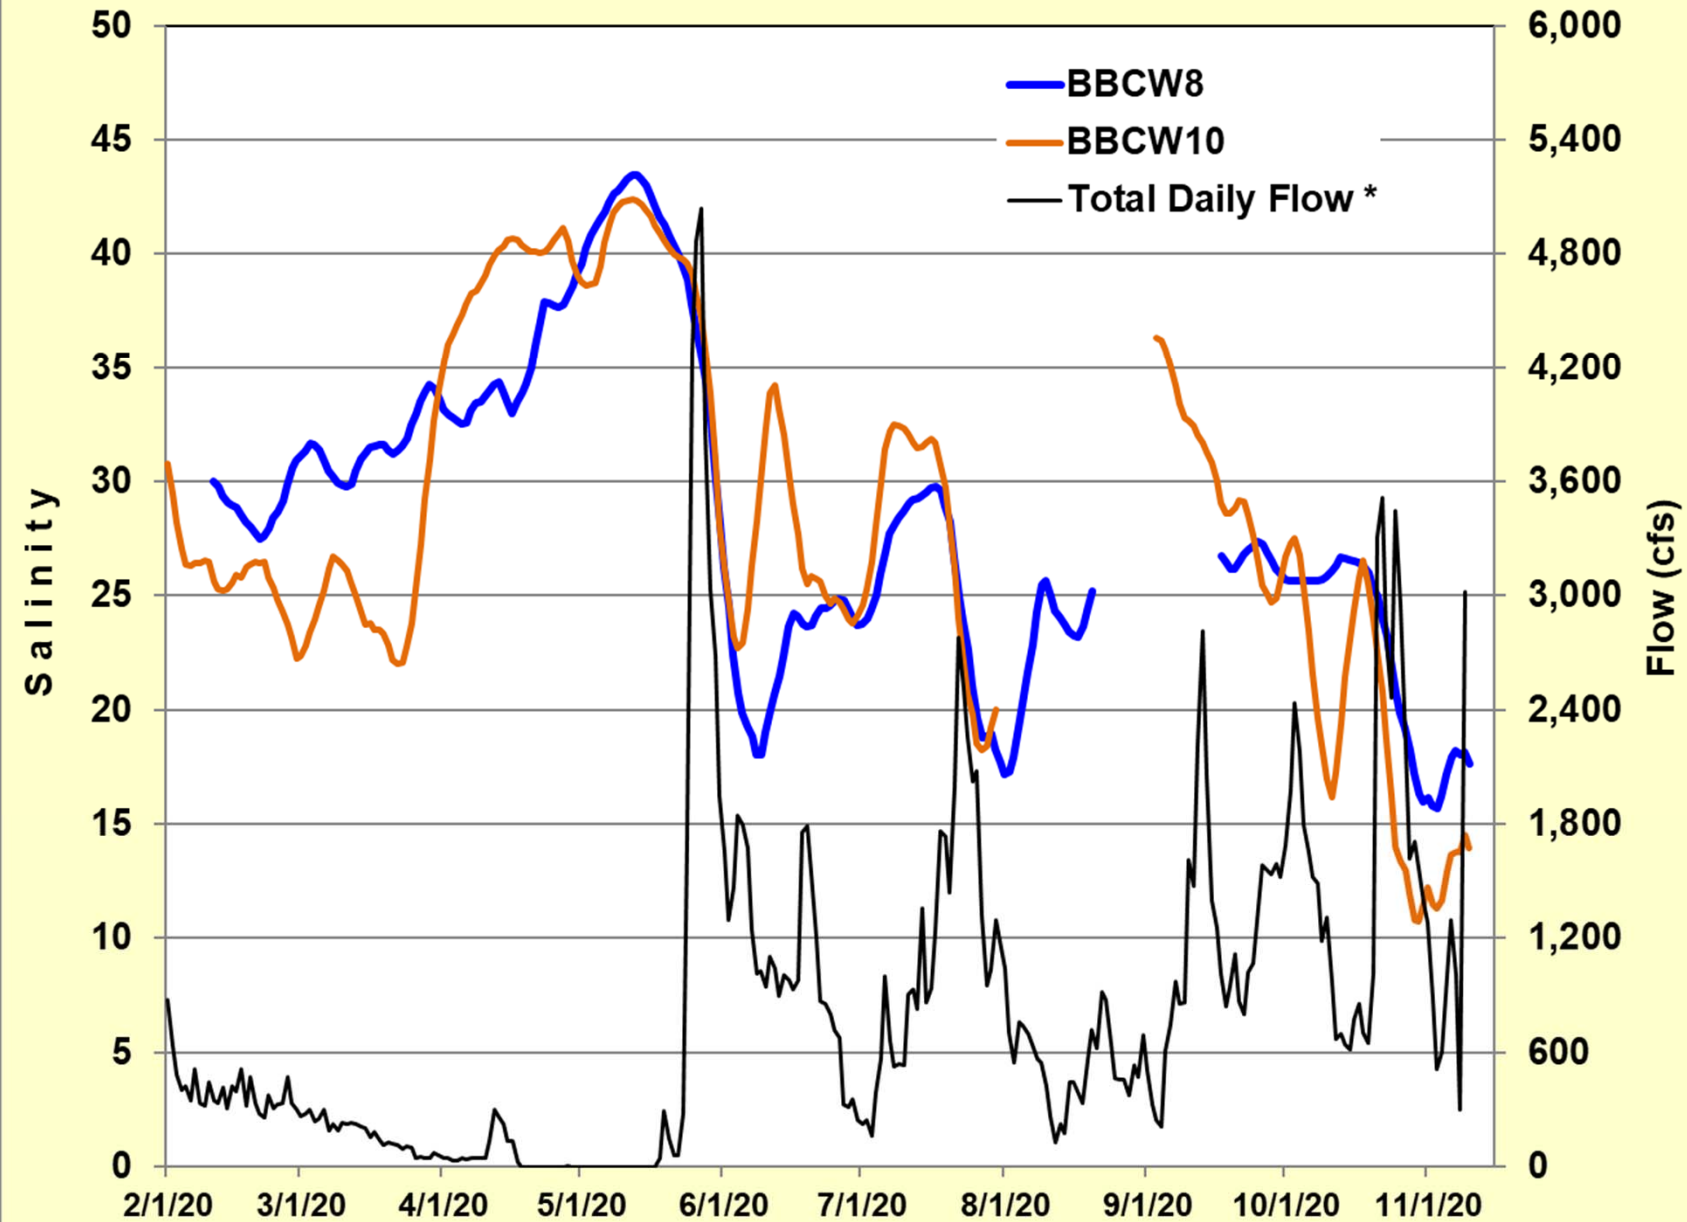
## Seven Day Mean Salinity (BBCW8 &amp; BBCW10) &amp; Total Daily Flow

\* Total flow from S20G, S20F, S21, S21A, S123, S700P

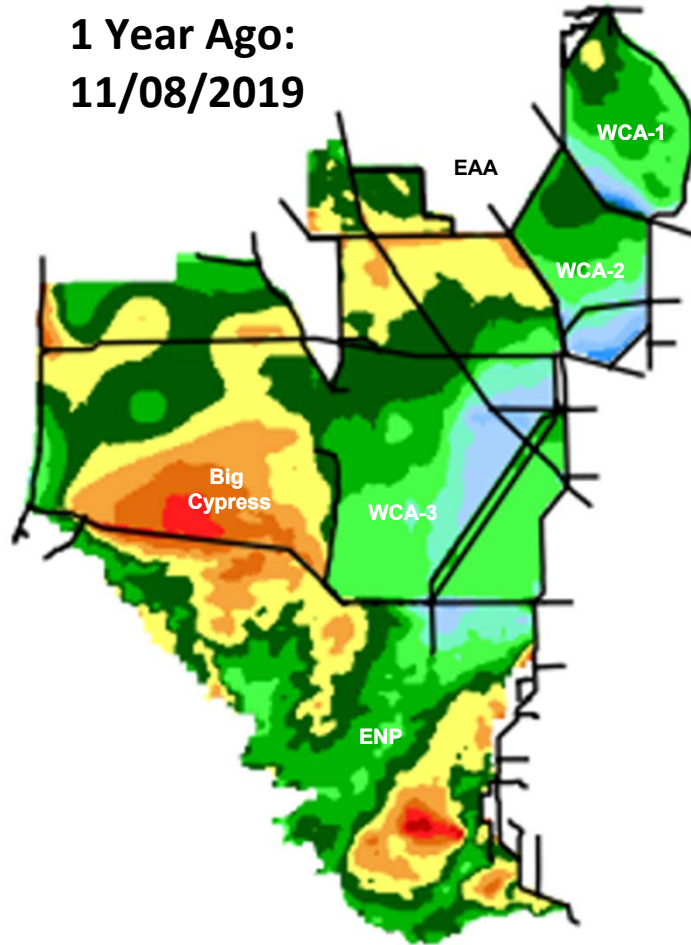
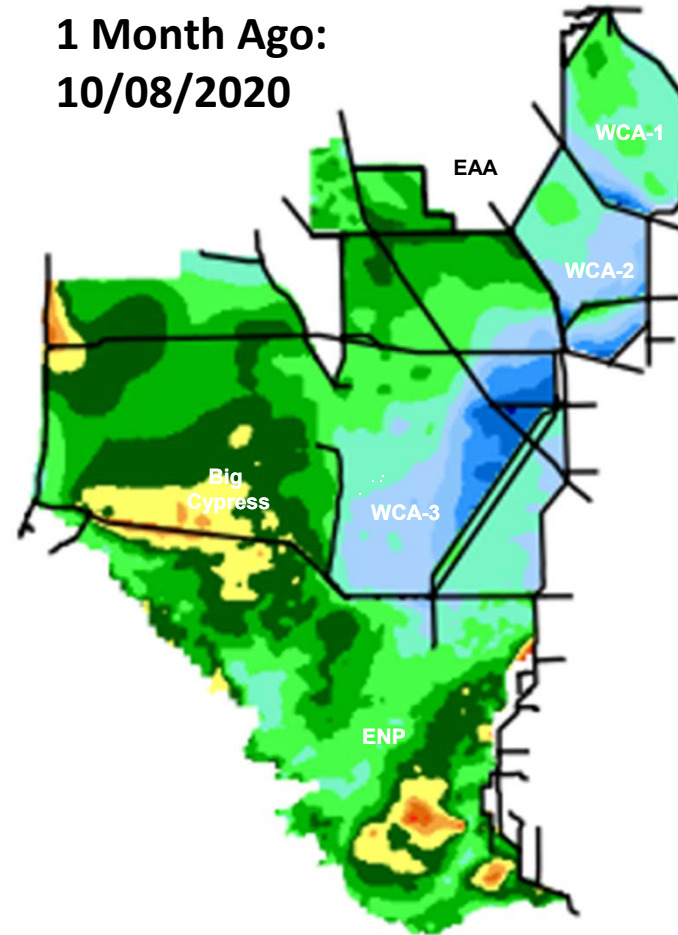
# Everglades Water Depth Maps

1 Year Ago:  
11/08/2019

1 Month Ago:  
10/08/2020

Current:  
11/08/2020

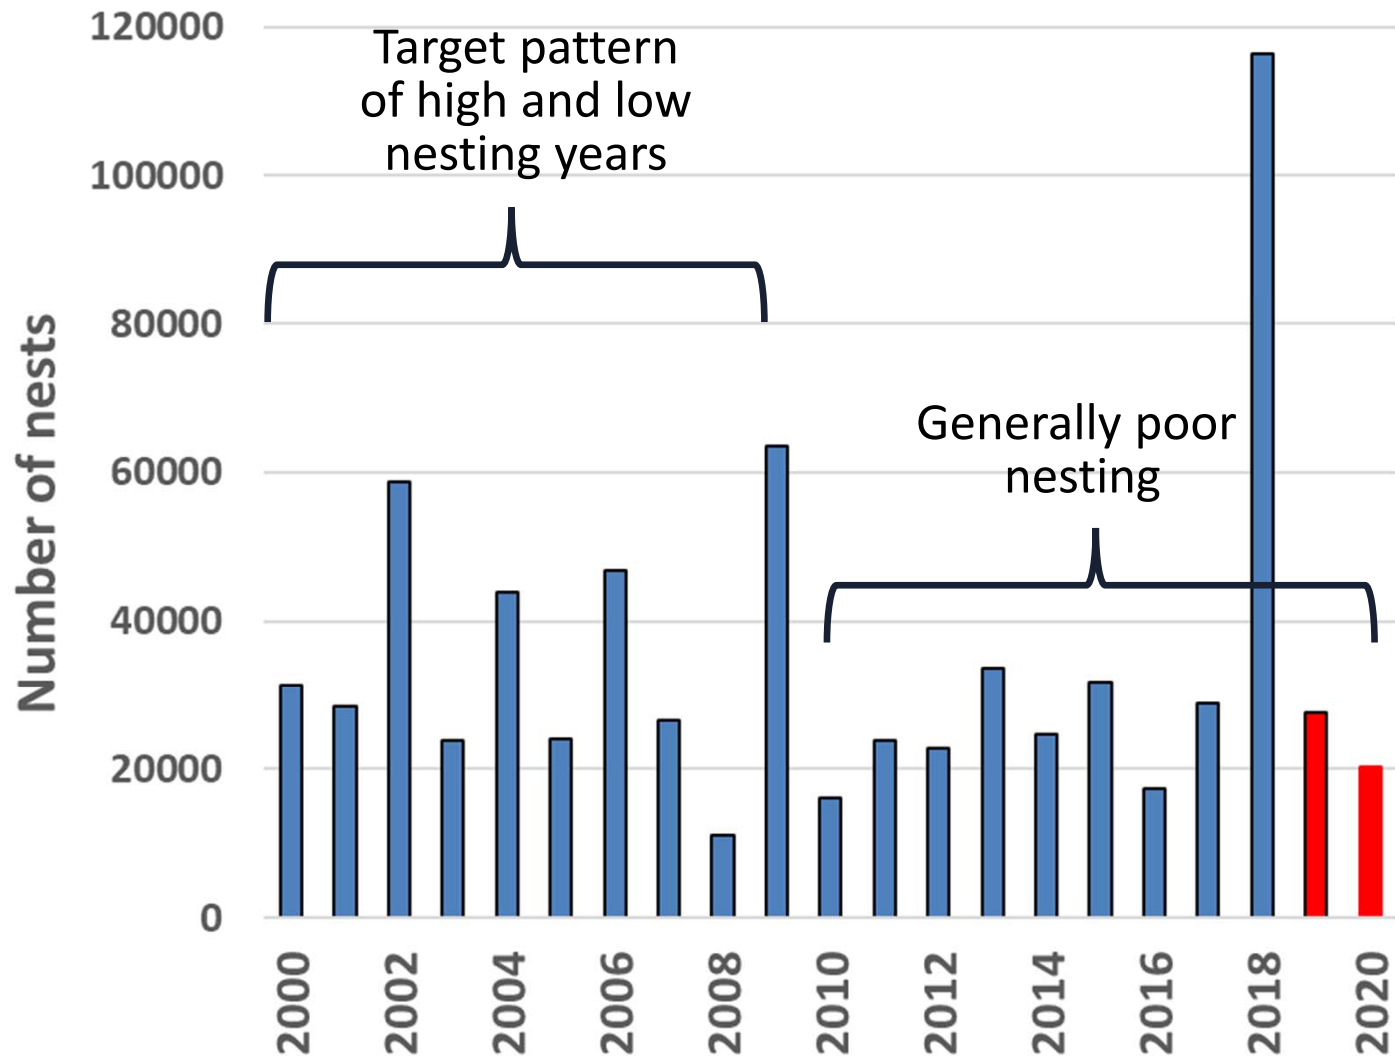
## Wading birds nesting effort in the Everglades (2000-2020)

- The natural pattern of nesting effort fluctuates (high to low) among years, e.g. 2000-2009
- But, we've seen consistent low nesting effort from 2010-2020 (except 2018)
- **Poor** nest effort/success in 2019 and 2020
- Need a good nesting year in 2021
