# Ecological Conditions Update

Governing Board Meeting  
April 8, 2021

*Phase II Restoration Area  
Riverwoods Floodplain  
January 28, 2021*

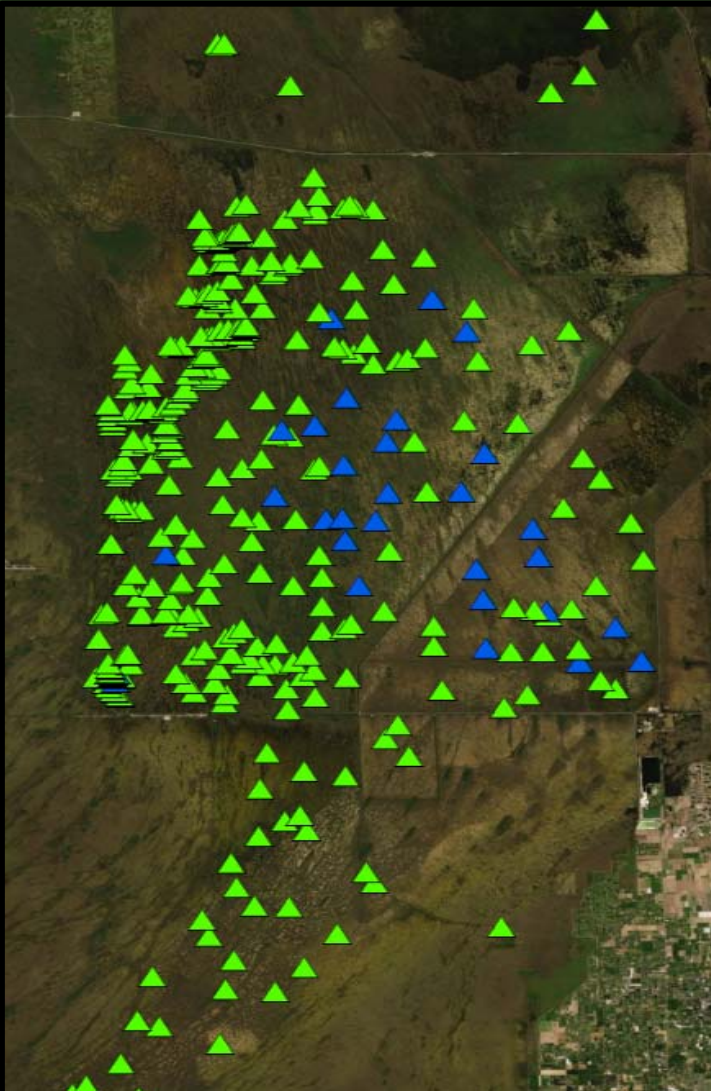
# Tree Island Inundation (days)

- Current preliminary estimates using WDAT indicate that 8% or 30 of the tree islands are currently inundated, down from 11% the week prior.
- Initial islands inundated beginning 5/26/20, longest duration of continuous inundation is 300 days. Inundation for more than 90 days has the potential for ecological harm. Inundation for more than 120 days will cause ecological harm to sensitive islands (11% of islands).
- In comparison on 4/4/18: 3 islands, 303 days, 1%.
