# Ecological Conditions Update

Governing Board Meeting  
September 9, 2021

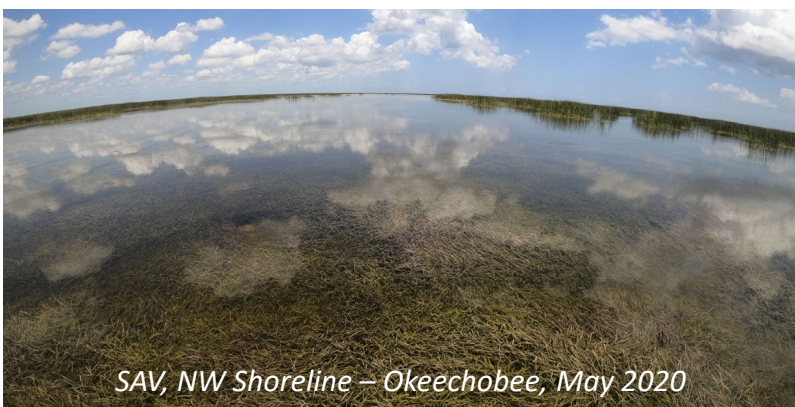
SAV Fall Biomass 2018-2021 (NW & SW Sites)

- After 2 years of recovery, SAV biomass is declining
- Robust, tall SAV survived but is more patchy
- Total biomass closer to 2019 levels but coverage is reduced
- Losses at all elevations but primarily deeper areas

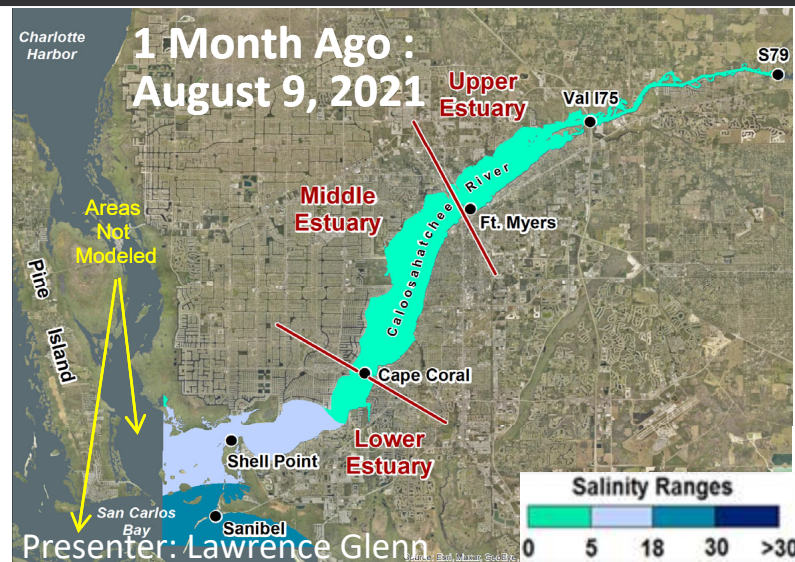
## Total Daily Inflow into the Caloosahatchee River Estuary

| 7-Day Mean Inflow<br>Aug. 27, 2021 - Sept. 2, 2021 | |
| Lake Okeechobee (S-77) | 0 cfs |
| C-43 Basin (S-79) | 2356 cfs |
| Tidal Basin | 1003 cfs |
| <b>Total</b> | <b>3,359 cfs</b> |
