# Appendix 2-1: The 2005 Hurricane Season in South Florida

(Technical Publication ERA-439)

**THE 2005 HURRICANE SEASON IN  
SOUTH FLORIDA**

**Water Quality Assessment Division  
Environmental Resource Assessment Department  
South Florida Water Management District  
3301 Gun Club Road  
West Palm Beach, FL 33406**

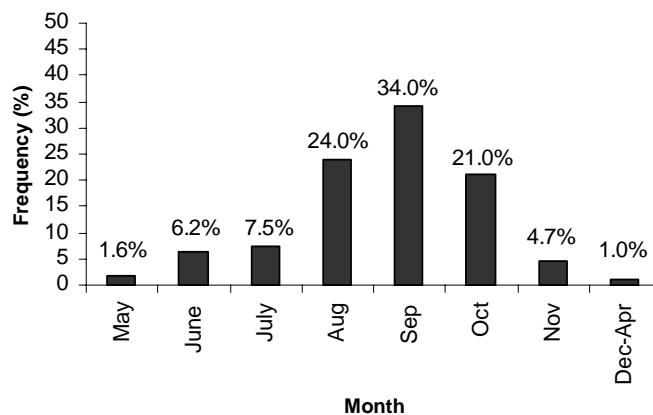
**Figure 1.** Distribution of North Atlantic hurricanes and tropical storms.

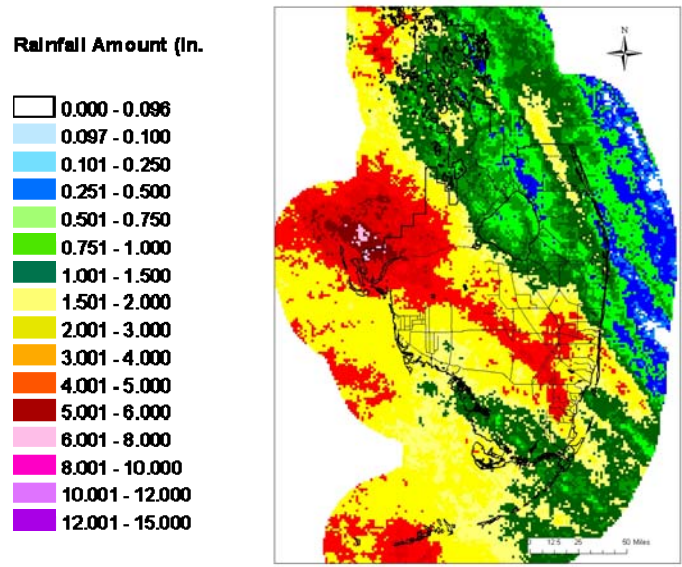
**Figure 2a.** Radar rainfall from Hurricane Dennis as it passed south of the Florida Keys (July 8-10, 2005).

For the purpose of hydrologic impact of Hurricane Dennis on South Florida, rainfall associated with the hurricane from July 8-10, 2005, is totaled for each rainfall area (**Figure 3**) and presented in **Figure 4**. Key West rainfall in July 2005 was 6.37 inches compared to a historical average of 3.27 inches (<http://www.srh.noaa.gov/eyw/HTML/climate/eywclimate.html>).

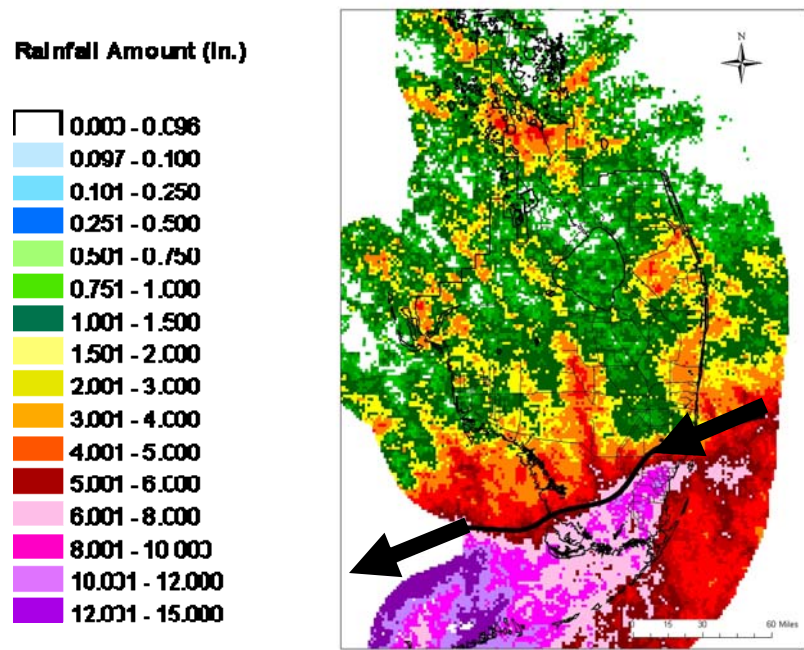
**Figure 2b.** Hurricane Katrina path and radar rainfall (August 24-27, 2005).

For the purpose of hydrologic impact of Hurricane Katrina on South Florida, rainfall associated with the system from August 24-27, 2005, is totaled for each rainfall area (**Figure 3**) and presented in **Figure 4**. As seen from the radar rainfall estimates (**Figure 2a**), the highest areal rainfall was observed in Miami-Dade (6.27 inches), followed by the Everglades National Park (ENP) (6.1 inches). Areal rainfall is reported on the District's web site (<http://iweb/iwebB501/omd/weather/opswthr.htm>) as the Thiessen average of a network of rain gauges for each rainfall area. ENP area rainfall is computed from a simple average of eight gauge readings (S332, S174, S18C, HOMESTEADARB, JBTS, S331W, S334, S12D). It should be noted that the eastern section of the ENP got higher rainfall than the north and northwest sections (**Figure 2a**). Hurricane Katrina impacted Key West in storm surge and high rainfall. August rainfall for Key West was 13.49 inches compared to the average for the month, 5.40 inches (<http://www.srh.noaa.gov/eyw/HTML/climate/eywclimate.html>).

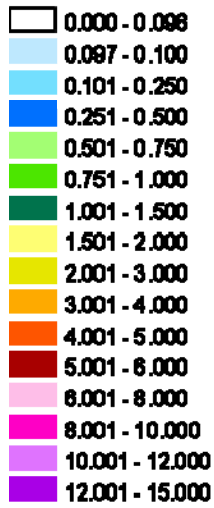
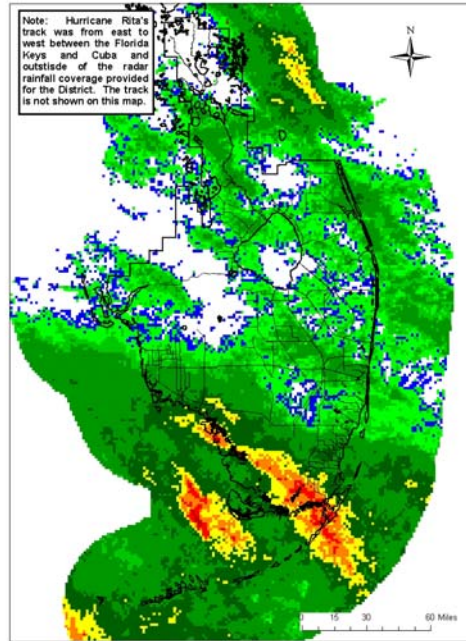
**Figure 2c.** Radar rainfall from Hurricane Rita as it passed through the Florida Straits (September 19-21, 2005).

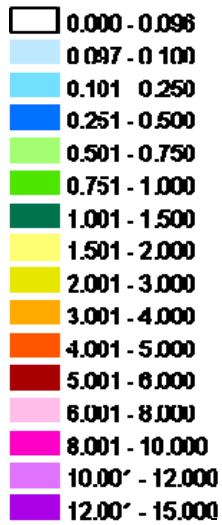
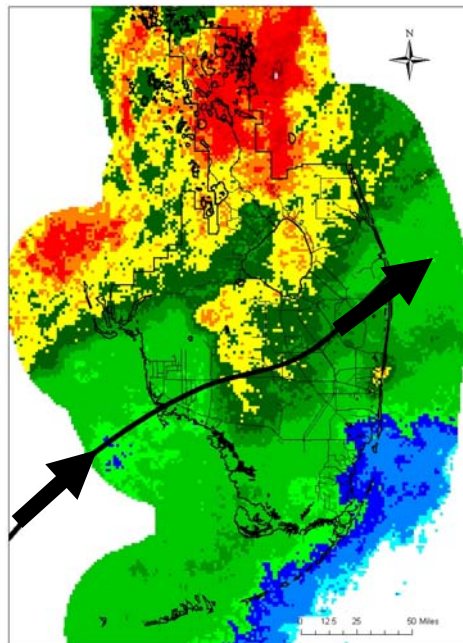
**Figure 2d.** Hurricane Wilma path and radar rainfall (October 22-25, 2005).

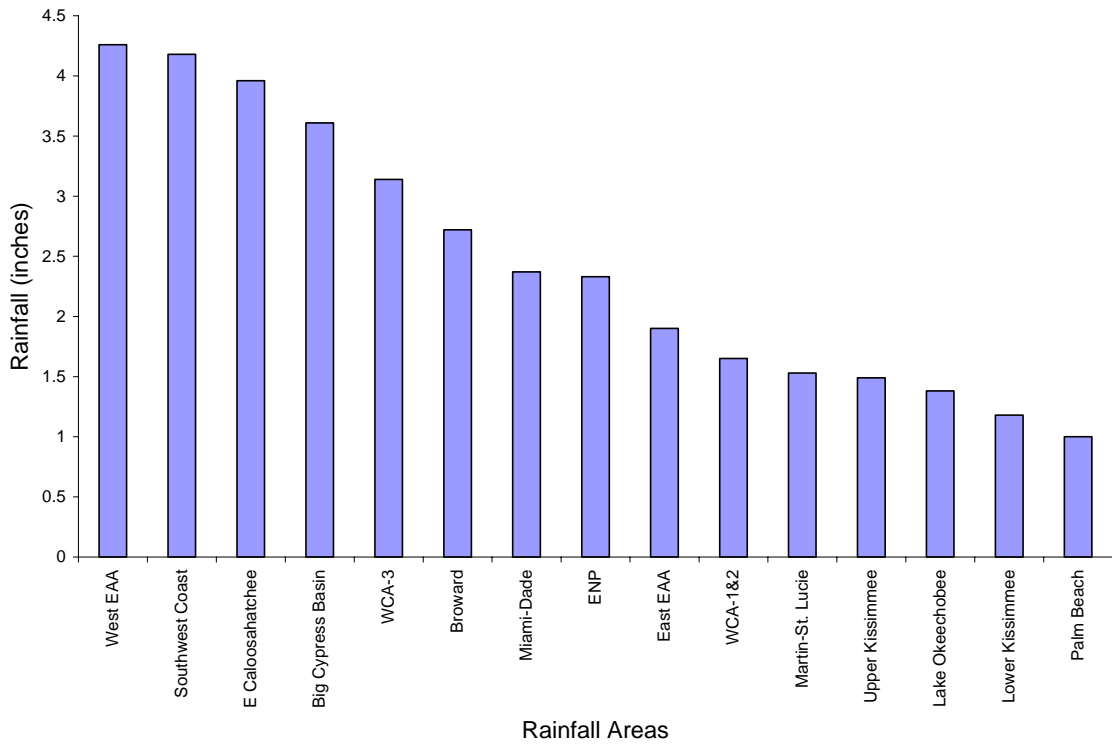
**Figure 4.** Hurricane Dennis areal average rainfall (July 8-10, 2005).

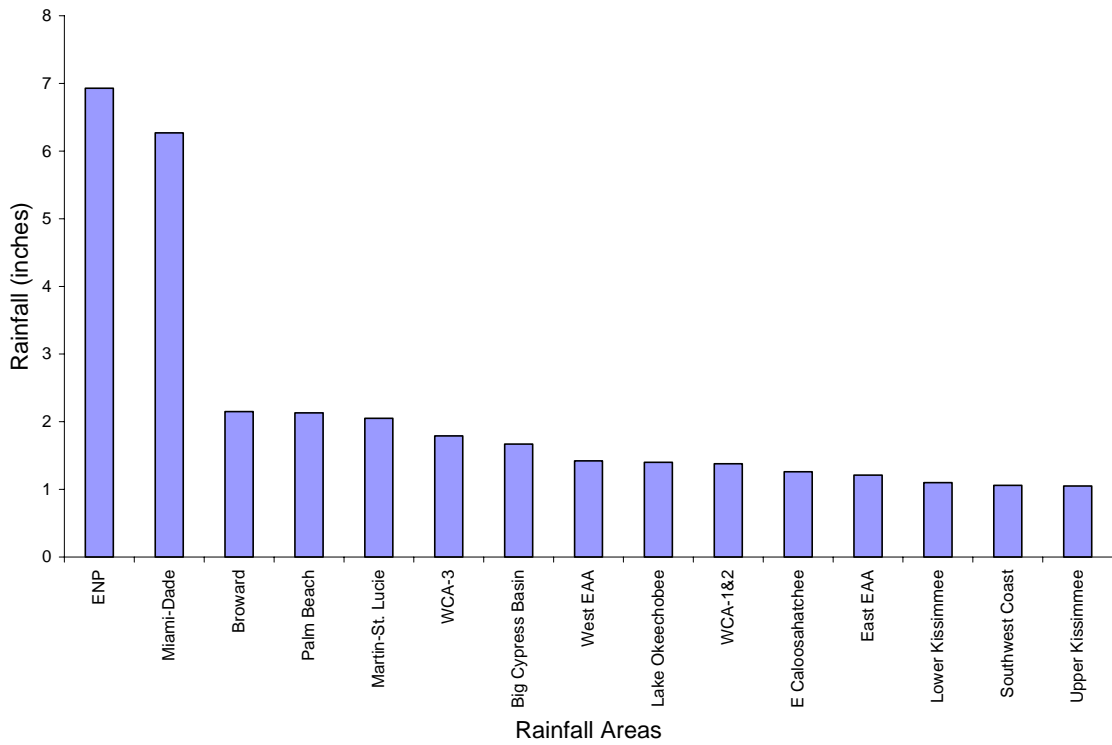
**Figure 5.** Hurricane Katrina areal average rainfall (August 24-27, 2005).

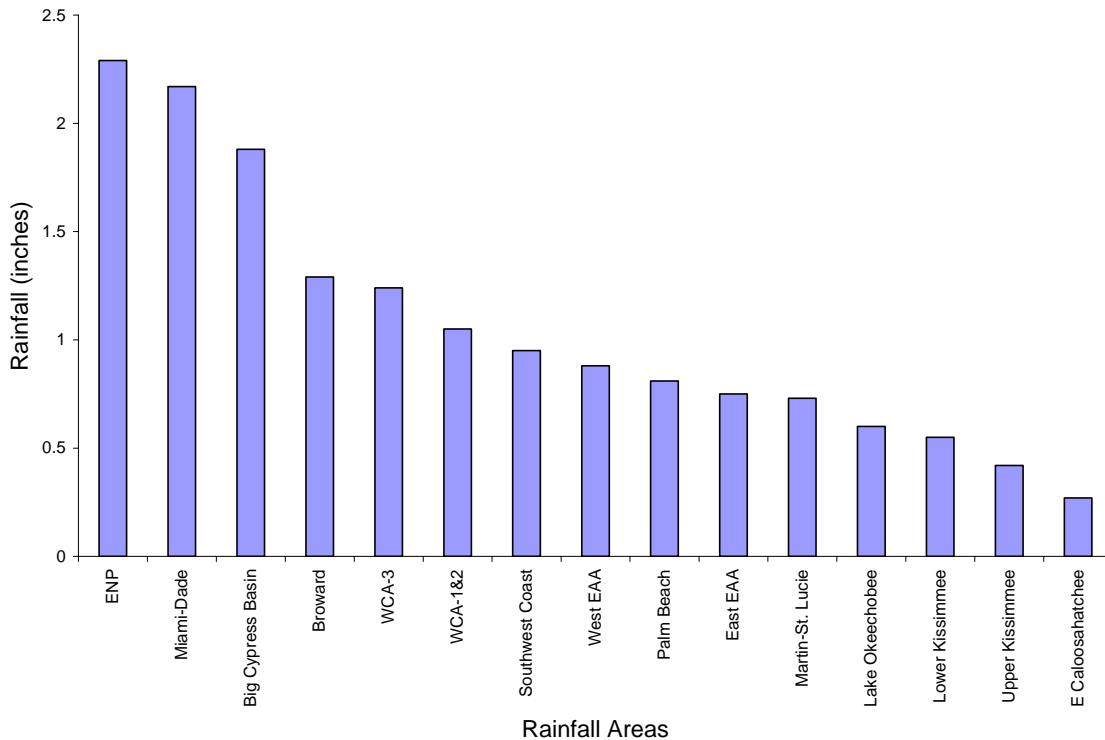
**Figure 6.** Hurricane Rita areal average rainfall (September 19-21, 2005).

For the purpose of hydrologic impact of Hurricane Rita on South Florida, rainfall associated with the system from September 19-21, 2005, is totaled and presented in **Figure 6** for each rainfall area. As seen from the radar rainfall estimates (**Figure 2c**), the highest areal rainfall was observed in the ENP, followed by Miami-Dade, the Big Cypress Basin, Broward and Water Conservation Area 3. Areal rainfall is reported on the District's web site (<http://iweb/iwebB501/omd/weather/opswthr.htm>) as the Thiessen average of a network of rain gauges. ENP area rainfall is computed from a simple average of eight gauge readings (S332, S174, S18C, HOMESTEADARB, JBTS, S331W, S334, S12D). September rainfall for Key West was 7.35 inches compared to the average for the month, 5.45 inches (<http://www.srh.noaa.gov/eyw/HTML/climate/eywclimate.html>).

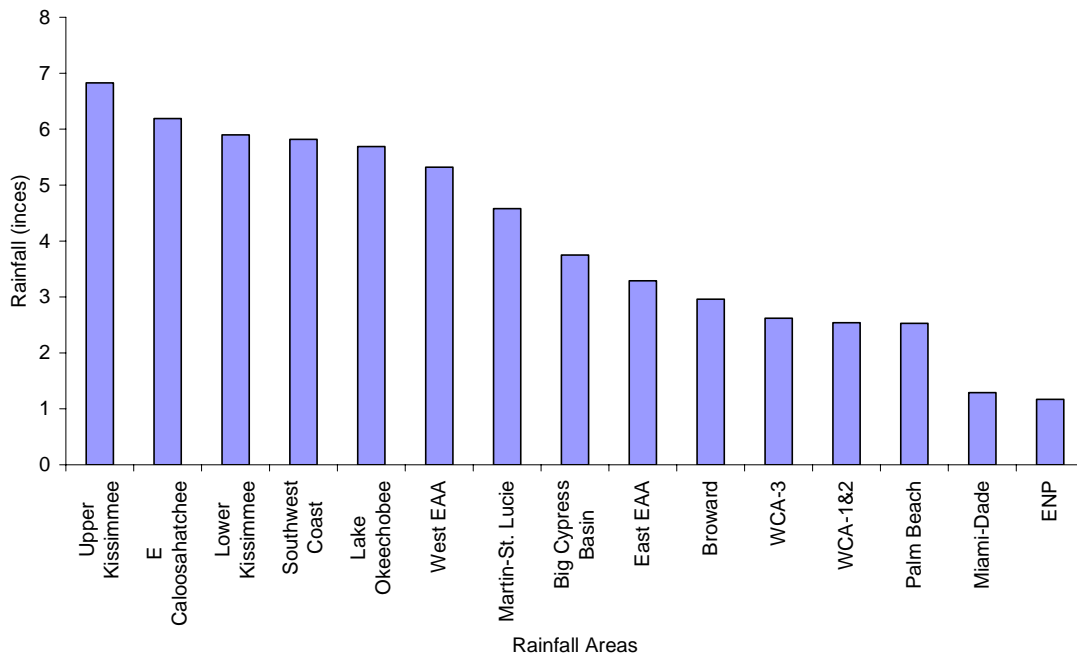
**Figure 7.** Hurricane Wilma areal average rainfall (October 22-25, 2005).

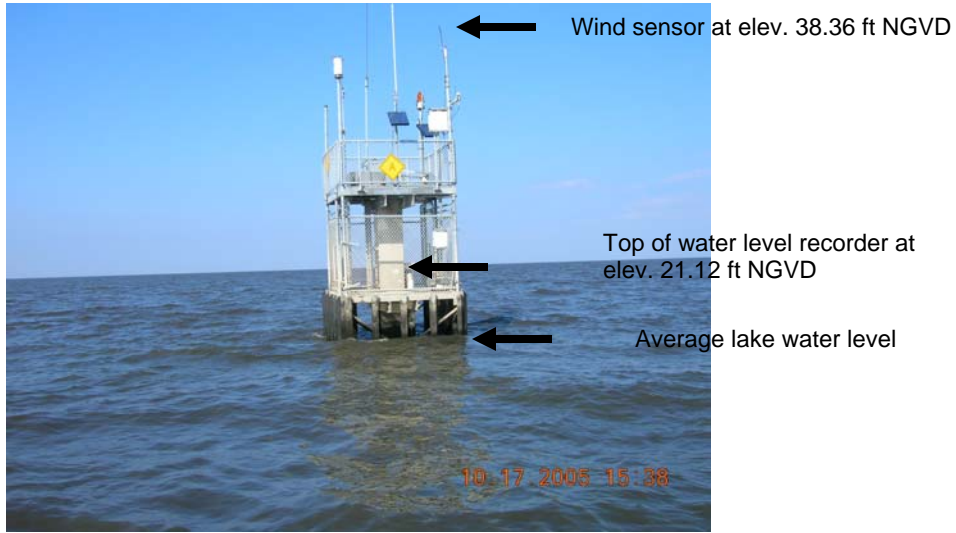
**Figure 8.** Weather station L006 in Lake Okeechobee (photo by SFWMD; October 17, 2005).

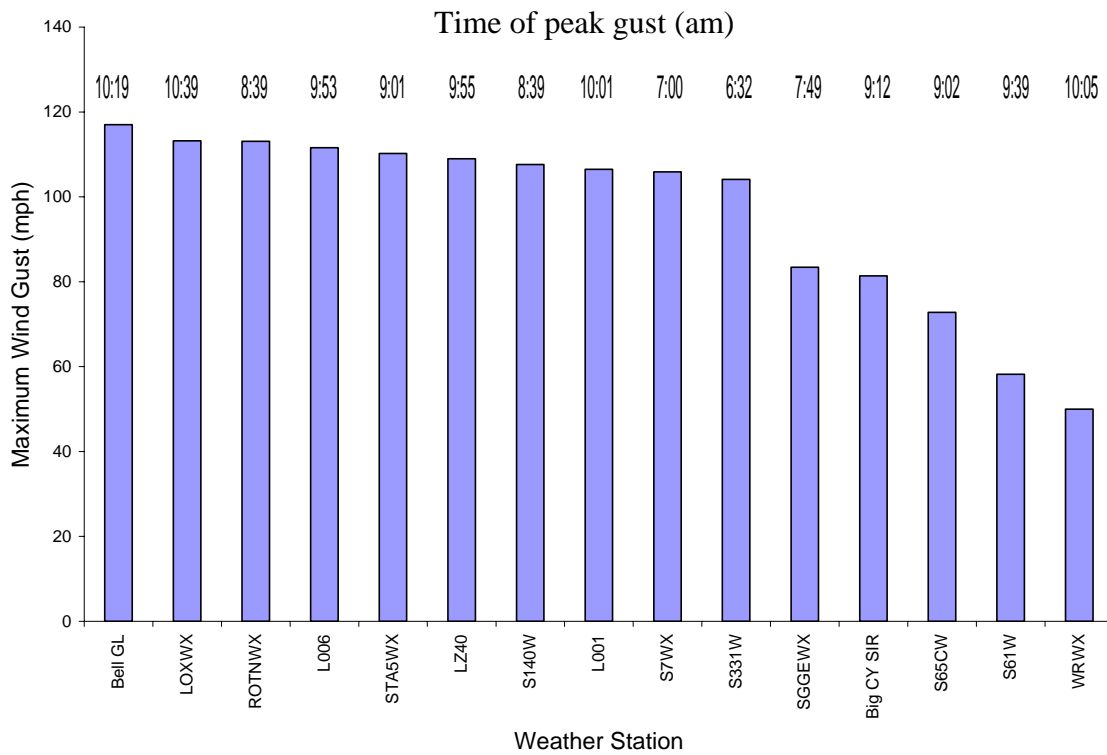
**Figure 9.** Instantaneous maximum gust wind speed (sampled at minute intervals) in 15-minute period at each weather station [Note: Big Cy SIR wind sensor readings were too low].

Lake Okeechobee was fully impacted by Hurricane Wilma, as shown with the maximum wind gust speed (Figure 9), maximum wind gust speed, 15-minute average wind speed on the lake (Figures 14, 16, and 18) and the path of the hurricane (Figure 2d). Lake Okeechobee is impounded with an earthen levee, except at Fisheating Creek, where it is an open water connection, with numerous inflow and outflow water control structures. The impact zones of wind-generated high waves on Lake Okeechobee depend on the path of the hurricane, wind speed, wind direction, and duration of impact. There are four weather stations within Lake Okeechobee (L001, L005, L006 and LZ40), as shown in Figures 10 and 49. Three of the weather stations (except L005) had gust wind speed, average wind speed, and wind direction data collected during Hurricane Wilma. Weather station L001 is at the northern side of the lake; LZ40 and L006 are in the middle of the lake. Maximum gust wind speed (sampled at one-minute interval, maximum in 15 minutes) and 15-minute average wind speed and direction over the lake shown in Figures 42 through 44 correspond with the area of levee erosion and high water levels. Wind direction over the lake is clearly shown as east-northeast (ENE) from the front side of the hurricane and NW from the back side of the hurricane. Both the gust and average wind speed data show that the back side of the hurricane had higher wind speed than the front side. Hurricane winds blow vegetation from the lake toward the levee banks. Water control structure built in the levees can get clogged with massive vegetation and debris, impeding emergency operations (Figure 45). The wind wave action stirs up the lake, resuspending settled sediment impacting water quality. High sediment concentration reduces the depth of light penetration into water, reducing the growth and maintenance of aquatic submerged vegetation. High sediment concentration is associated with increase in nutrient concentration. Due to the high water level in the lake, water has to be discharged. The quantity and quality of the discharge impact the receiving systems.

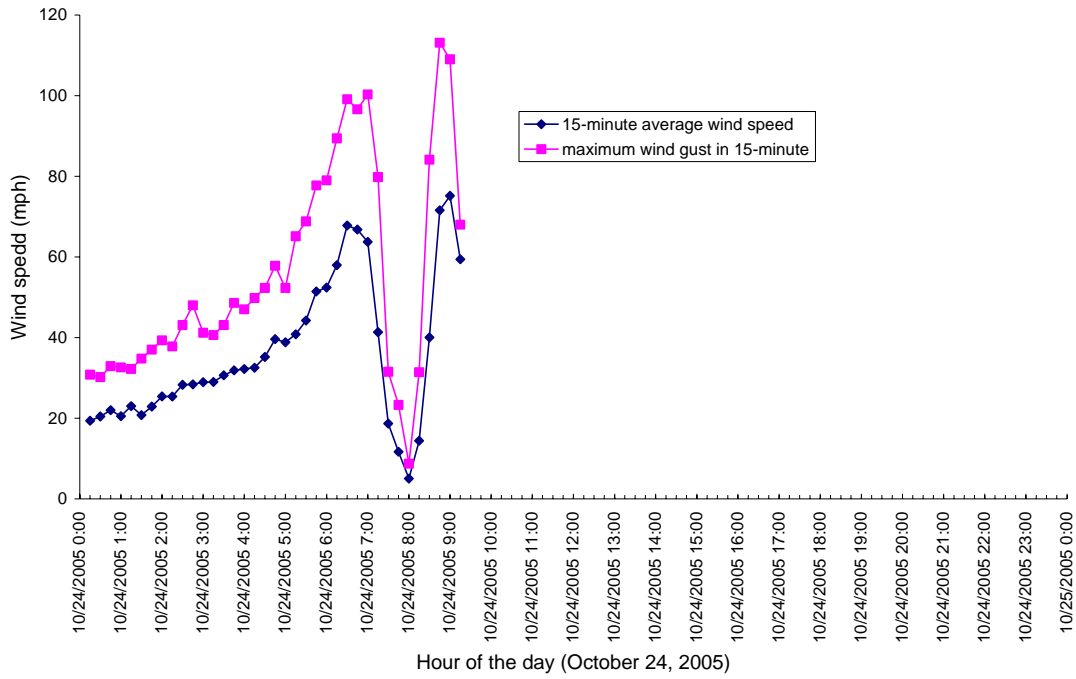
**Figure 13.** Wind speed at ROTNWX weather station during Hurricane Wilma [Note: sensor failed after the eye of the hurricane passed].

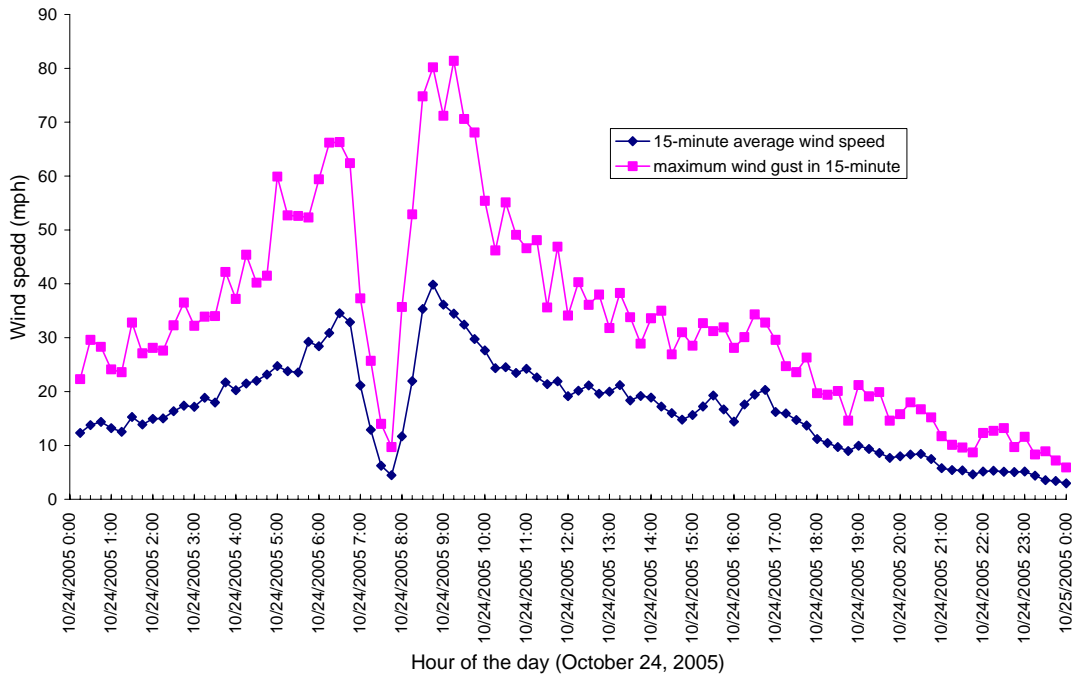
**Figure 22.** Wind speed at BIG CY SIR weather station during Hurricane Wilma (consistently recorded lower than neighboring stations).

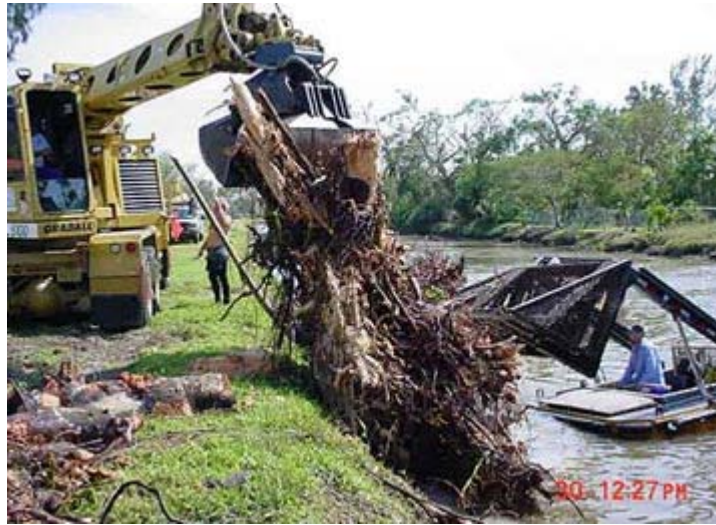
**Figure 28.** Removal operation of vegetation- and debris-filled canal after Hurricane Wilma (photo by SFWMD).

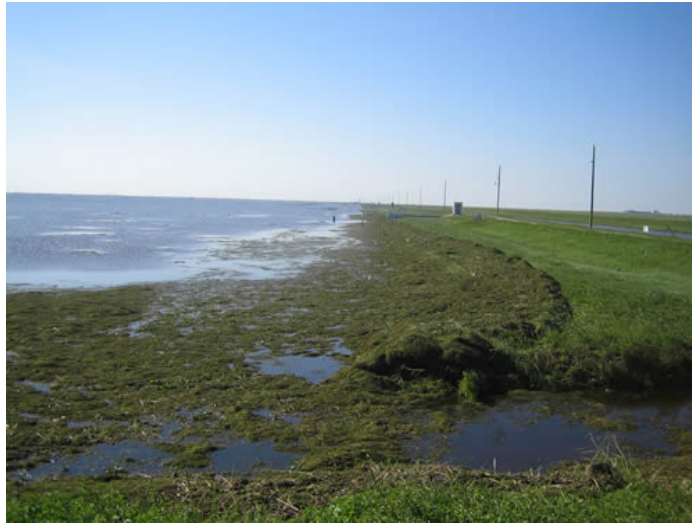
**Figure 35.** Vegetation pushed by Hurricane Wilma from the interior of the STA to the bank of a levee (photo by SFWMD).

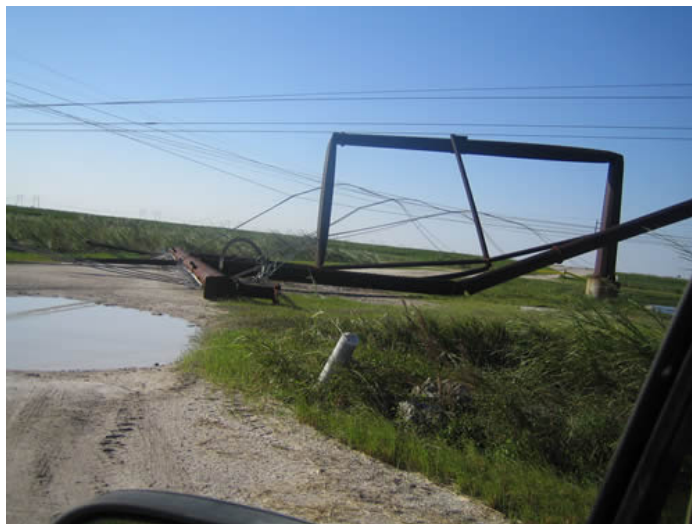
**Figure 36.** High-power transmission line damage by Hurricane Wilma in an STA (photo by SFWMD).

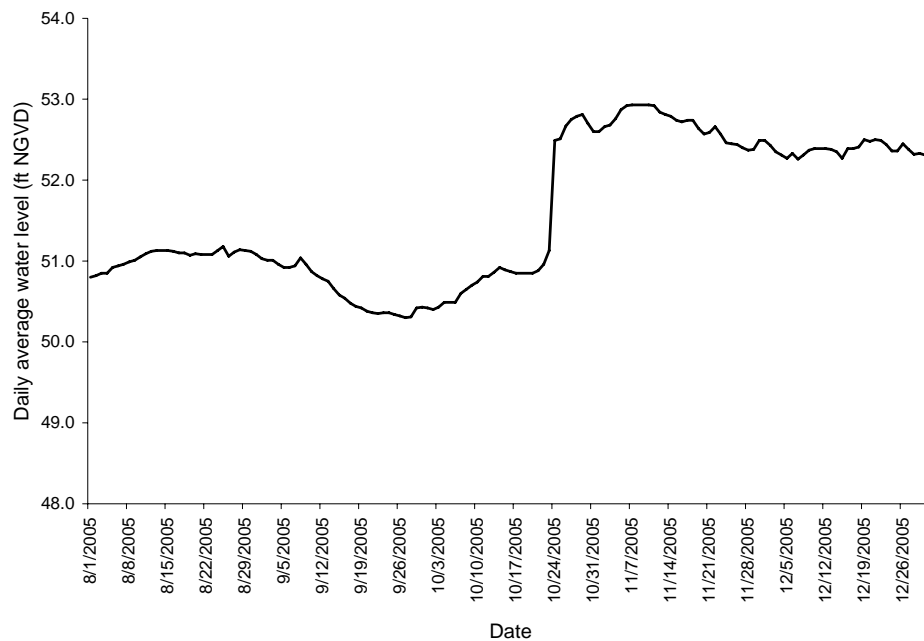
**Figure 37.** Water level changes in Lake Kissimmee during the 2005 hurricane season.

The Upper Kissimmee Basin, Lake Myrtle, Lake Mary Jane, Lake Gentry, Lake Tohopekaliga, and Lake Kissimmee were above regulation schedule following Hurricane Wilma, which generated more than 6 inches of areal average rainfall (**Figure 7**). A sharp increase in the water level of Lake Kissimmee depicts the rainfall impact of Hurricane Wilma on the Upper Kissimmee Chain of Lakes (**Figure 37**). Also, the sharp increase in surface water flow in the Kissimmee and surrounding basins is shown by the sharp increase in outflows from Lake Kissimmee (S-65), outflows from Lake Istokpoga (S-68), and inflows into Lake Okeechobee through the Kissimmee River (C-38 canal) through structure S-65E (**Figure 38**). Inflow into Lake Okeechobee through the Kissimmee River (S-65E) between the landfall of Hurricane Wilma and the end of 2005 was 525,369 ac-ft. There are many inflow points to the lake. Kissimmee River floodplain water levels at the restoration area climbed more than 7 feet due to surface water flow increases from the hurricane rainfall (**Figure 39**). The weather station with the lowest maximum gust wind speed from Hurricane Wilma is WRWX (50 mph), which is located in the Upper Kissimmee Basin at Disney Wilderness Preserve. Maximum wind gust speed and 15-minute average wind speed with wind direction are depicted in **Figure 40**. Wind speed during Hurricane Wilma was also relatively lower in the Lower Kissimmee Basin (**Figure 41**).

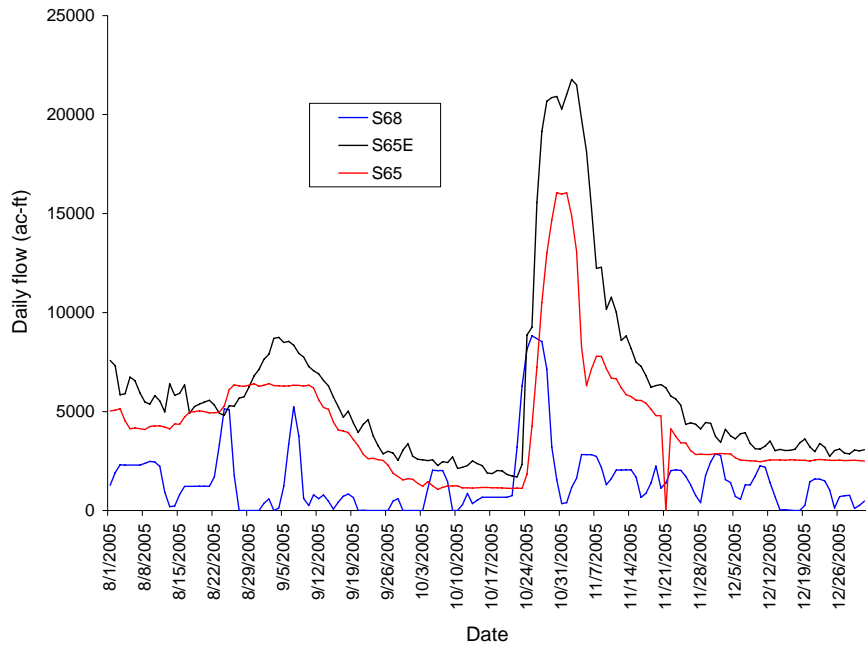
**Figure 38.** Lake Istokpoga outflows (S-68), inflows into Lake Okeechobee through S-65E, and outflows from Lake Kissimmee (S-65) during the 2005 hurricane season.

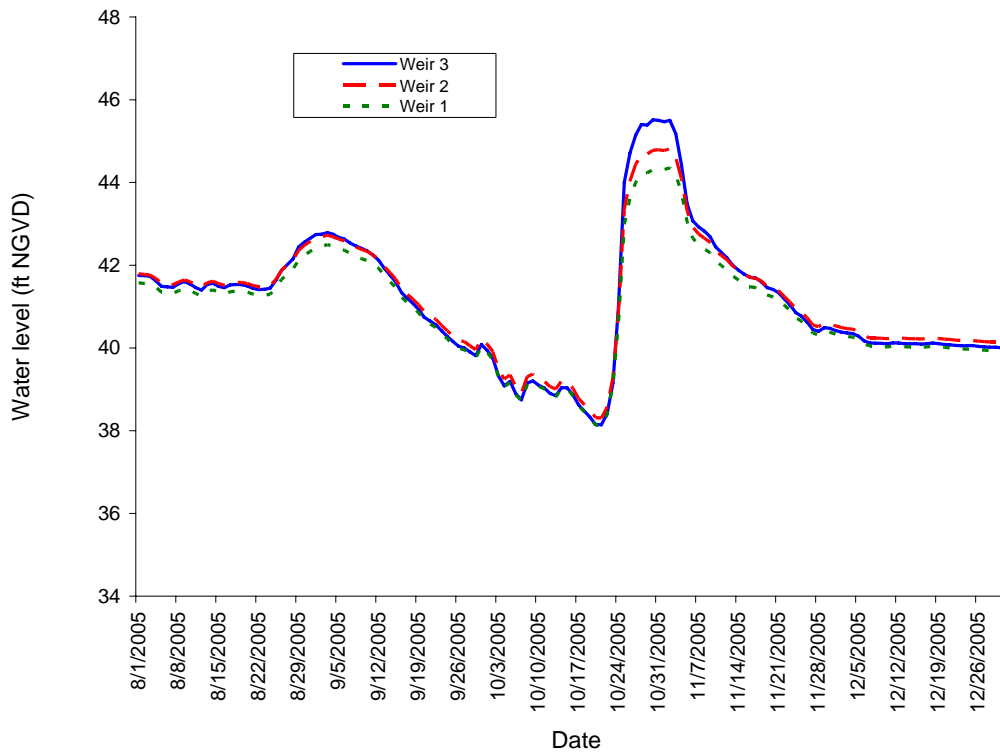
**Figure 39.** Kissimmee River floodplain water levels at the restoration area, weirs 1, 2, and 3, during the 2005 hurricane season.

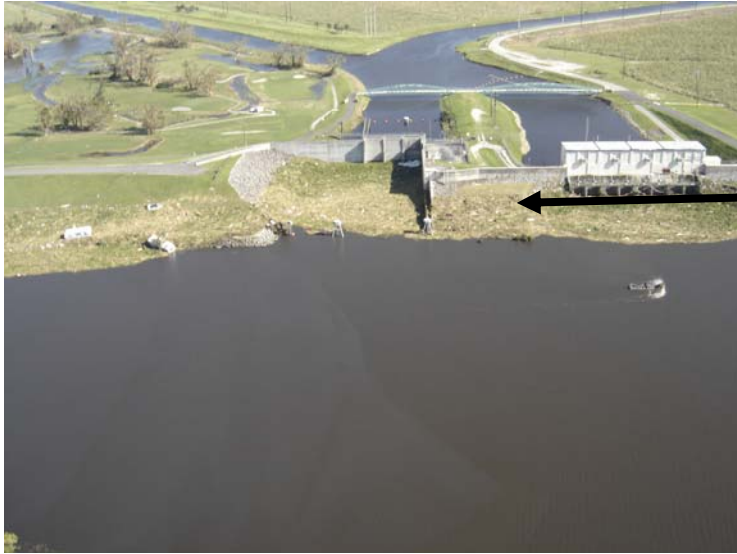
**Figure 45.** Vegetation pushed into hurricane gate S-351 and pump station S-2 along the south shore of Lake Okeechobee during Hurricane Wilma (photo by SFWMD.)

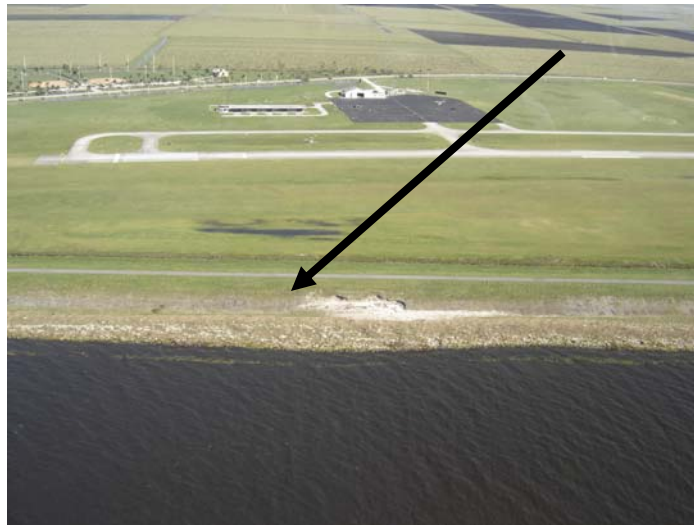
**Figure 46.** Lake Okeechobee levee damage from Hurricane Wilma (photo by SFWMD).

Hurricane winds can generate high waves, and the energy from the back-and-forth battering of an earthen levee can result in cutting the levee. Also, failure can occur around structures on the levee. According to The Tribune, there were five or six eroded areas along the lakeshore after Hurricane Wilma. If the wave setup exceeds the height of the levee, then washout could occur to the lakeside, top, and outer side of the levee. It was also reported that a \$19.7 million project is under way to reinforce the Lake Okeechobee levee. Initial work is on a 4.6-mile segment from Port Mayaca to Sand Cut. Lake Okeechobee impacts, especially levee damage, from Hurricane Wilma are depicted in **Figures 45** through **48**. The levee erosion - at least in some cases - is confirmed to be from wave action.

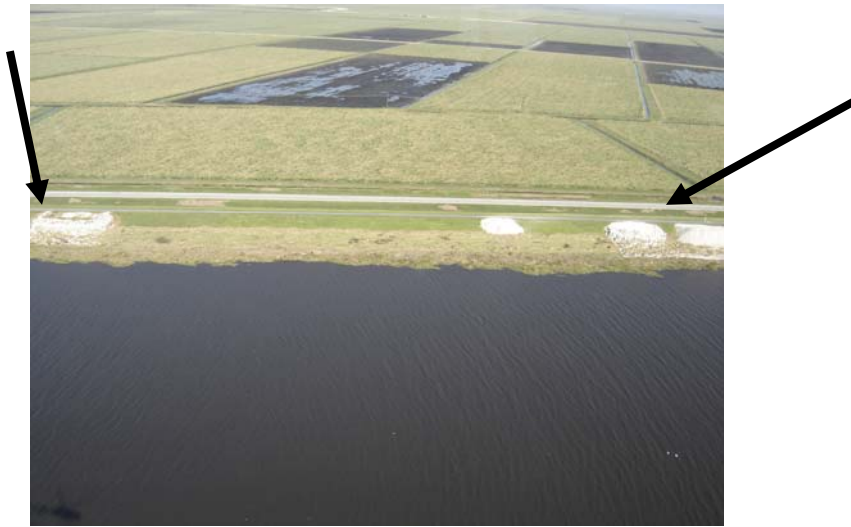
**Figure 47.** Lake Okeechobee levee damage from Hurricane Wilma (photo by SFWMD).

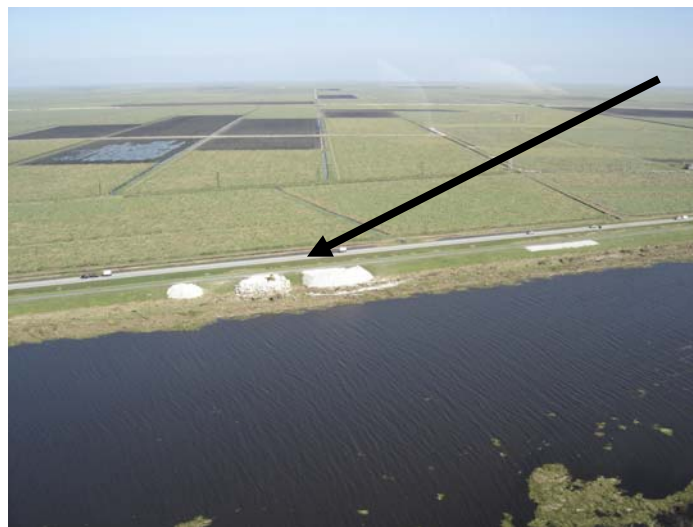
**Figure 48.** Lake Okeechobee levee damage from Hurricane Wilma (photo by SFWMD).

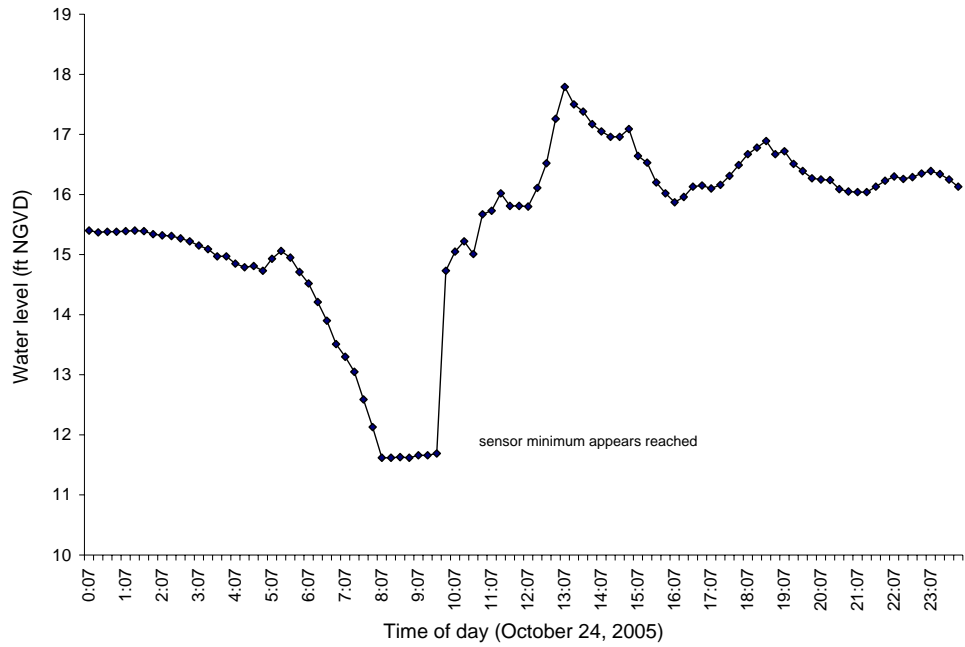
**Figure 50.** Lake Okeechobee water level changes at the S-135 structure during Hurricane Wilma.

Instantaneous water level changes inside Lake Okeechobee and at the levee banks during Hurricane Wilma help demonstrate the impact of a hurricane on the lake. The District break-point water level data collection platforms provide this information. Unfortunately, three weather station-based water level recorders inside the lake (L005, L006, and LZ40) malfunctioned at the approach of the hurricane. As such, there is no record of temporal variation of water level inside the lake during the impact of the hurricane. Also, the recorders at the southern side of the lake, where there was the highest wave setup, were not able to record the maximum level of the wave because the maximum recording setting in the recorders was exceeded. Estimates of the highest level of wave setup can be made from water mark preserved at the S-2 pump station at the time by the District staff. The initial estimate before surveying is 26 ft NGVD (Walter Smelt, SFWMD, personal communication). A survey of the mark will provide accurate record. Based on data collected at the high resolution District water level recorders (**Figure 49**) on the perimeter of Lake Okeechobee, **Figures 50** through **59** depict water level changes at the lake's banks as Hurricane Wilma passed through the area. The figures are presented sequentially from north of the lake to the west, south, and southwest.

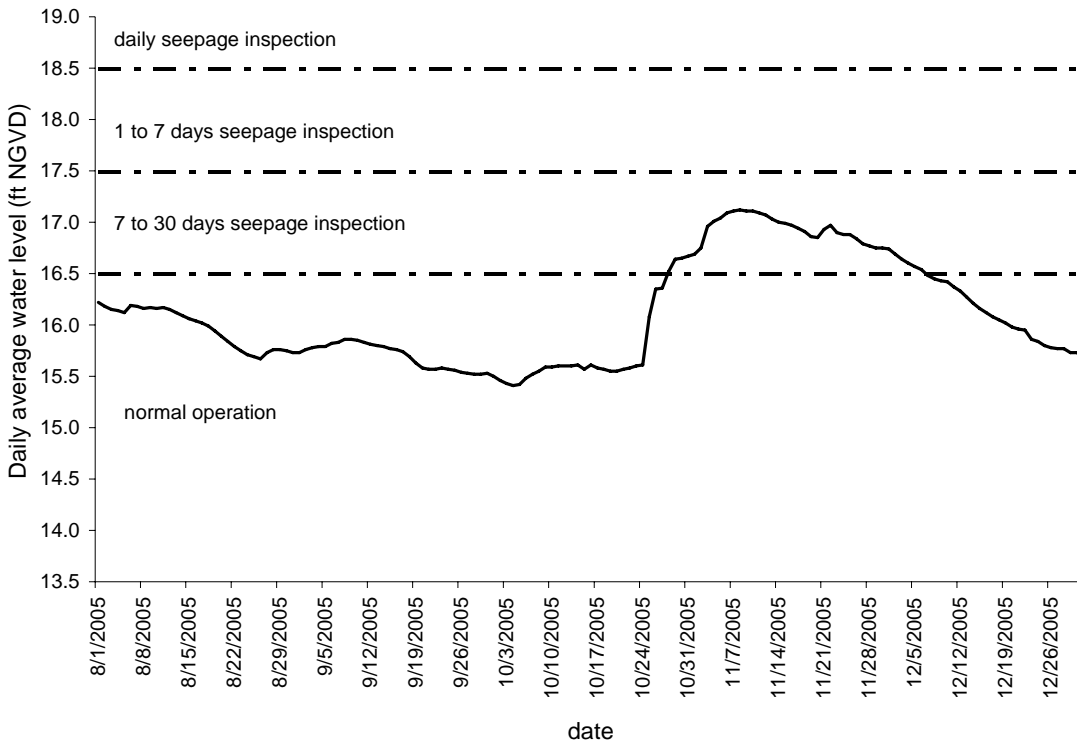
**Figure 60.** Lake Okeechobee daily average water level rise due to Hurricane Wilma.

Hurricane Wilma's impact on Lake Okeechobee is not limited to the impact during the hurricane. Runoff associated with the hurricane rainfall has lingering impact on the lake. Lake Okeechobee water level rise following Hurricane Wilma is depicted in **Figure 60**. **Figure 38** depicts the increase in inflow to Lake Okeechobee through the Kissimmee River outlet (S-65E). Rise in lake stage results in high rate discharge to manage the lake water level. The impact of high water levels in the lake was discussed previously. **Figure 61** depicts discharge from Lake Okeechobee into the Caloosahatchee River (S-77) and the St. Lucie River (S-308). Approximately 1 million ac-ft of water had been discharged through the two outlets following Hurricane Wilma (on October 24, 2005) and through the end of the year.

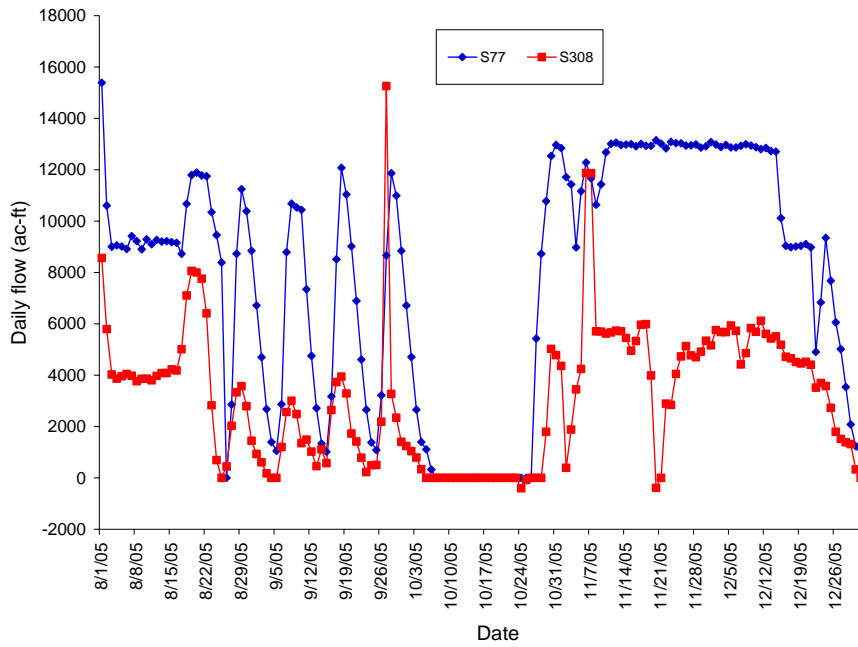
**Figure 61.** Lake Okeechobee daily discharge through S-77 (Caloosahatchee River) and S-308 (St. Lucie River).
