Lake Okeechobee Water Depth Maps

Lake Okeechobee Water Levels

Lake Okeechobee Algal Blooms

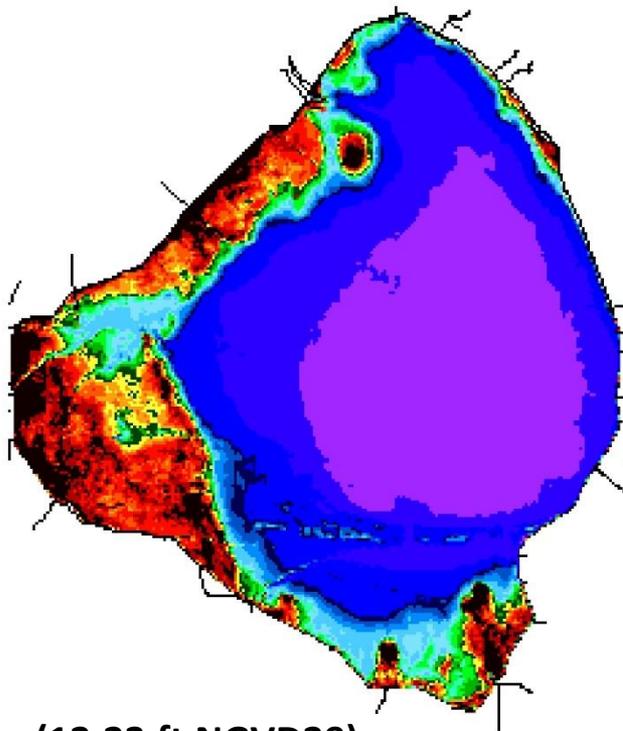
1 Year Ago: 08/01/2015

(12.23 ft NGVD29)

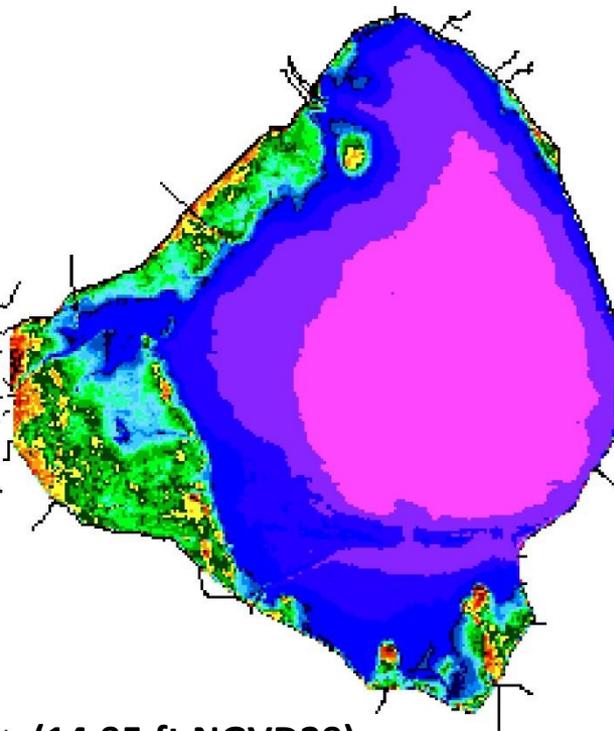
1 Month Ago: 07/02/2016

(14.95 ft NGVD29)

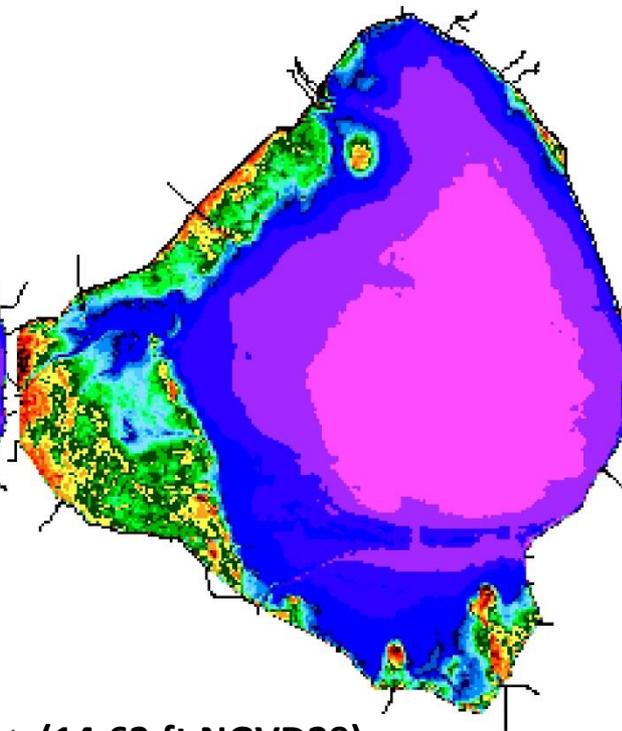
Current: 08/01/2016

(14.63 ft NGVD29)

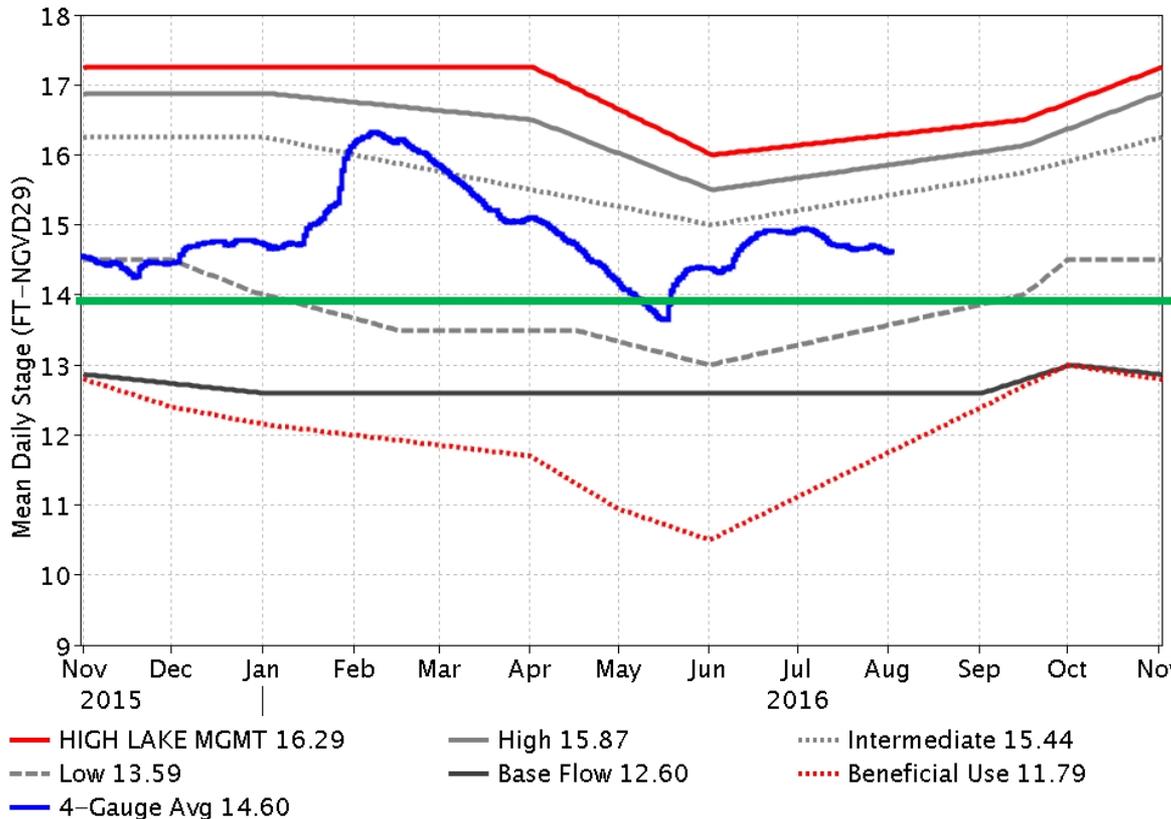
Lake Okeechobee (2 August 2016) 14.62' NGVD29

- El Nino rainfall resulted in high lake stages in Winter and Spring
- Army Corps of Engineers is making discharges to Caloosahatchee and St. Lucie to gain lake storage for hurricane season
- Until recently, WCAs were above regulation schedule
- Smaller discharges to L-8 Canal to C-51 Canal

Lake Okeechobee has been above 14' NGVD almost continuously for 10 months (since September 2015)

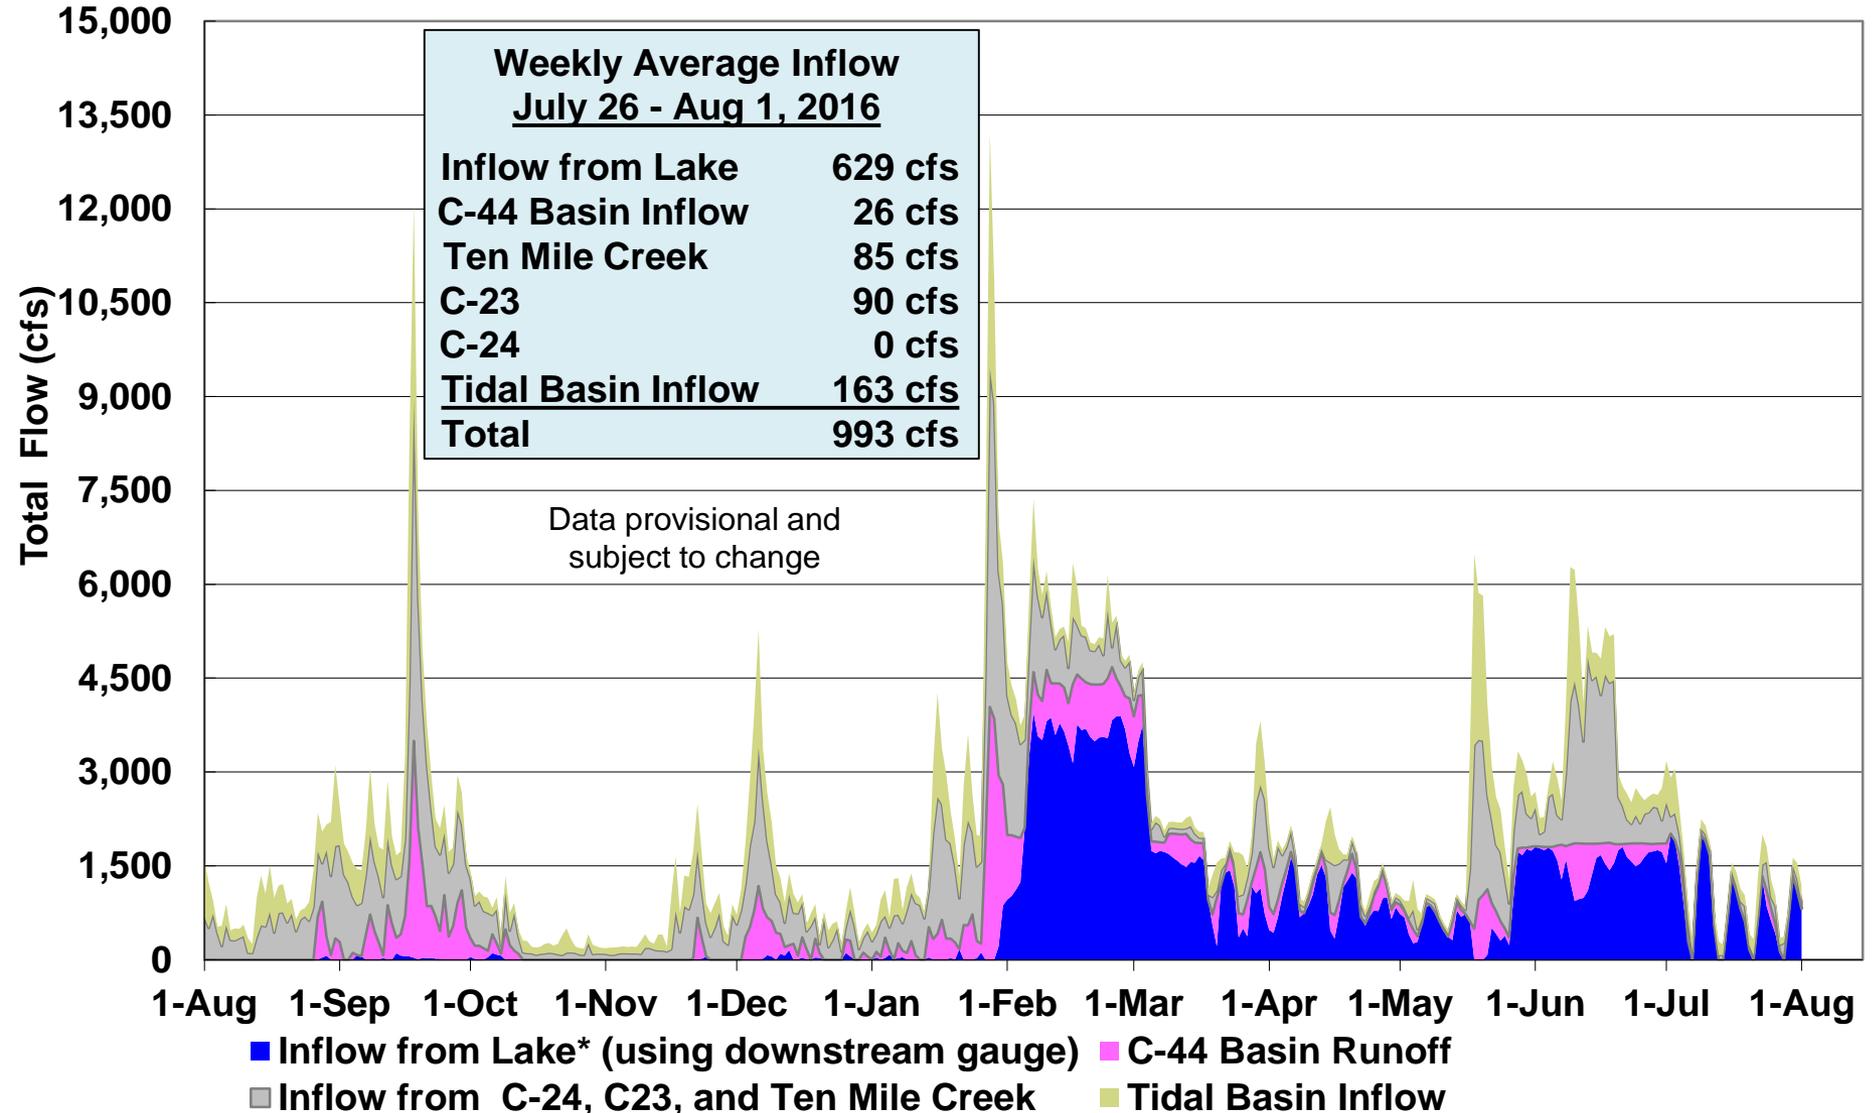
Weekly Average Inflow July 26 - Aug 1, 2016	
Inflow from Lake	629 cfs
C-44 Basin Inflow	26 cfs
Ten Mile Creek	85 cfs
C-23	90 cfs
C-24	0 cfs
Tidal Basin Inflow	163 cfs
Total	993 cfs

Data provisional and subject to change

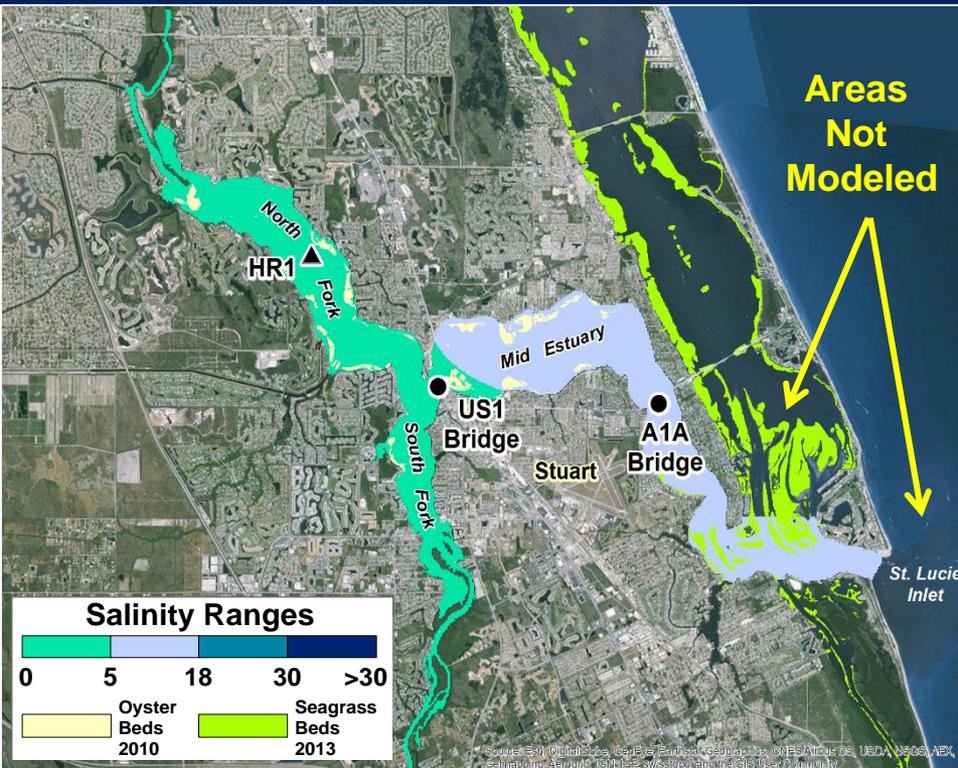
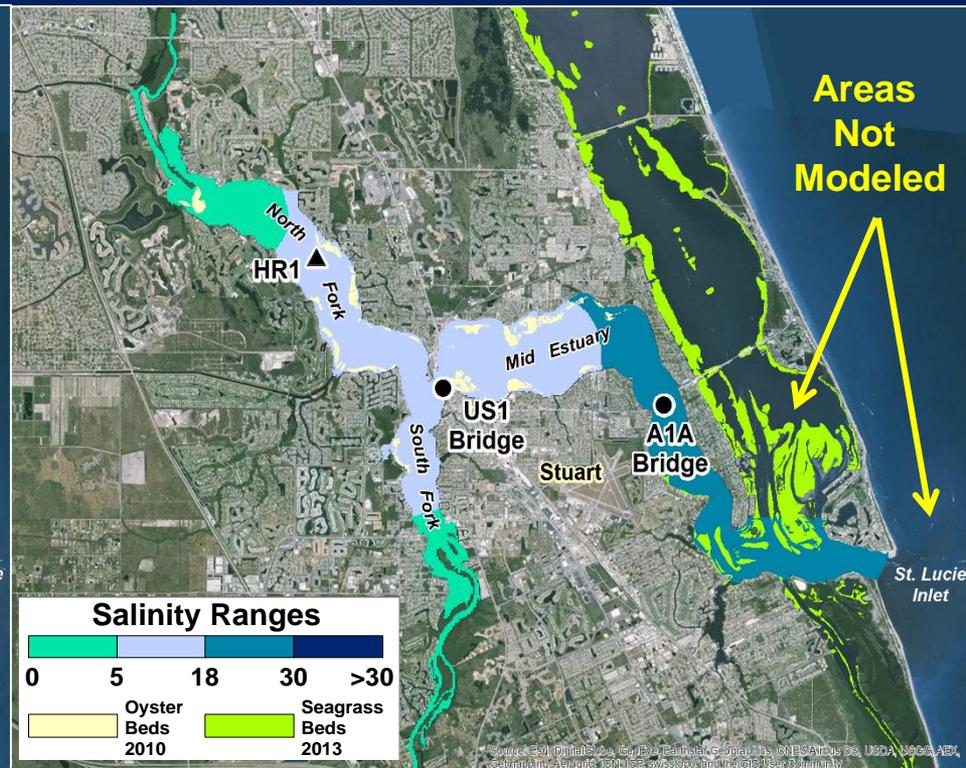
Salinity Conditions

July 11, 2016

August 1, 2016

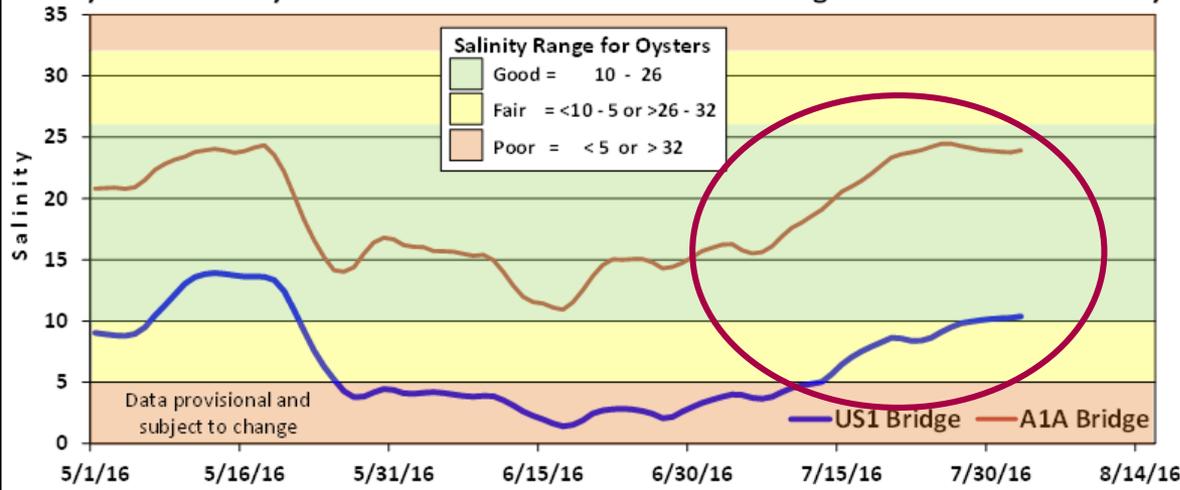
7-day mean salinity of the water column at US1 & A1A Bridges in the St. Lucie Estuary

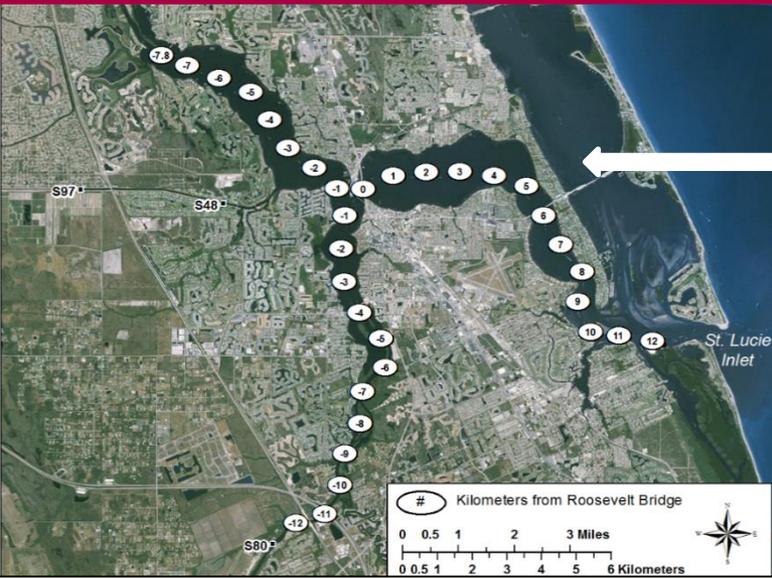
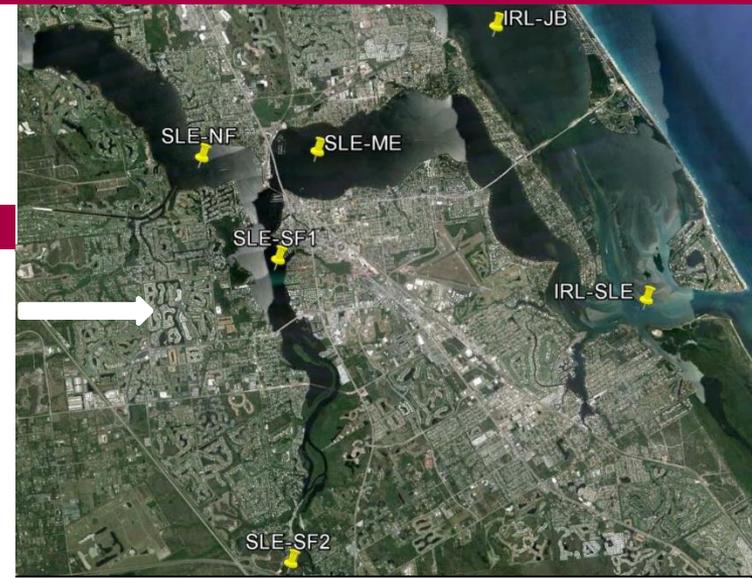
St. Lucie Estuary measurements of Chlorophyll *a*

SFWMD water quality mapping survey track (left)

Location of the LOBO stations managed by Harbor Branch/ Florida Atlantic University (right)

- 7-7-16 transect data collection
 - *St. Lucie Inlet to North Fork Narrows*
 - *South Fork to St. Lucie Locks (S-80)*
 - *C-44 Canal from S-80 to Port Mayaca*
- Sampled water continuously at 0.5 m depth using a flow through system:
 - Temperature
 - Specific Conductivity
 - Turbidity
 - Blue Green Algae
 - Dissolved Oxygen
 - * Salinity
 - * pH
 - * Chlorophyll a
 - * CDOM (Color)
- Same data collected on 4-28-16 under pre-bloom conditions

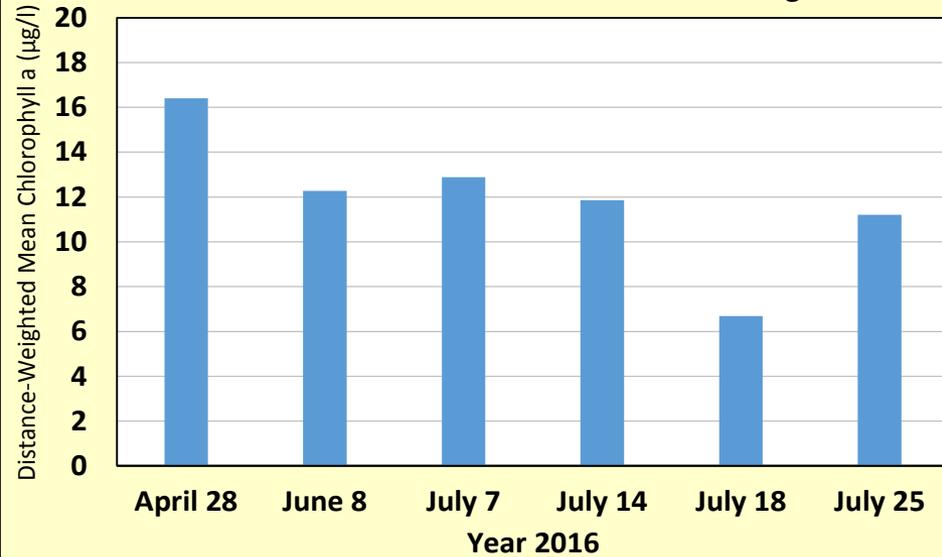
Distance-Weighted Mean Chlorophyll a (ug/l) near the St. Lucie Inlet to Roosevelt Bridge

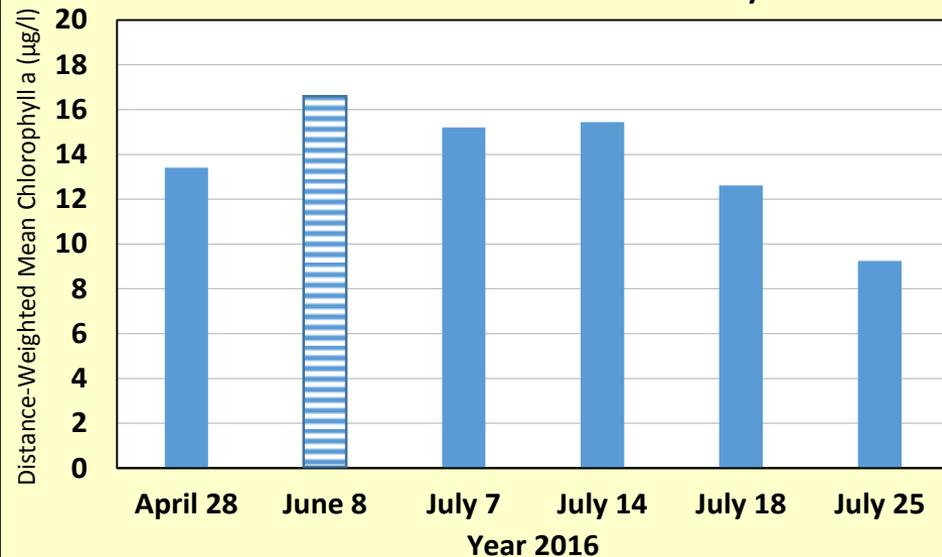
Distance-Weighted Mean Chlorophyll a (ug/l) South Fork of the St. Lucie Estuary

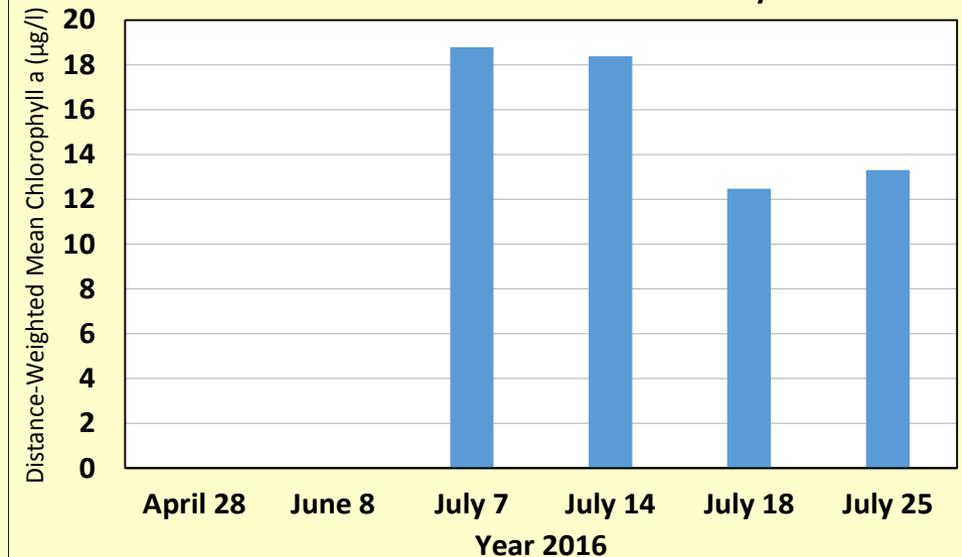
Distance-Weighted Mean Chlorophyll a (ug/l) North Fork of the St. Lucie Estuary

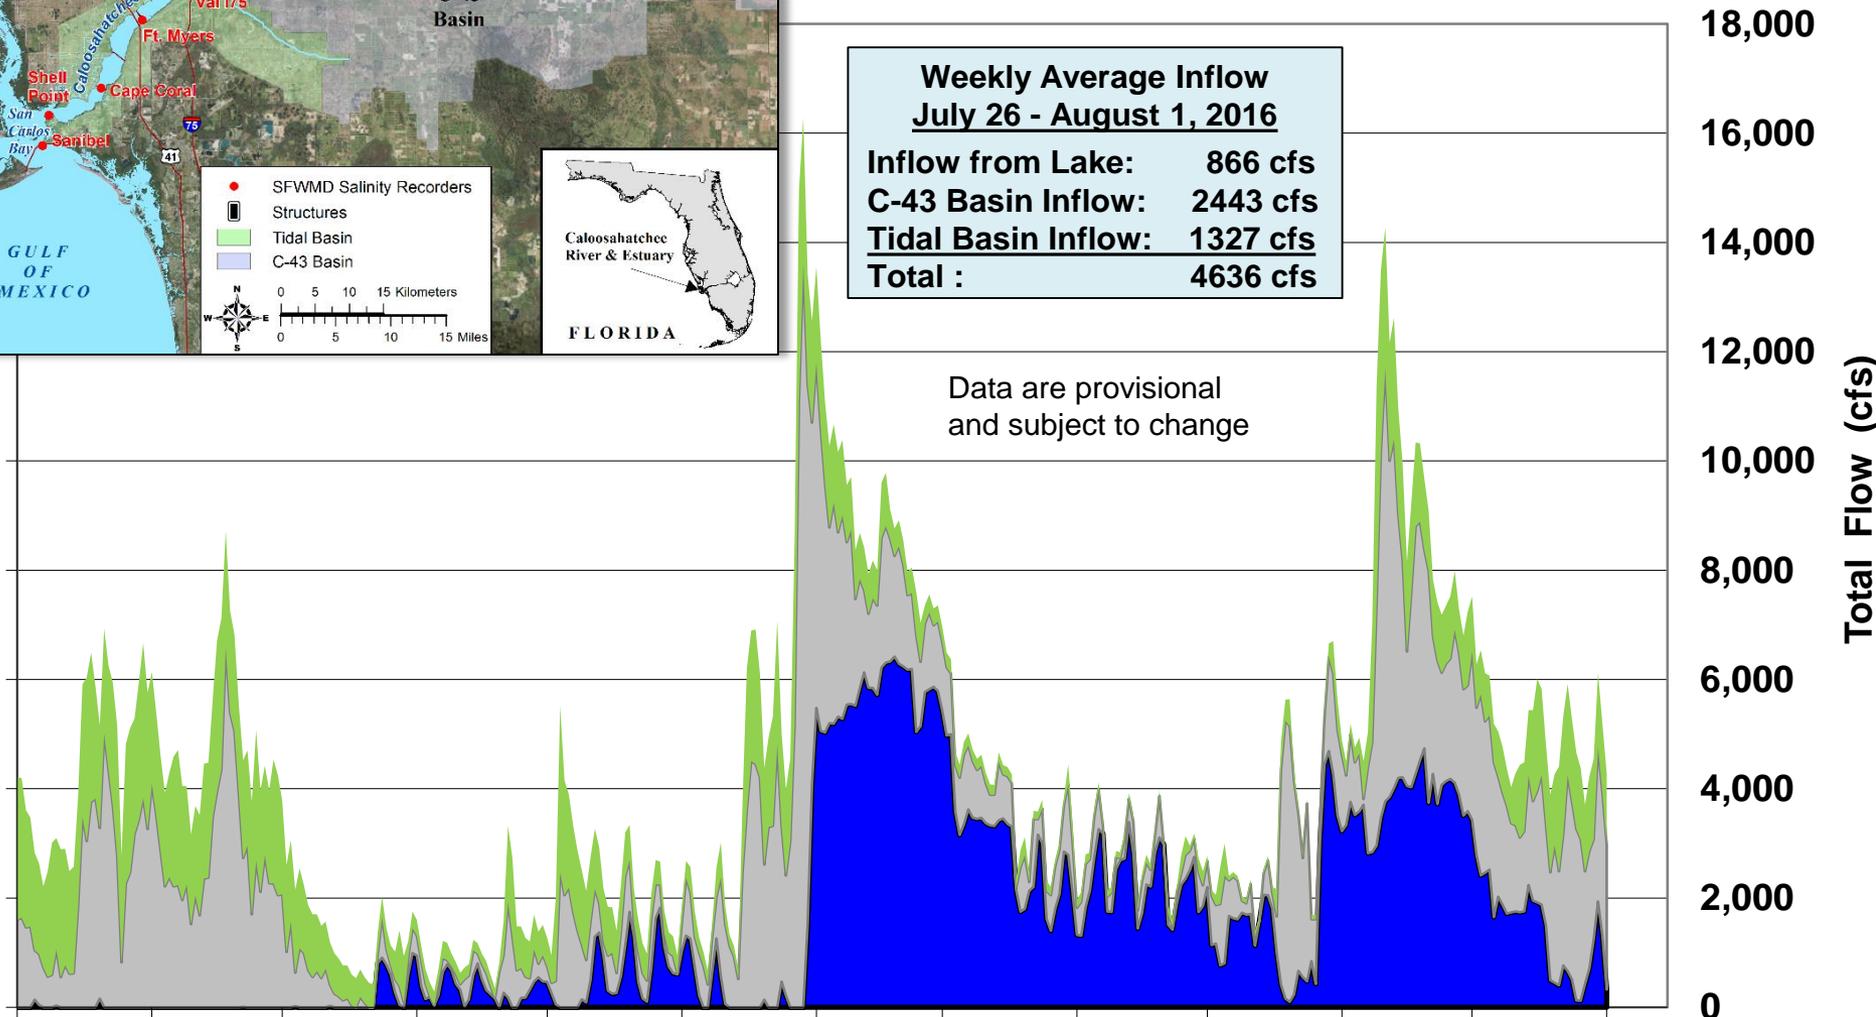
Weekly Average Inflow July 26 - August 1, 2016	
Inflow from Lake:	866 cfs
C-43 Basin Inflow:	2443 cfs
Tidal Basin Inflow:	1327 cfs
Total :	4636 cfs

■ Inflow from Lake* (using downstream gauge)
 ■ C-43 Basin Inflow
 ■ Tidal Basin Inflow (downstream of S79)

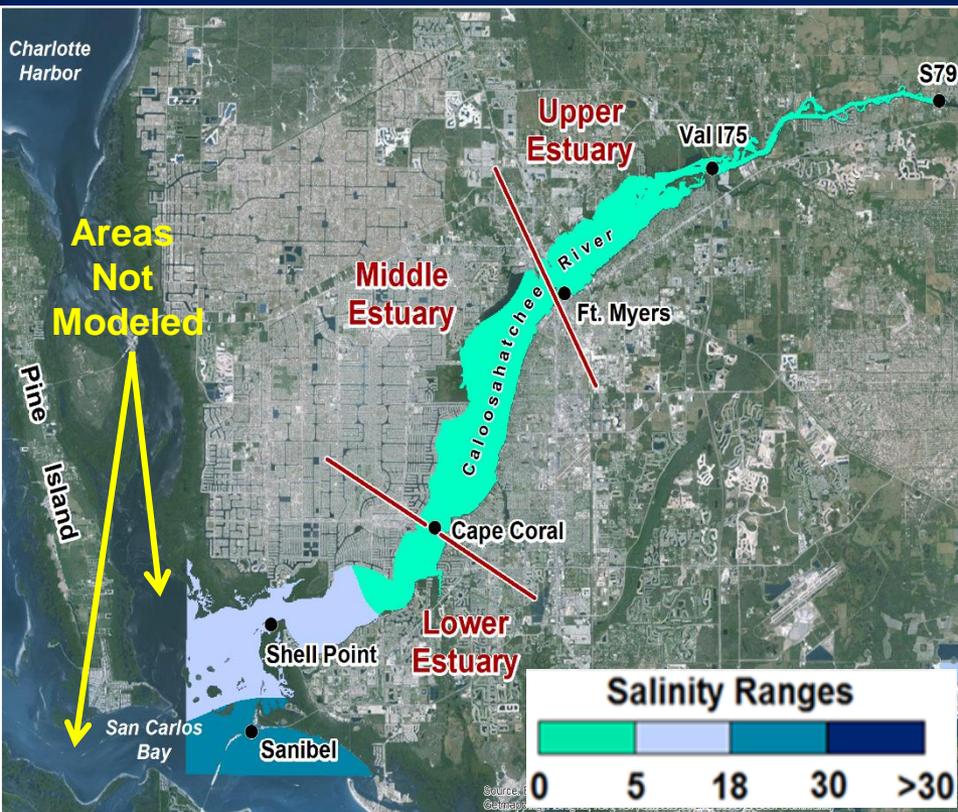
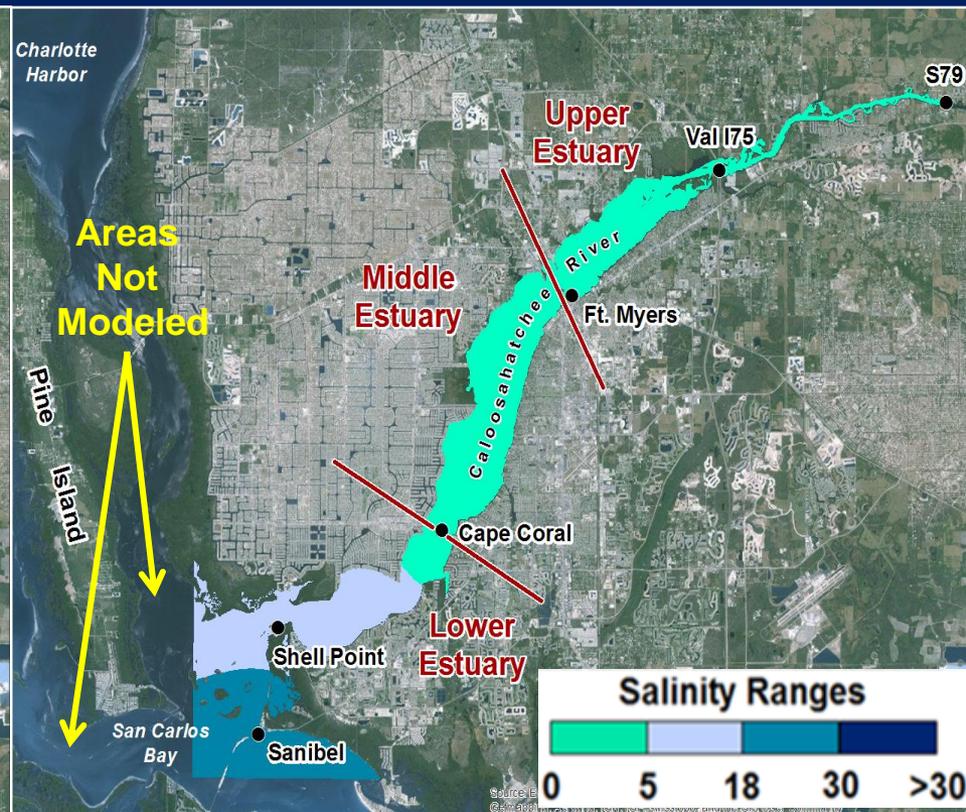
Salinity Conditions

July 11, 2016

August 1, 2016

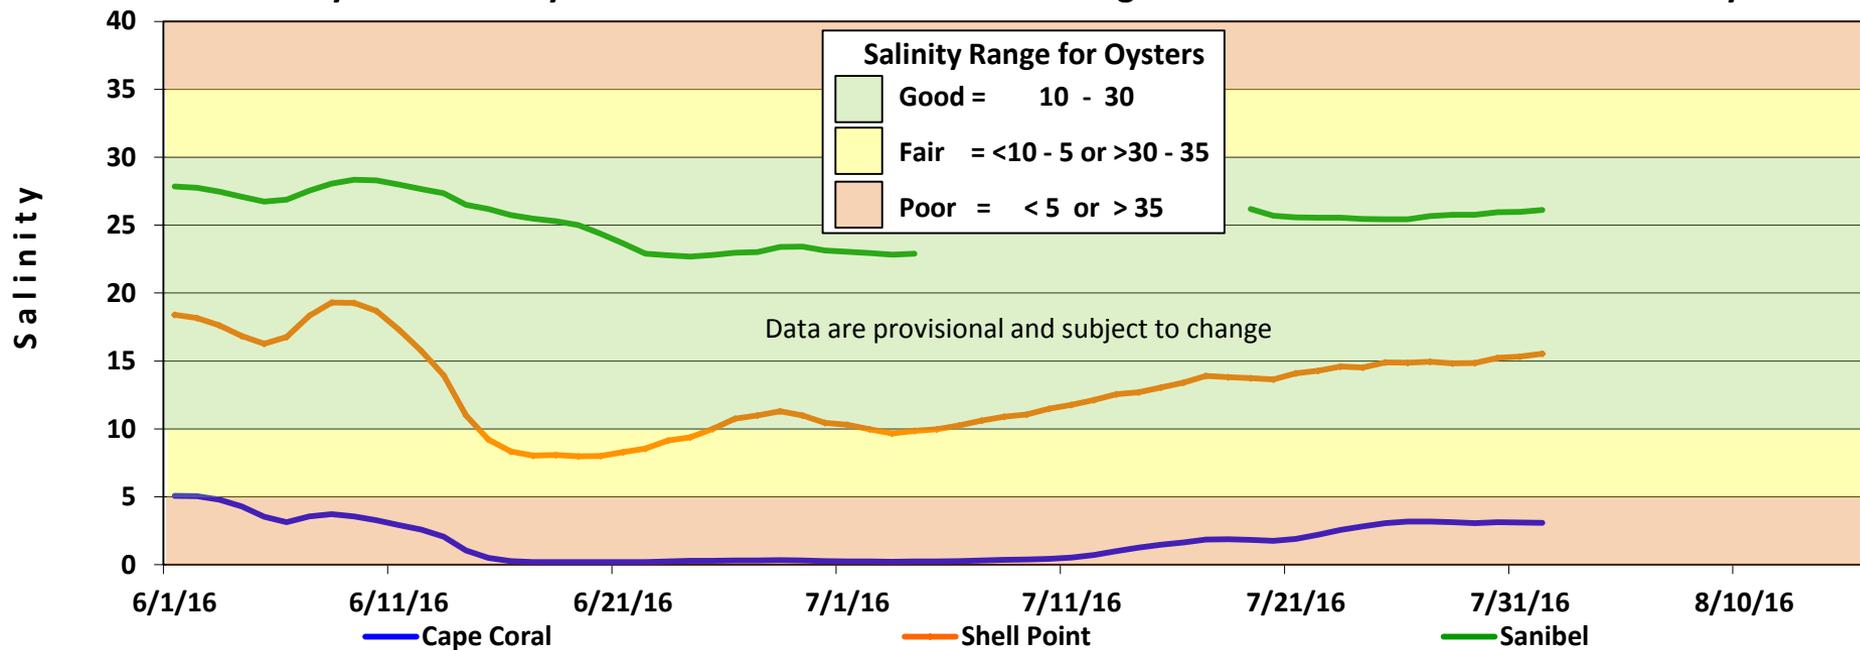
Seven day mean salinity of the water column at 3 monitoring stations in the Caloosahatchee Estuary
