Governing Board Meeting

August 11, 2016

Ecological Conditions Update

Water Resources Division

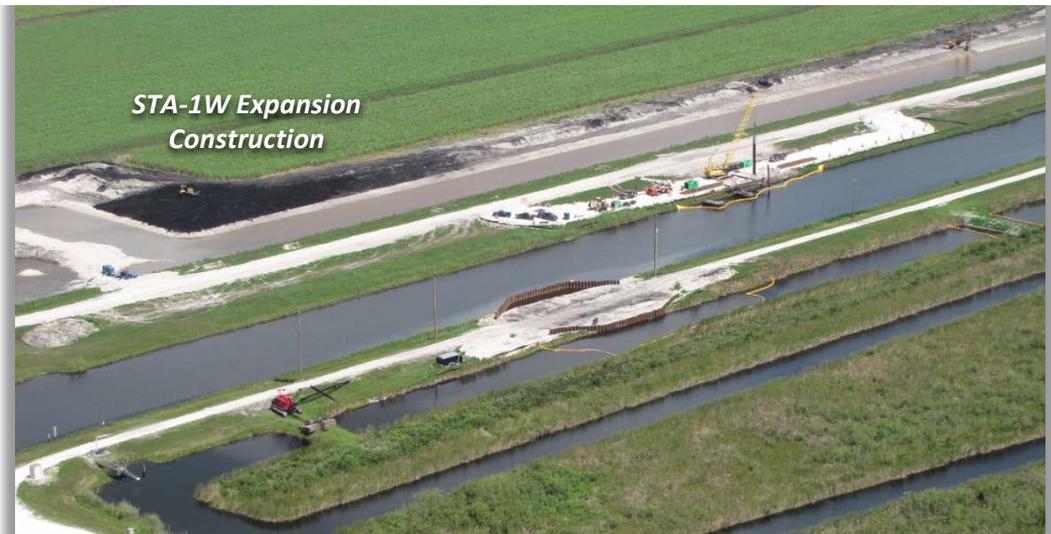
Stormwater Treatment Areas (STAs) Current Conditions

- Continued to send Lake releases south through A-1 FEB and STAs in July
 - Total Lake regulatory releases to FEBs/STAs in WY2017 (since May 1) ~56,000 ac-ft

Water Year 2017 (5/1/16 to 7/31/16)						
	STA-1E	STA-1W	STA-2	STA-3/4	STA-5/6	Total
Inflow TP (ppb)	155	171	95	28	148	89
Outflow TP (ppb)	24	28	19	13	25	19
Inflow Vol. (ac-ft)	49,133	22,385	88,053	121,586	29,034	310,191

- All treatment cells are at or above target depths
- Operation of existing STA-1W continues during STA-1W Expansion construction
