Governing Board Meeting  
July 9, 2019

# Ecological Conditions Update

**Lawrence Glenn**  
Water Resources  
Division Directory

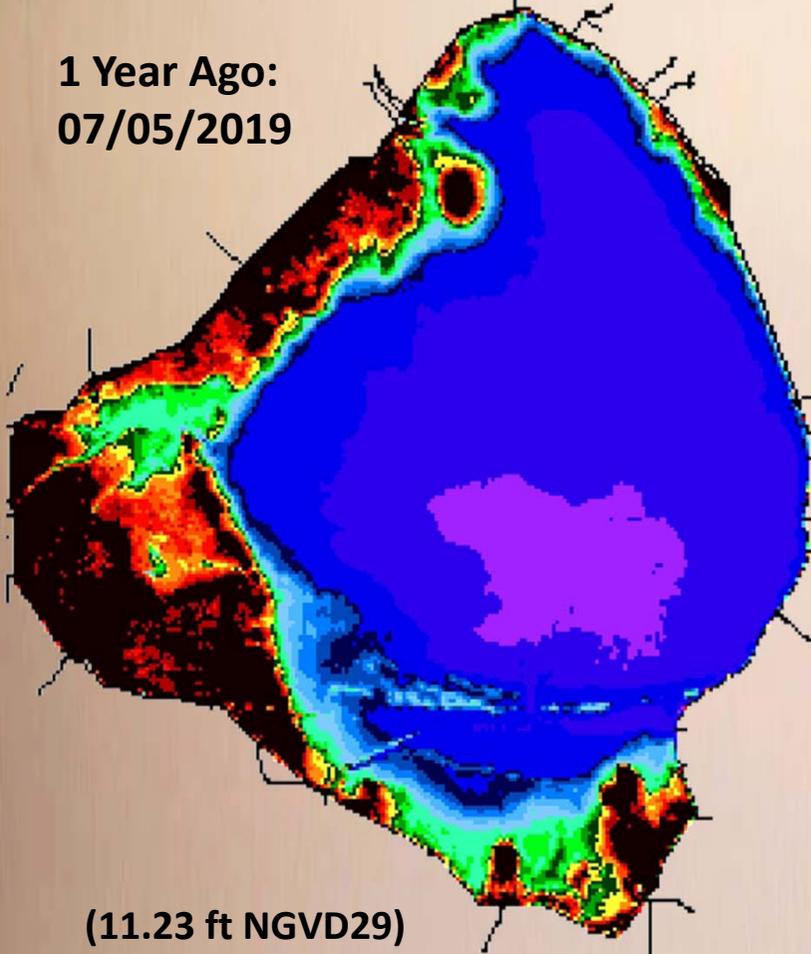
1 Year Ago:  
07/05/2019

(11.23 ft NGVD29)

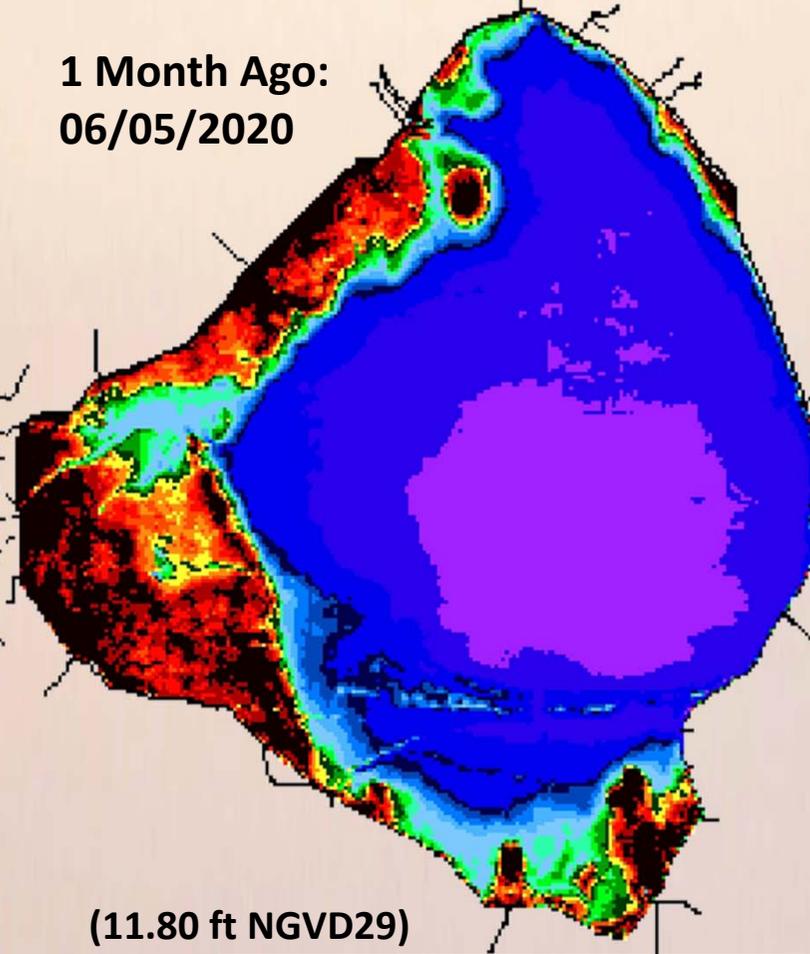
1 Month Ago:  
06/05/2020

(11.80 ft NGVD29)

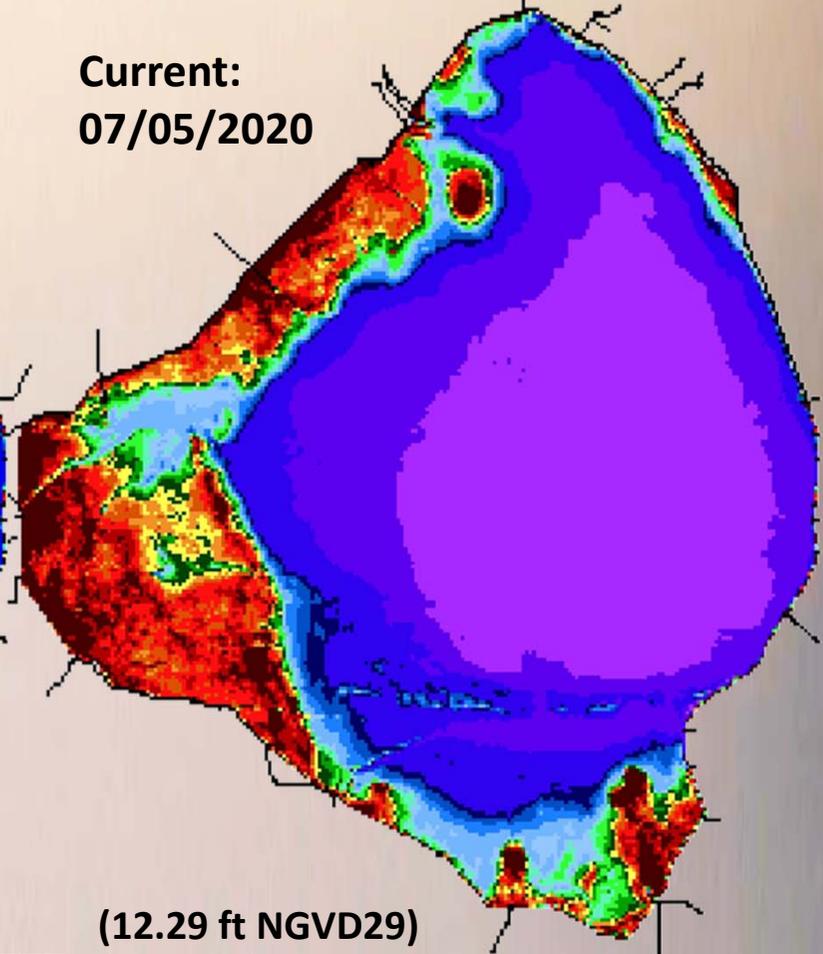
Current:  
07/05/2020

(12.29 ft NGVD29)

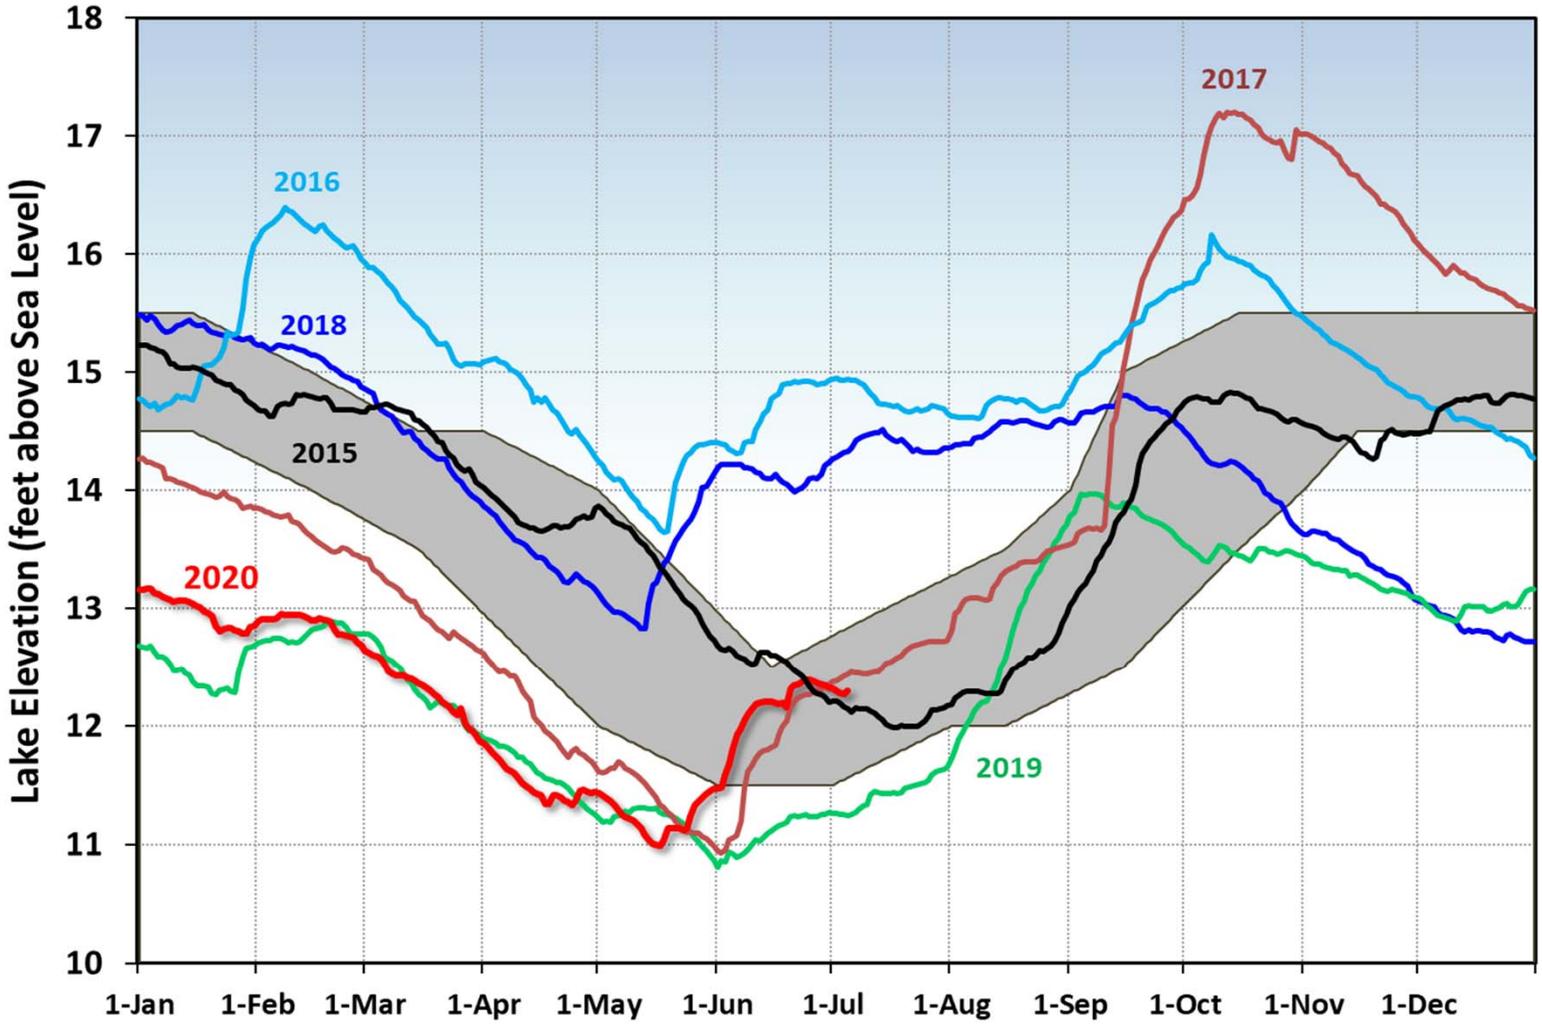
Lake Okeechobee Stage vs Updated Ecological Envelope

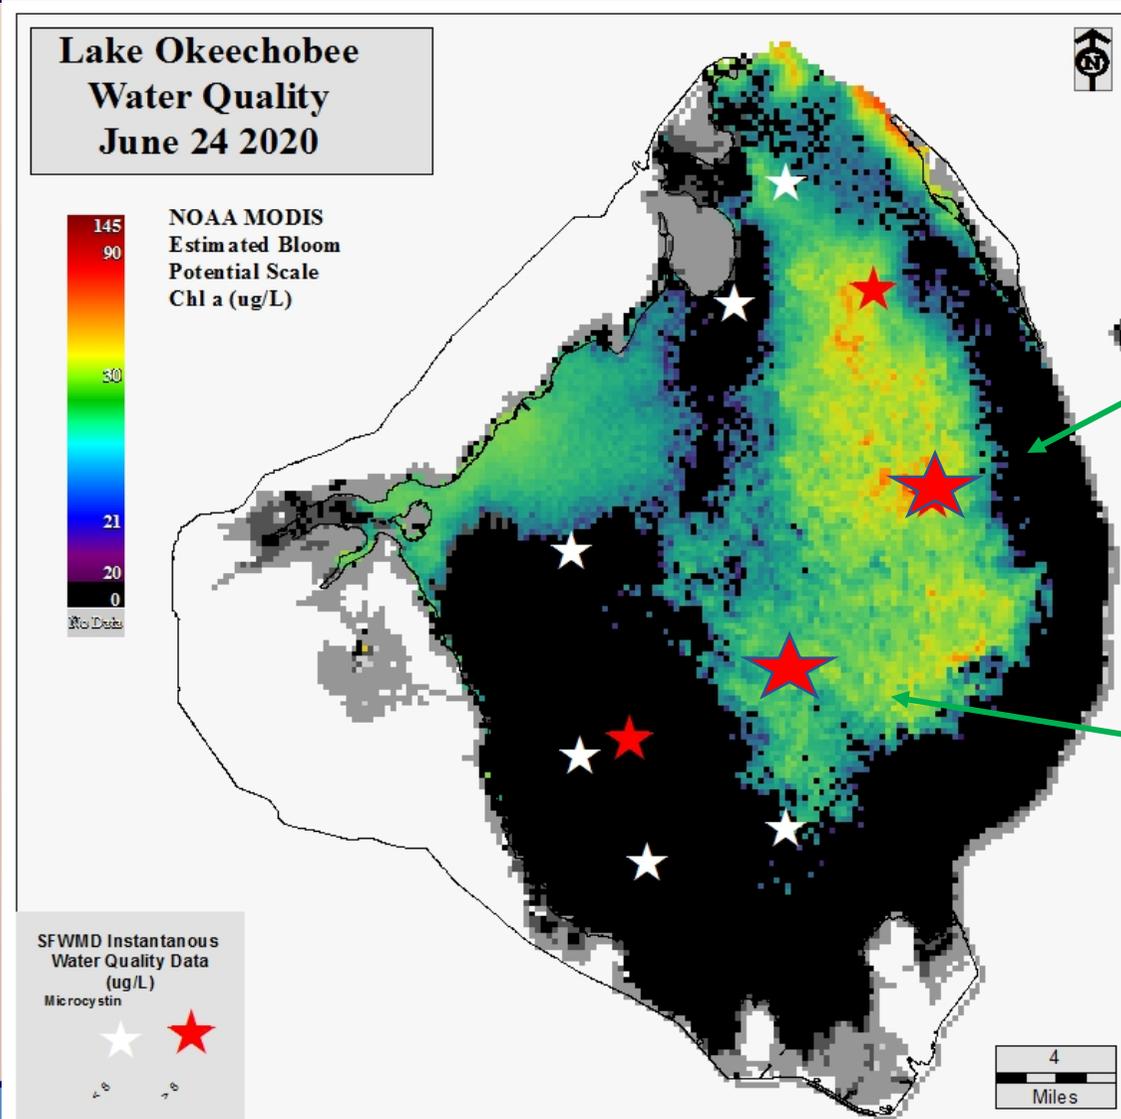
L004 – 6/23/2020  
BGA Observed  
*M.aeruginosa*  
MC @ **800** µg/L

LZ40 – 6/24/2020  
BGA Observed  
*M.aeruginosa*  
MC @ **290** µg/L

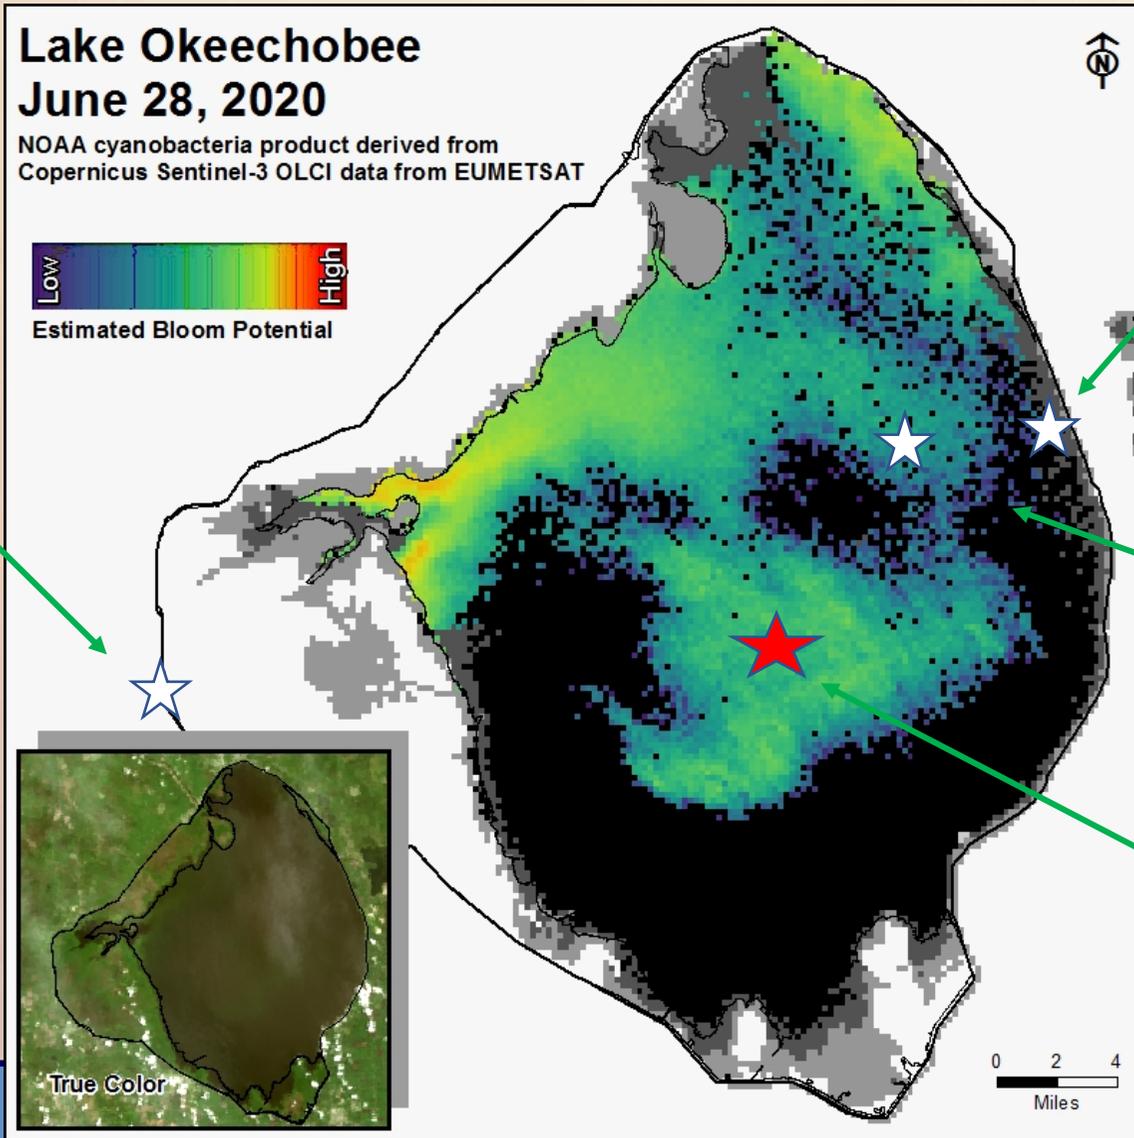
S-77 – 6/29/2020  
No bloom observed  
*No dominant taxa*  
MC = BDL

S308C – 6/29/2020  
No bloom observed  
*M. aeruginosa*  
MC = BDL

L004 – 6/30/2020  
BGA Observed  
*M. aeruginosa*  
MC @ 1.3 µg/L

L004 – 6/23/2020  
BGA Observed  
*M. aeruginosa*  
MC @ 800 µg/L

LZ40 – 6/30/2020  
BGA Observed  
*M. aeruginosa*  
MC @ 99 µg/L

LZ40 – 6/24/2020  
BGA Observed  
*M. aeruginosa*  
MC @ 290 µg/L

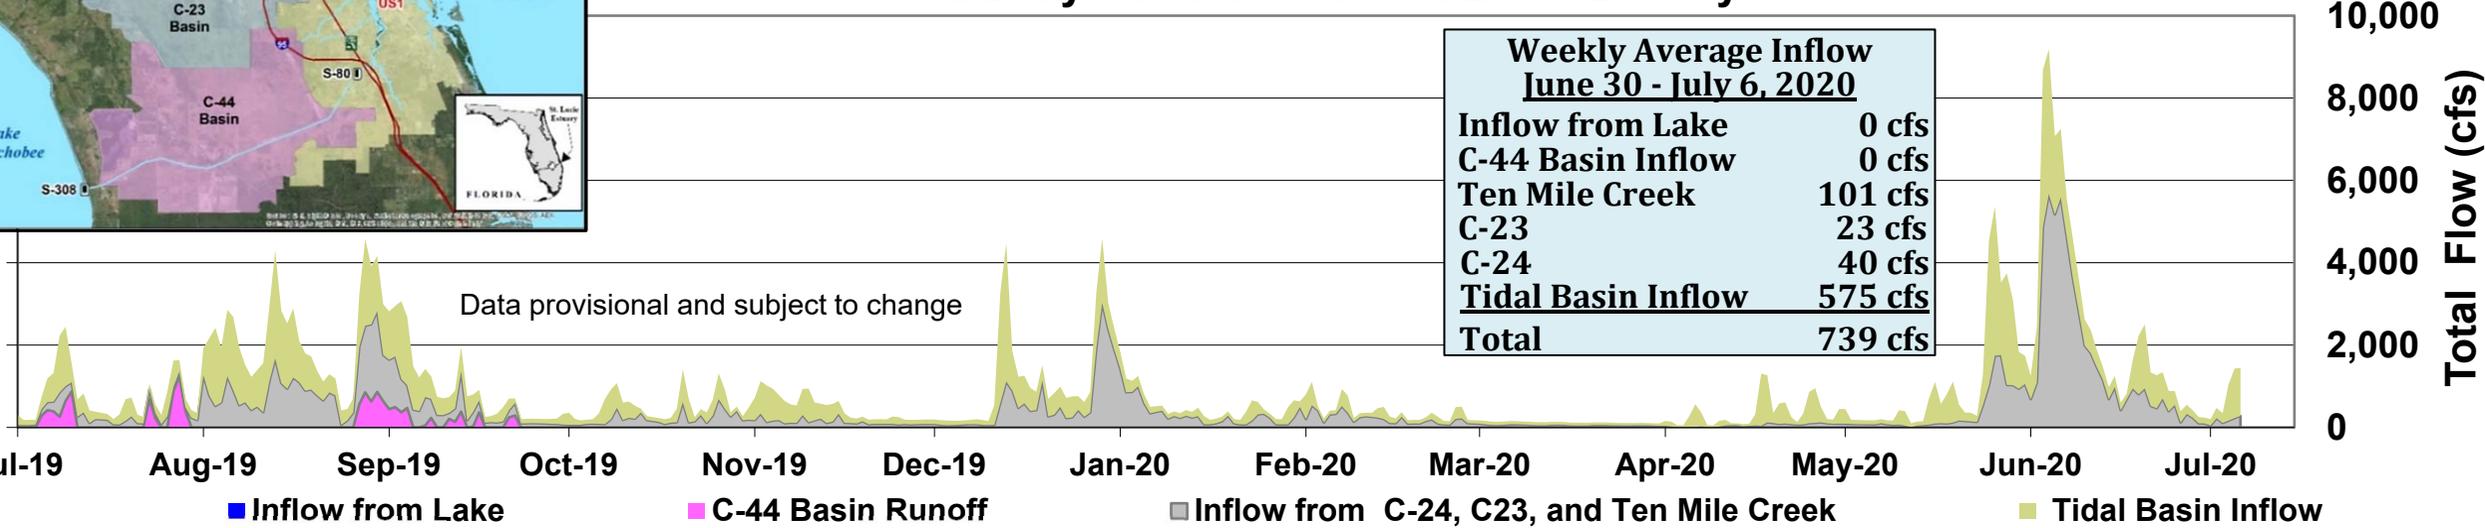
Total Daily Inflow into the St. Lucie Estuary

**Weekly Average Inflow  
June 30 - July 6, 2020**

Inflow from Lake	0 cfs
C-44 Basin Inflow	0 cfs
Ten Mile Creek	101 cfs
C-23	23 cfs
C-24	40 cfs
<b>Tidal Basin Inflow</b>	<b>575 cfs</b>
<b>Total</b>	<b>739 cfs</b>

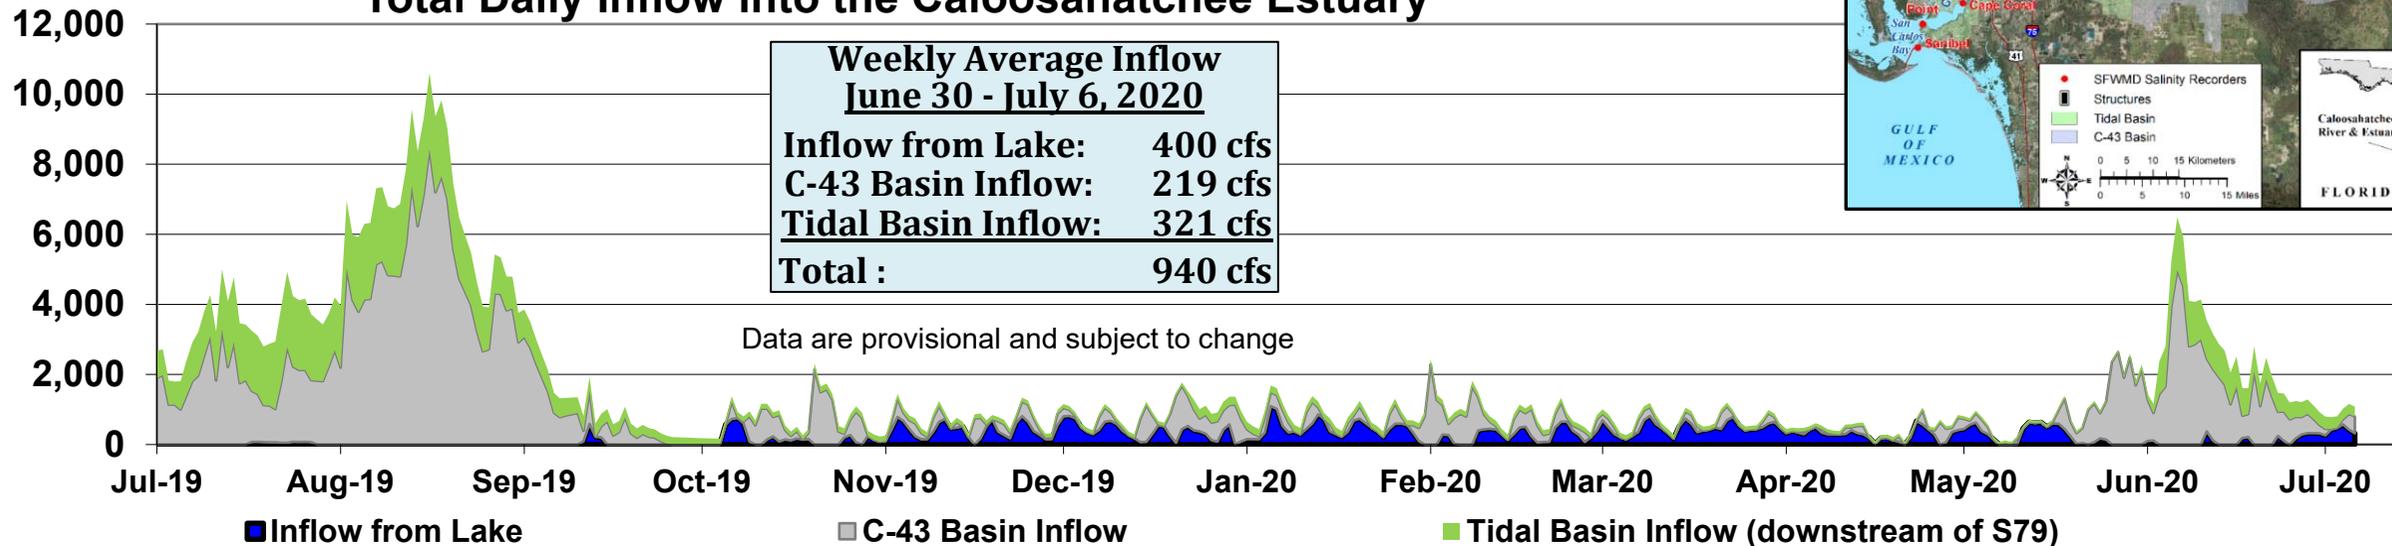
## Total Daily Inflow into the Caloosahatchee Estuary

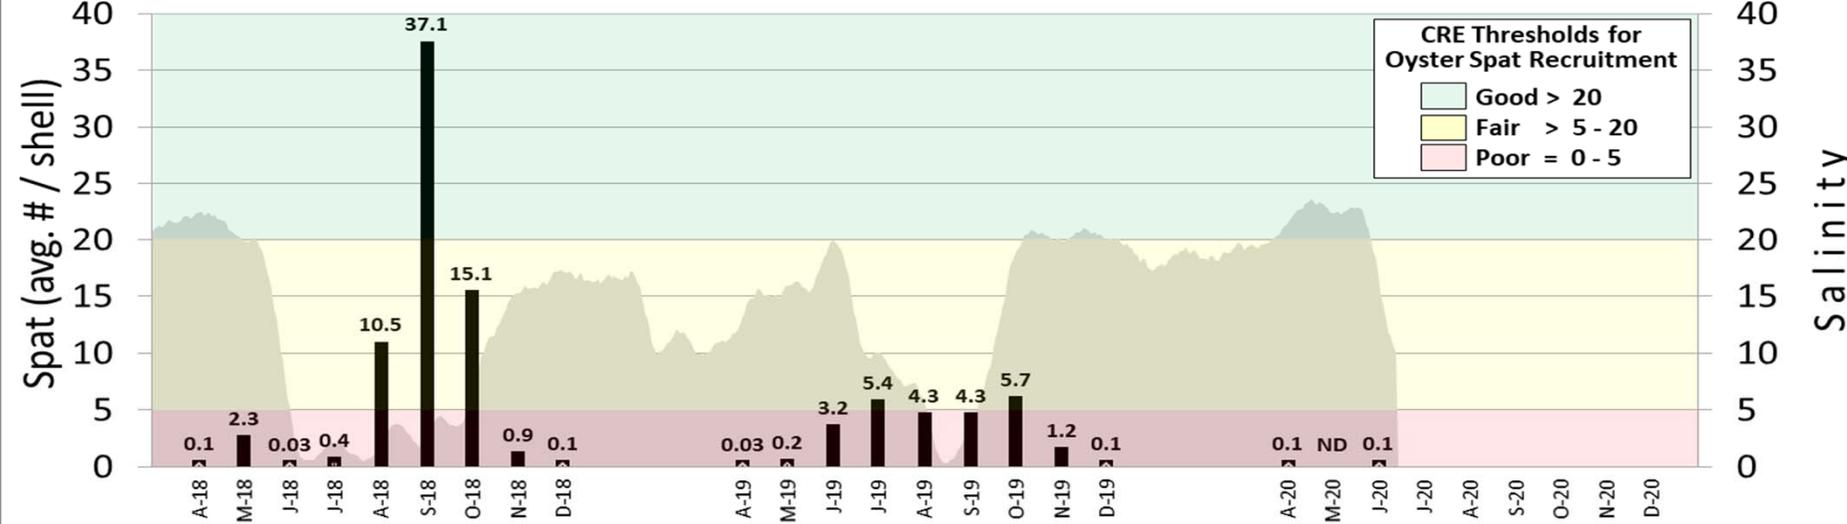
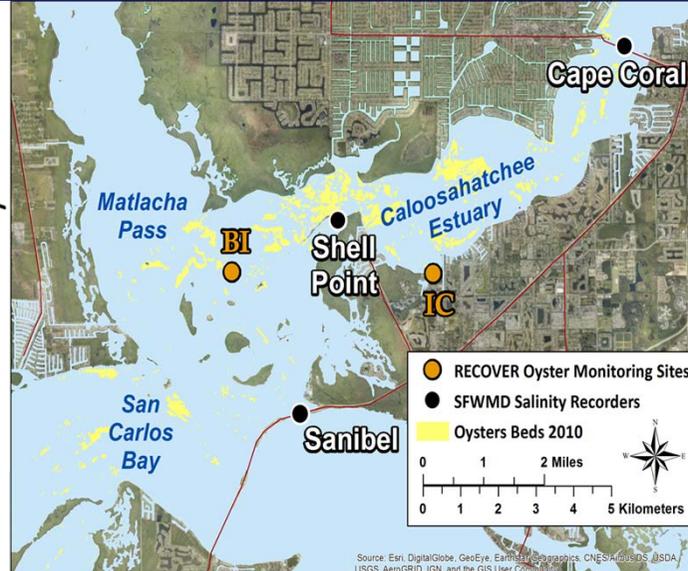
2018 - 2020 Iona Cove Oyster Recruitment Season and 14 day mean Salinity at Cape Coral

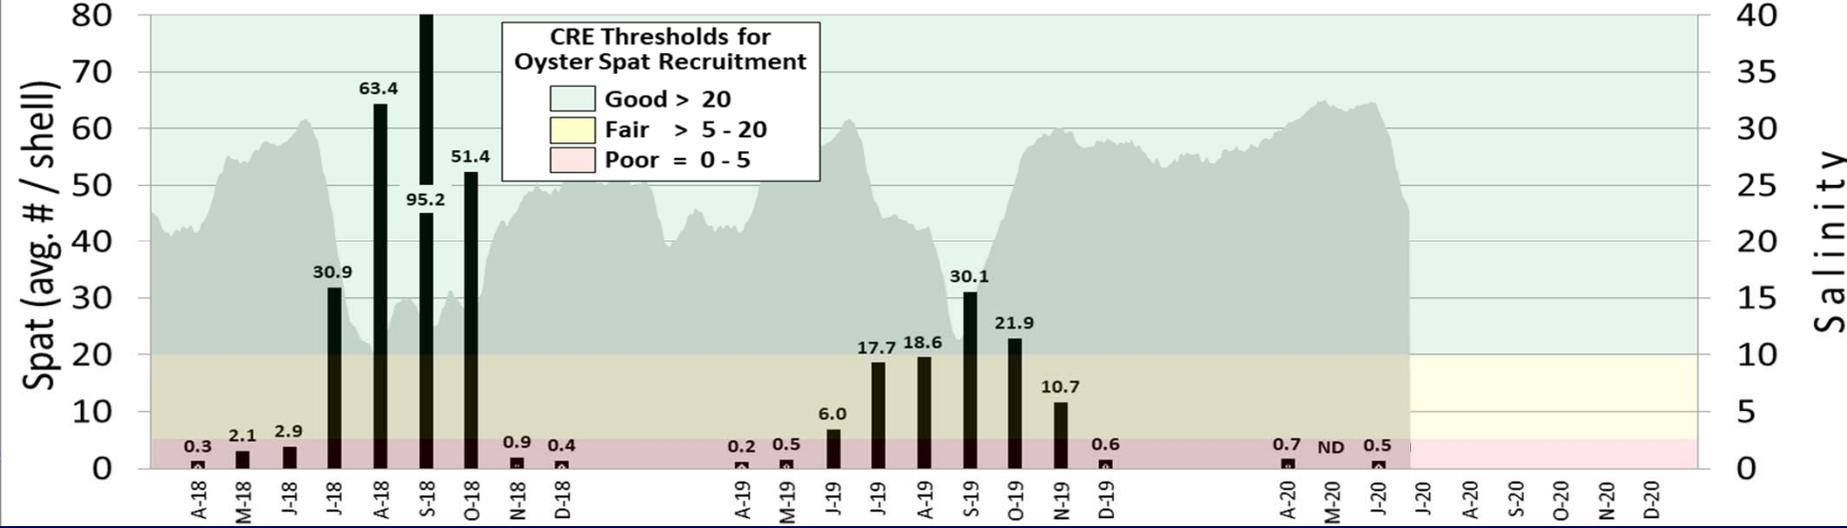
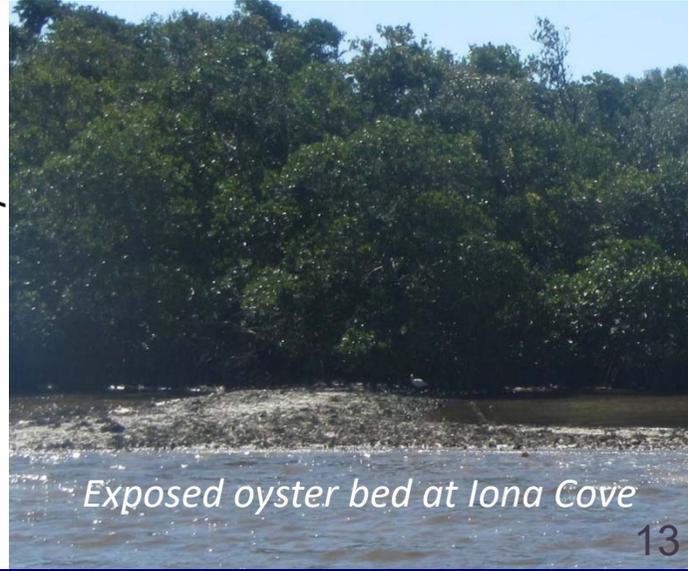
2018 - 2020 Bird Island Oyster Recruitment Season and 14 day mean Salinity at Shell Point

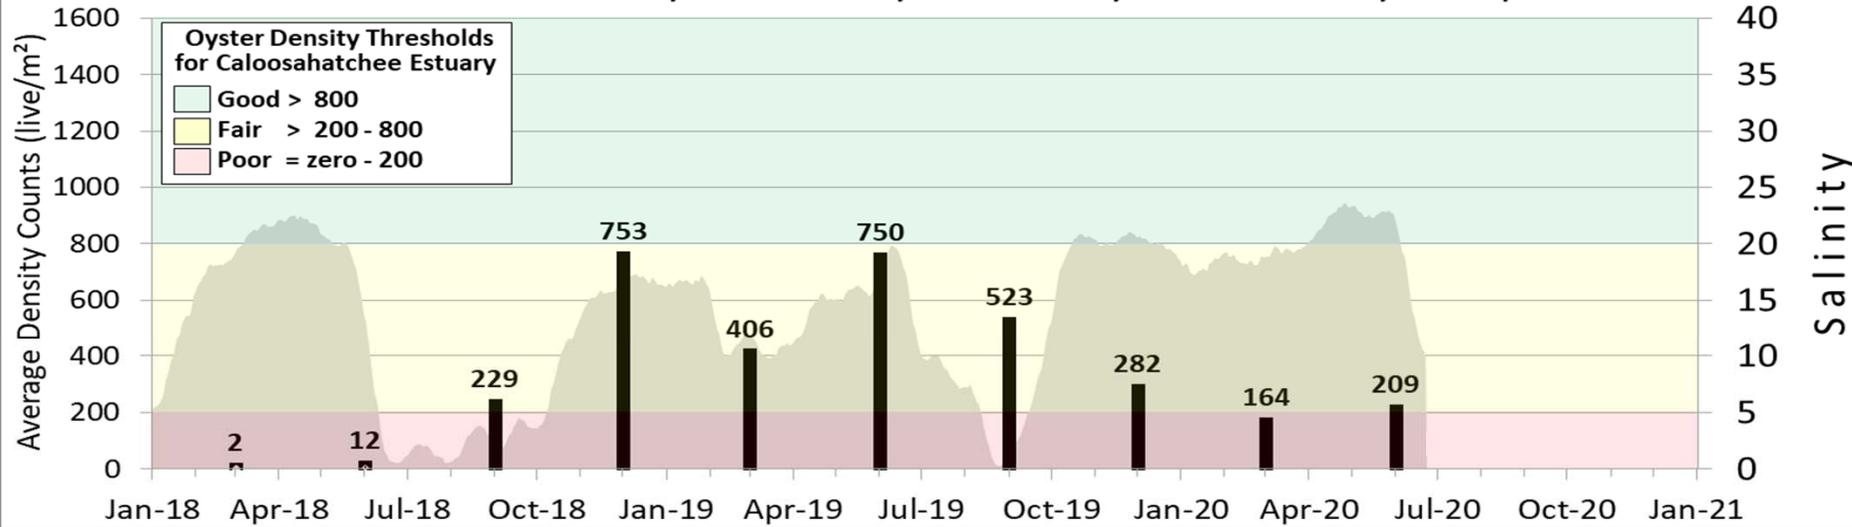
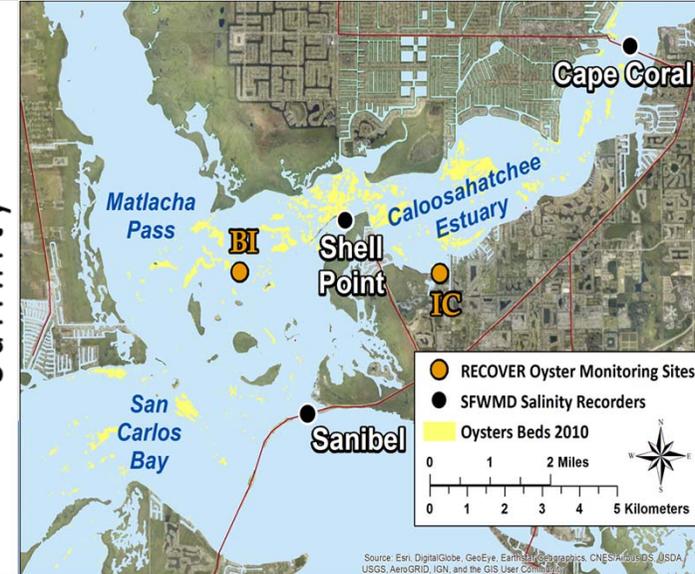
2018 - 2020 Iona Cove Oyster Density and 14 day mean Salinity at Cape Coral

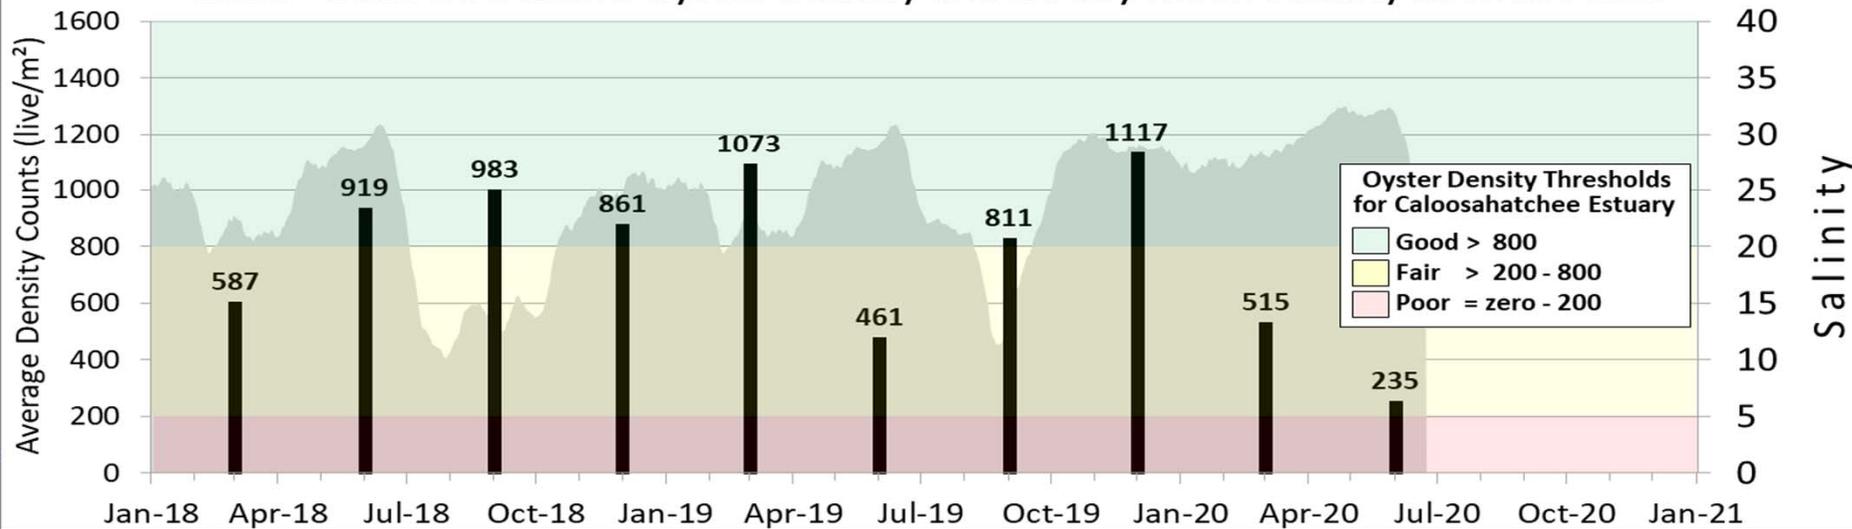
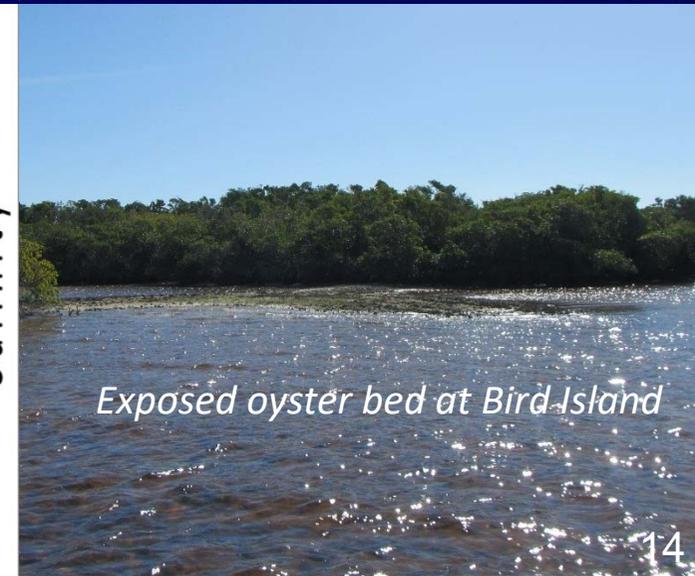
2018 - 2020 Bird Island Oyster Density and 14 day mean Salinity at Shell Point

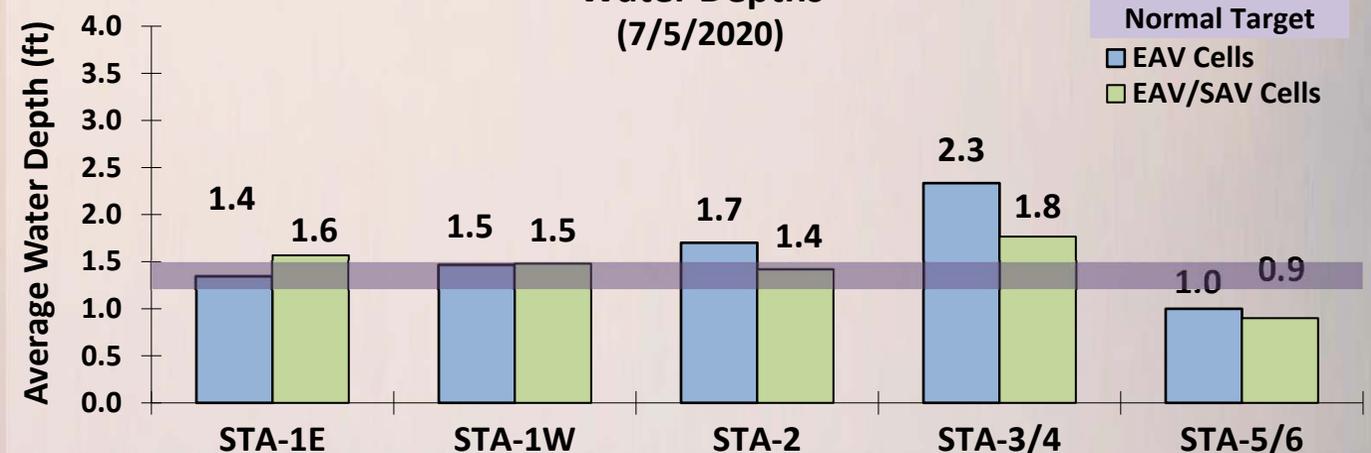
Water Depths  
(7/5/2020)

*Includes preliminary data; Emergent Aquatic Vegetation (EAV); Submerged Aquatic Vegetation (SAV)*

- STAs treated high inflow volumes from basin runoff in June
- Total Inflows to STAs in WY2021 ~309,000 ac-ft
- Lake Okeechobee releases to STAs in WY2021 ~ 10,000 ac-ft (3% of total)
- Extensive vegetation management activities underway to address stressed and highly stressed vegetation especially in EAV cells
- Most treatment cells are at or above target depth; STA-5/6 has rehydrated following extended dry-out period

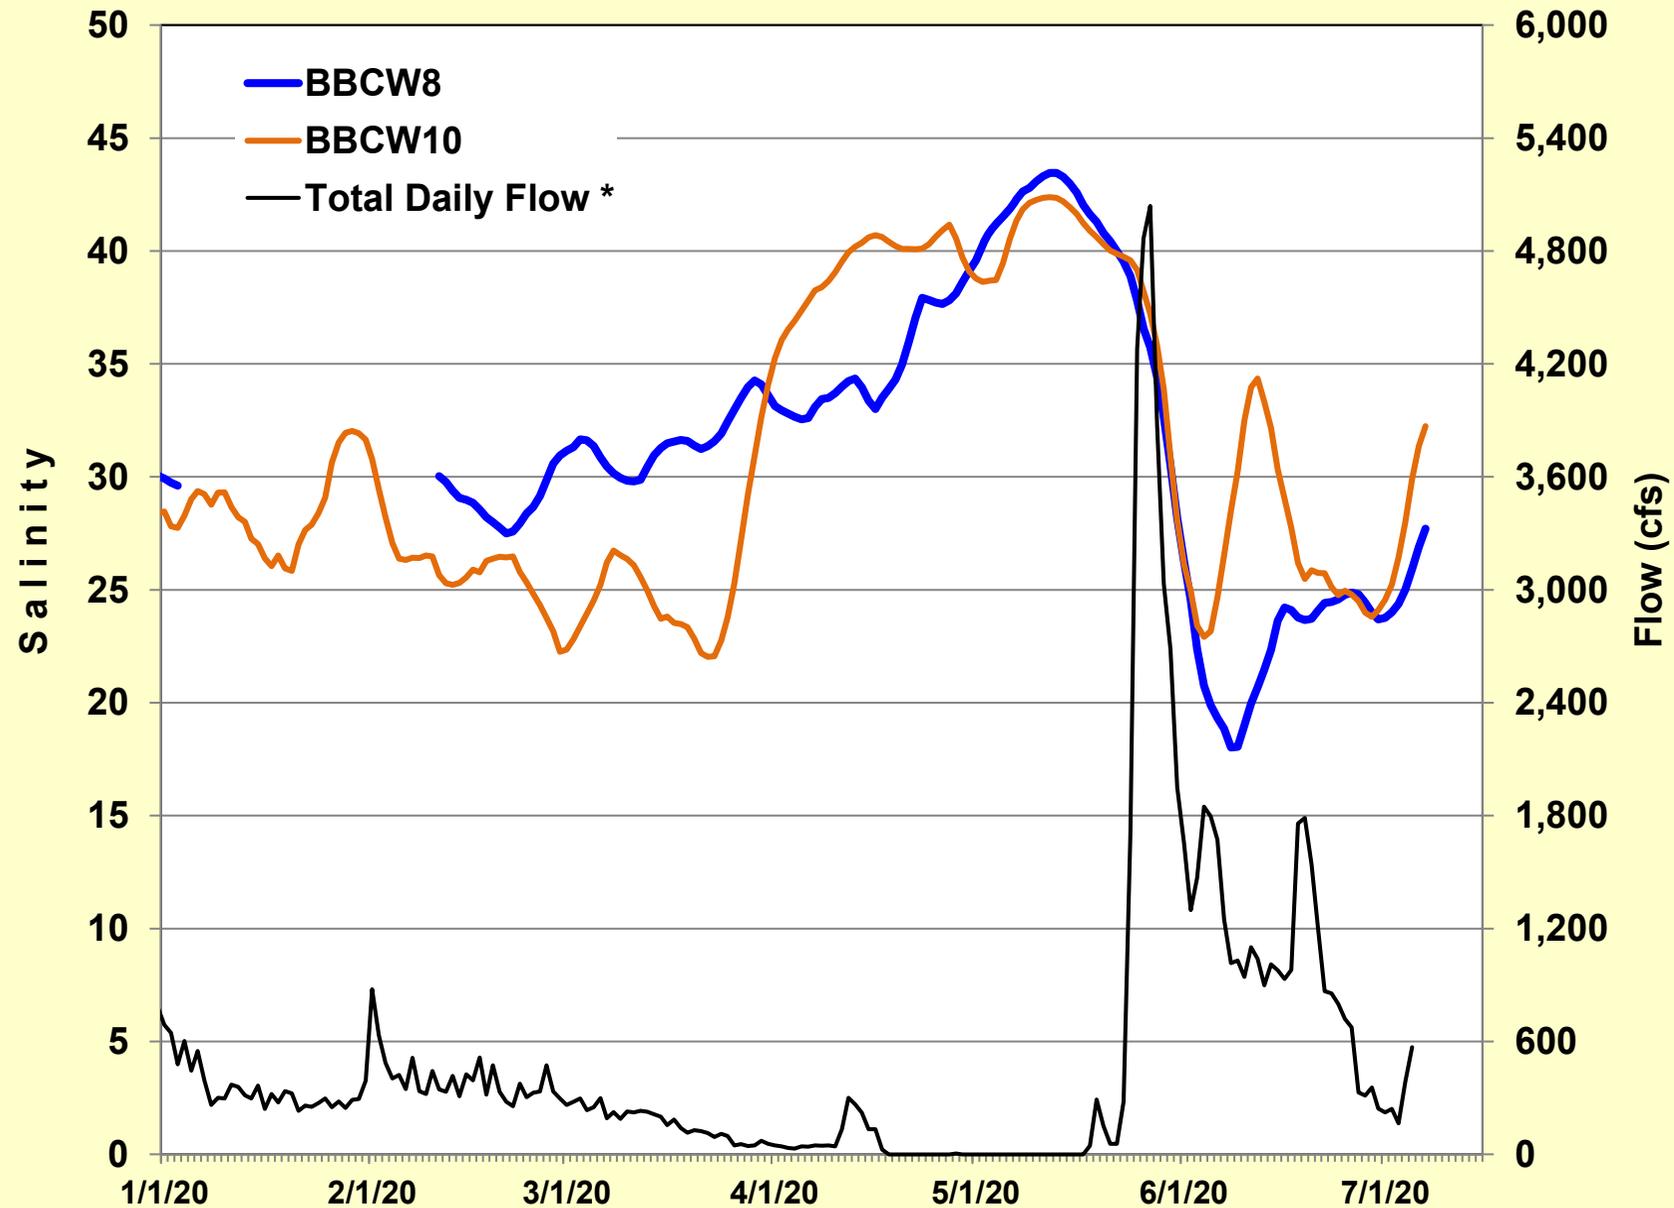
Seven Day Mean Salinity (BBCW8 & BBCW10) & Total Daily Flow

\* Total flow from S20G, S20F, S21, S21A, S123, S700P

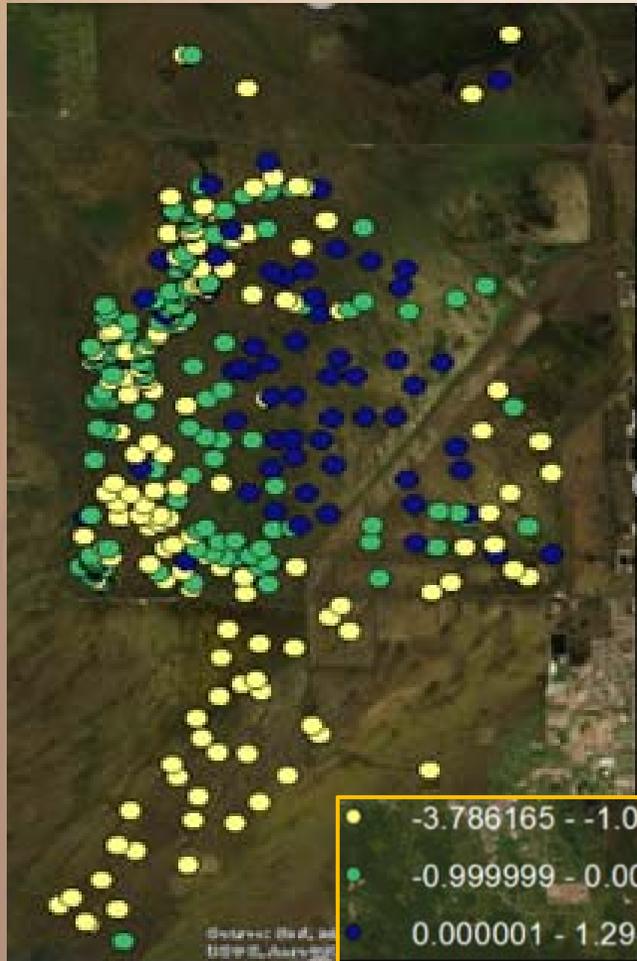
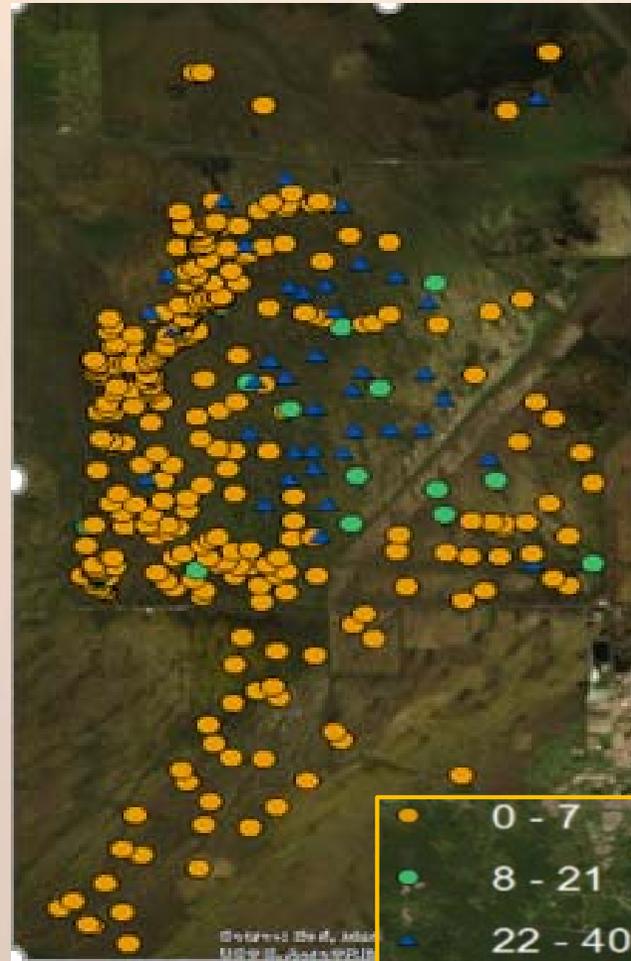
## Water Depth

## Inundation Period

- 371 tree islands with known elevation
  - WCA 3 A&B, Shark Slough
- 66 (18%) inundated currently
- Longest period of continuous inundation is 40 days (5/24/20)
  - 90-120 days = concern
- Maximum water depth relative to tree island head is 1.18 feet

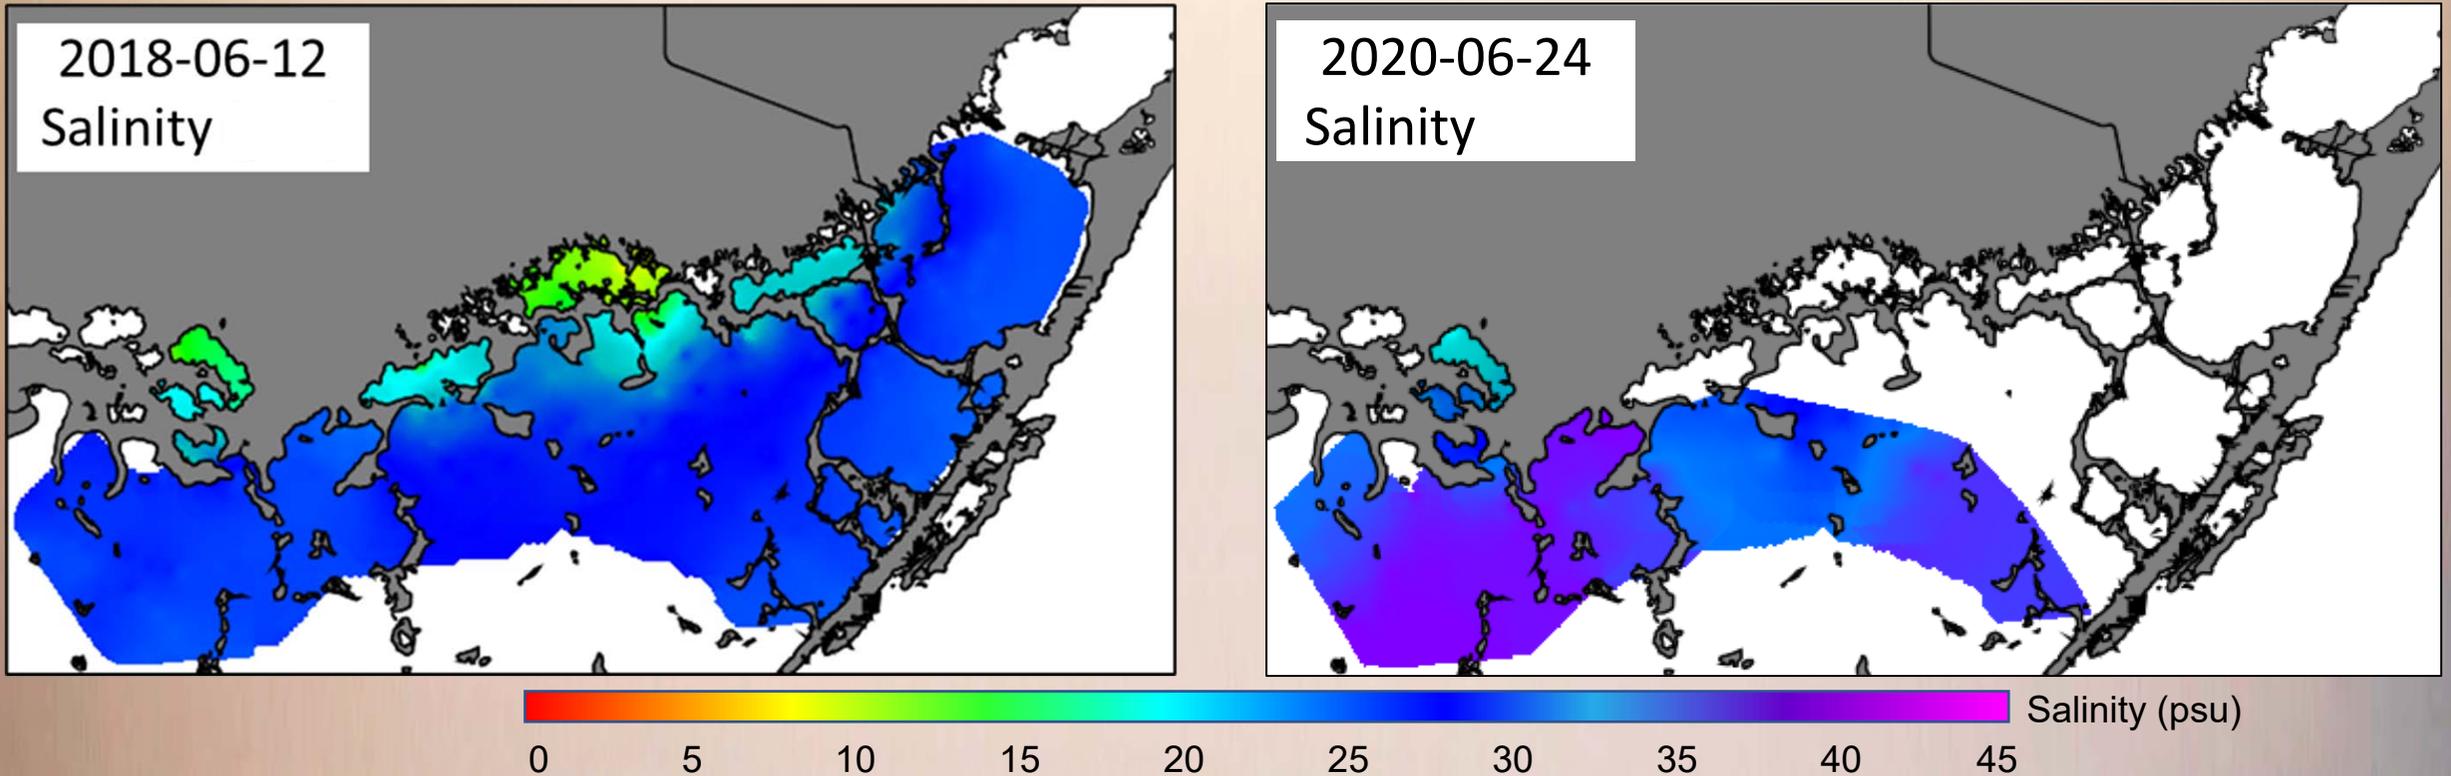
- Equipment difficulties only allowed sampling of the Central Florida Bay region where salinities continue to be elevated (map on right)
- Typical pattern for this time of year has evidence of freshwater inputs with lower salinities along the northern shoreline as shown in the map from 2018 (left)
