## Appendix 2B-1: Trends in Tidal Water Levels at Coastal Structures

Nicole A. Cortez and Tibebe Dessalegne

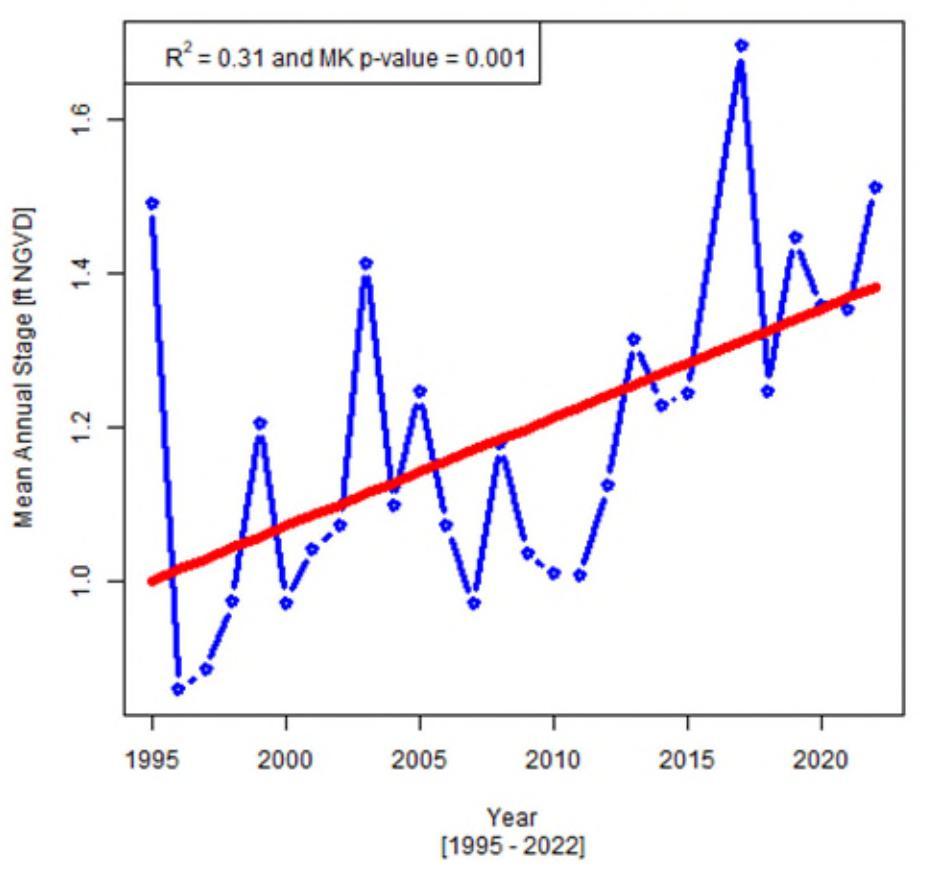
Average Annual Tailwater Stage at COCO1 - [4.31 mm/year]

**Figure 1.** Plotted average annual tailwater stage and trendline at the COCO1 structure along South Florida's east coast.

In the figures, the blue line is the average annual tailwater stage and the red line is the linear trend of average annual tailwater stage. The average annual stage is measured in feet (ft) National Geodetic Vertical Datum of 1929 (NGVD) and the change over the period of record is provided in millimeters per year (mm/yr). The period of record varies for each structure and is indicated under the x-axis title in each figure.

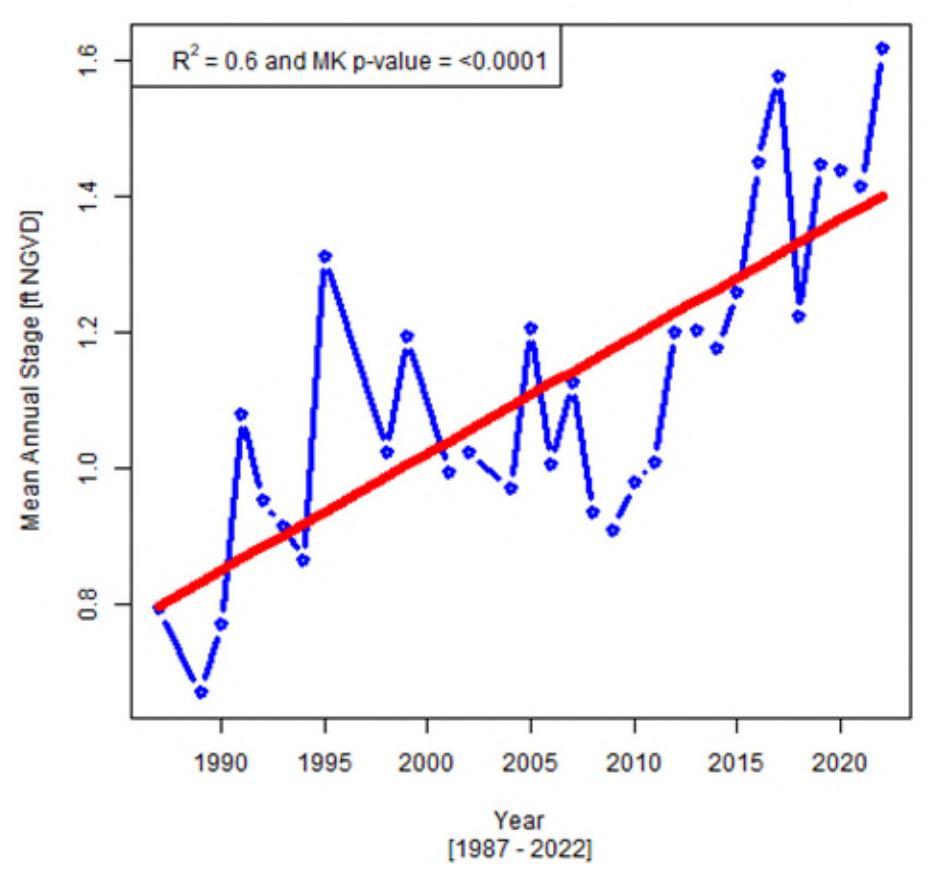
Average Annual Tailwater Stage at FU1 - [5.24 mm/year]

Figure 2. Plotted average annual tailwater stage and trendline at the FU1 structure along South Florida's east coast.
